## Summary of June 24, 2012 Lake Placid Tornado

David Roueche  
Ashlie Kerr  
Xinlai Peng

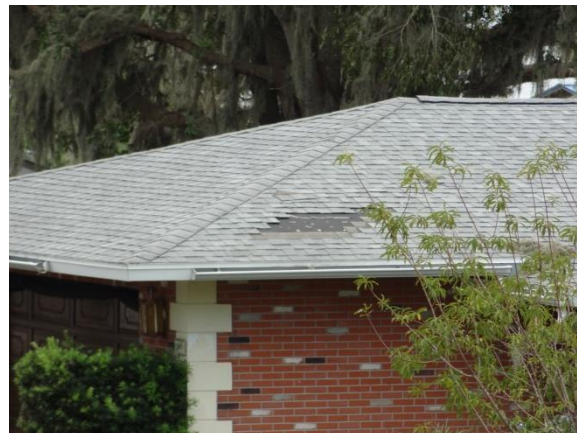
*DOD 1: Threshold of Visible Damage*

Minor damage such as loss of a few shingles but no evidence of any further damage.

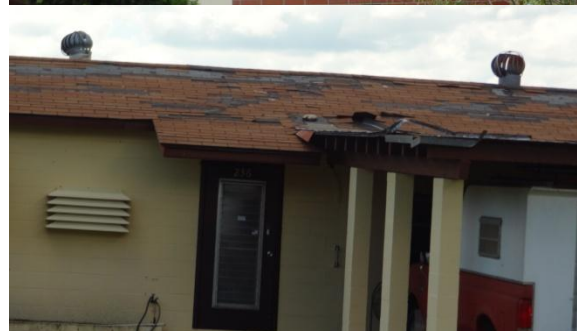
*DOD 2: Loss of roof covering material (<20%), gutters and/or awning; loss of vinyl or metal siding*

A few homes were observed which had relatively significant roof covering loss together with other minor damages, such as metal edge flashing, gutters, etc.

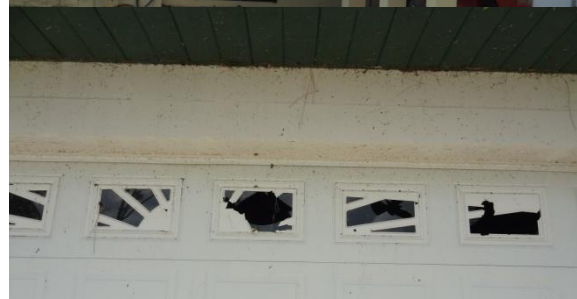
*DOD 3: Broken glass in doors and windows*

Several homes observed with broken glass. The picture to the right is in the garage door of a home off Cloverleaf Rd. Larger windows with broken glass were also observed, for the most part in walls facing the direction of the tornado's translation.

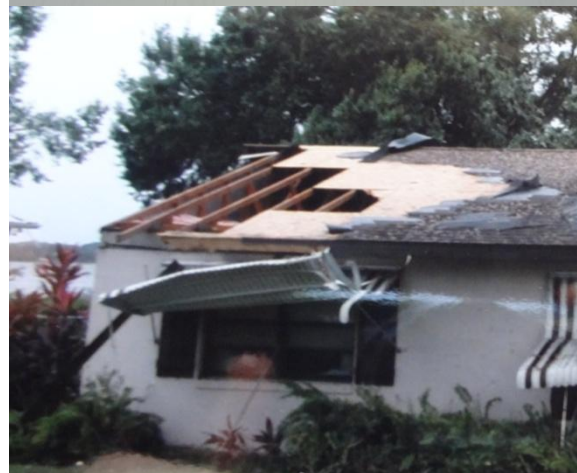
*DOD 4: Uplift of roof deck and loss of significant roof covering material (>20%); collapse of chimney; garage doors collapse inward or outward; failure of porch or carport*

Loss of roof deck was observed in several homes, including one which had been fastened with 4d nails in a 6:6 nailing pattern. Metal roof decking had also failed which had been fastened with #4x1-1/2" screws every 8" laterally and every 24" longitudinally.

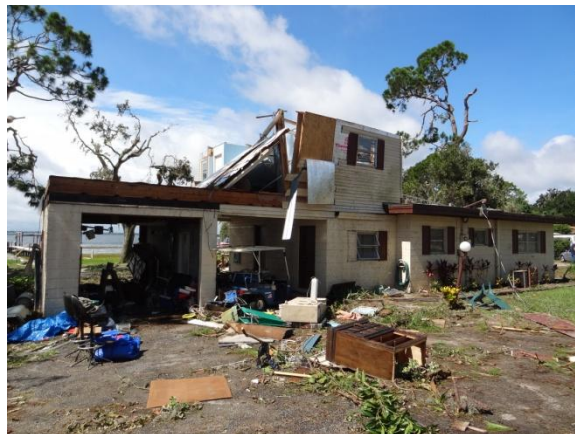
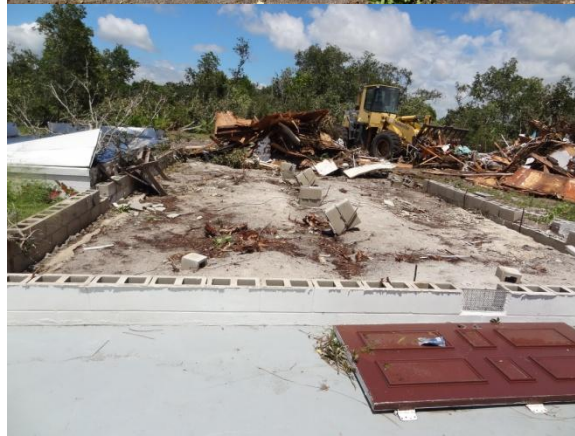
*DOD 9: Most walls collapsed in bottom floor, except small interior rooms*

Conversation with the homeowner and neighbors indicated this DOD may have occurred to one home but no pictures were available as further evidence. The surveying team took this picture upon arrival, but as can be seen the debris-cleanup was already in progress so the original state of the home could not be ascertained. Debris from this home though, including a complete, approximately 20' long truss, was found over 300 feet from the home location.

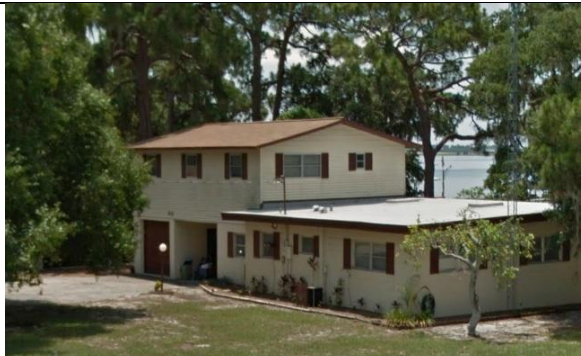
Address: 832 Lake June Rd	DOD Rating: 7
Structure Use: Single Family Residential	Wind Speed Estimate: 132mph
Year Built: 1960	EF Rating: EF2
This two-story single-family home was originally constructed in 1960, but garage and second floor were additions built in the 1970s. Original structure was CMU block with wood rafters forming essentially a monoslope roof constructed from 2x8 wood beams. Second story roof was also monoslope using rafters. Second story walls were constructed using 2x4 wood studs and plywood sheathing.

Original view from Google StreetView, clearly showing the flat roof original portion and the added gabled second story.

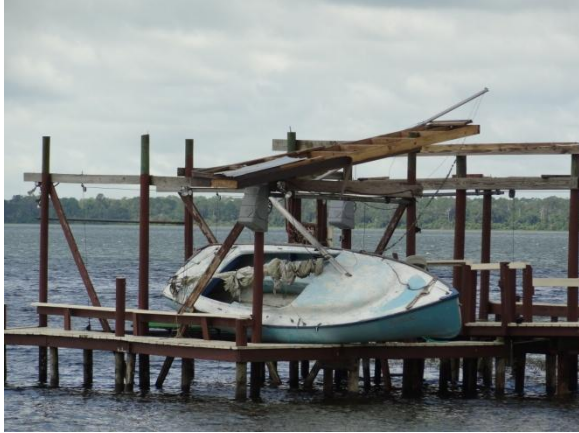
This boat house was on the lake behind the 2-story home damaged at the address above. Conversation with the homeowner and personal observations indicated that the boat house was a partially covered wood-frame structure with partial metal roofing. A sketch of the general roof plan is given below and was validated by the homeowner. Columns consisted of round 6" wood posts set in the lake bottom. Roof framing consisted of (2) wood 2x8's bolted to the posts on the exterior and nailed to the posts on the interior. Exterior bolts were 1/2"Øx14" long with rounded heads. Interior nails connecting 2x8 beams to posts were 0.25"x4". Hurricane straps were present on the right side of the structure for each rafter. On the left side a few straps were present near the front of the structure but none on the rafters, however this area was not accessible enough to determine what type of connection was used. Failures were clearly visible on the right side connections. The outer 2x8 split above the anchor bolts at the back connections, breaking the load path from the hurricane straps to the posts. In the front connections, two hurricane straps failed in tension at the center of the strap. The other straps likely failed through nail withdrawal but no nails remained in the straps and there was no indication that the nails pulled through the straps. Therefore either the nails fell out after the strap was separated from the rafter or were never installed in the first place. If the latter case was true the lack of a connection in those places likely accelerated the failure of the correctly installed straps.

Overview Picture of Boat House

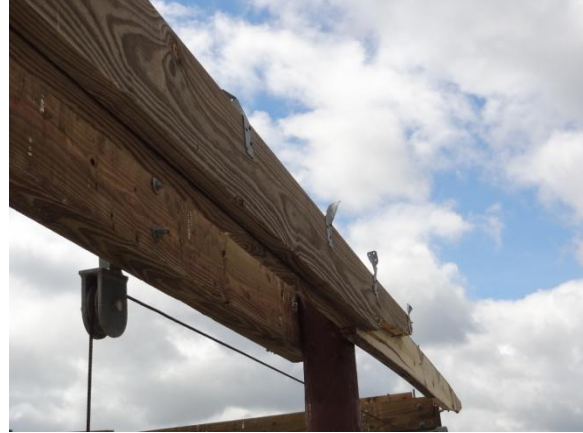
Failed roof-to-wall strap connections and split spandrel on right side

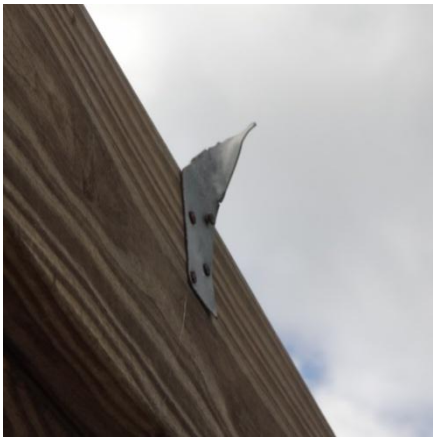
Failed hurricane strap at right-side spandrel

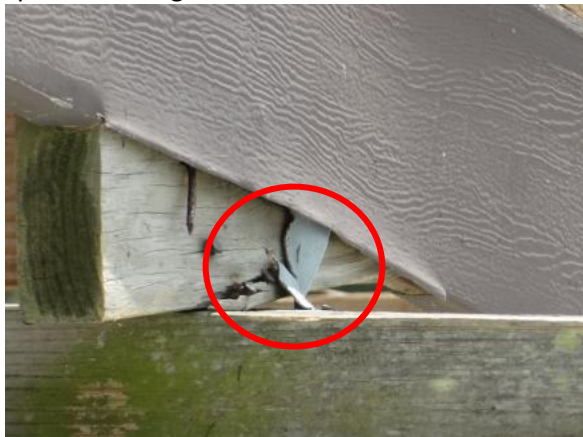
Sheared hurricane strap on left interior spandrel

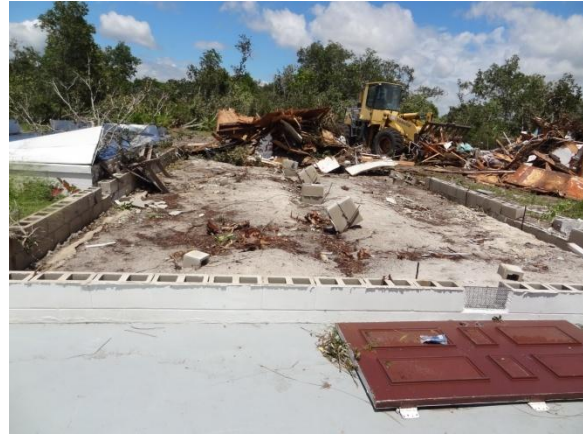
Summary: This home was purchased by the homeowner in the early 1980's for \$57,000. It was a wood-frame house built onto a CMU block stem-wall with grouted cells 8' O.C. Workers were already cleaning up debris from the home by the time the assessment team arrived but from discussion with the homeowner and the workers there was very little remaining from the house after the tornado had passed through. Debris from the house, including a complete 20' truss, were scattered several hundred feet further in the path of the tornado. From analysis of the remaining debris the house appeared to be poorly built. The only foundation anchorage consisted of metal straps embedded in the concrete footing of the stem wall and screwed to one side of the sill plate with two small screws. There were no anchors in the grouted cells. Some metal straps were visible but they only appeared to be used at the corners and were anchored through the ground to the stem wall foundation. Trusses were toe-nailed with (3)8d nails. No indication as to how corners were connected.

Only Stem Wall Remains of the Original House

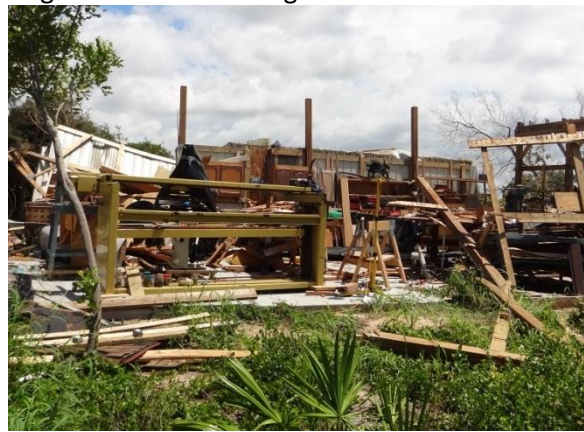
Adjacent to the house was a large workshop constructed out of 6x6 wood columns at 8' O.C. anchored to a concrete slab with wood purlins overlaid with metal sheathing. The wood purlins were fastened to the columns with (4) 3" long nails. Three of the four walls were totally collapsed, largely due to the shattering of the wood columns at the base along the front wall perpendicular to the path of the tornado. Fracture of wood purlins was also observed in multiple locations.

Only Back Wall Remains from Adjacent Workshop

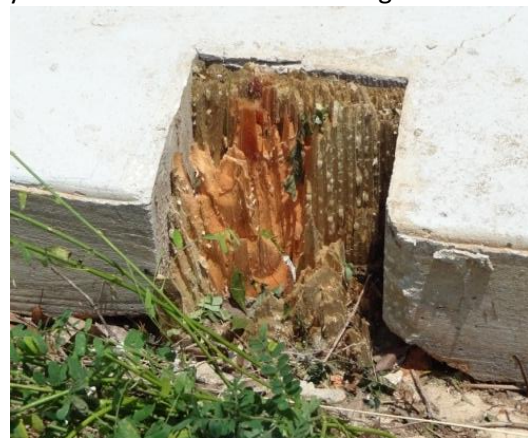
Fracture of Post Anchored Concrete Slab

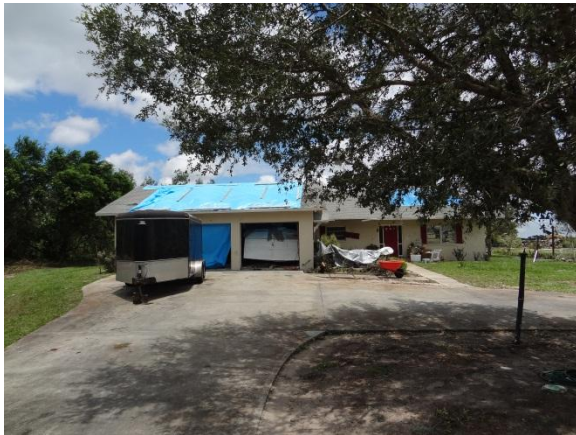
This 2211 square foot home consisted of a gable roof structure and 2-car garage at the front of the street. Walls were constructed of CMU block with unknown reinforcement. The roof consisted of wood trusses, plywood sheathing and asphalt shingles. The home experienced minor roof damage including the loss of approximately 200 square foot of roof sheathing and shingles. The garage door was blown inward and separated from its track. The support frame, consisting of wood 2x6's, for the garage was detached from the CMU wall on one side, but close inspection revealed that while ½" diameter bolts were used to fasten the frame to the CMU block, no nuts or washers were used to close the connection, allowing for failure at minimal wind speeds. Approximately 6-8ft of soffit was missing or damaged and a window shutter was disconnected from the wall. No broken glass or other damages were observed.

Overview of House from Street

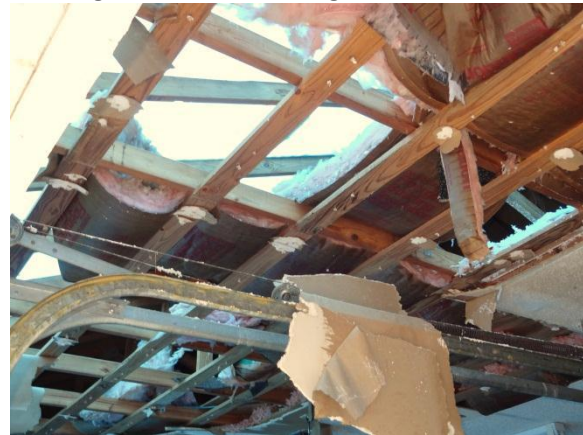
Roof Sheathing Failure

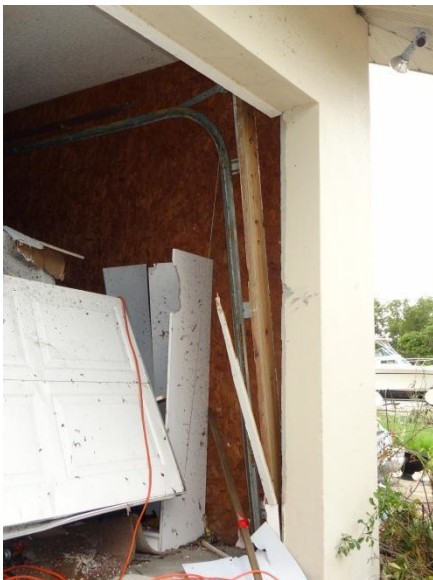
Garage Door Failure

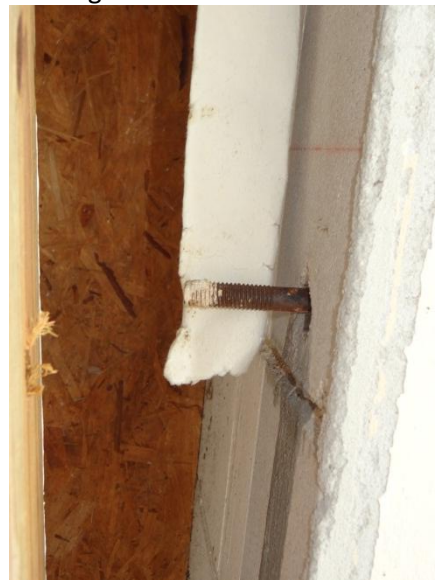
Garage Door Frame with Bolt Missing Nut

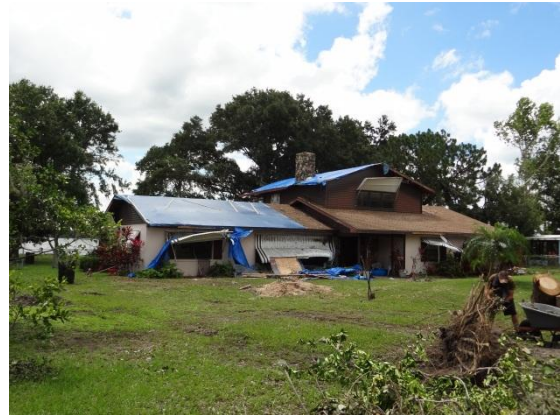
This 2269 square foot gable home was built to South Florida Building Code standards. The homeowner was originally from Miami and when he moved from there to have this home built, he directed the builders to use the much more stringent Southeastern Building Code rather than the Central Florida Building code that was in existence. Because of this the construction quality of the house was above average. The walls were constructed of reinforced concrete. A wood top plate was bolted to the concrete wall with  $\frac{1}{2}$ " bolts and 1" washers every 4' O.C. Wood trusses were fastened to the top plate with metal hurricane straps, although it was noted that some hurricane straps only used three nails. A vent along the entire ridge of the house was provided by means of an approximately 3" gap in the sheathing at the ridge joint. Structural damage to the house was relatively minor at first glance. Approximately 30% of the roof sheathing had been lost and the garage door had buckled inward. However the failure of the sheathing led to the ingress of large quantities of water into the interior, which consisted of mainly wood paneling. As a result the economic impact of the structural failure was substantial.

Post-tornado View from Damage Survey

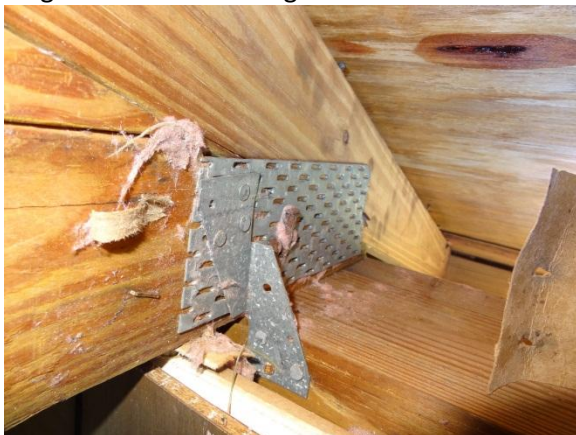
Hurricane Strap with only three nails

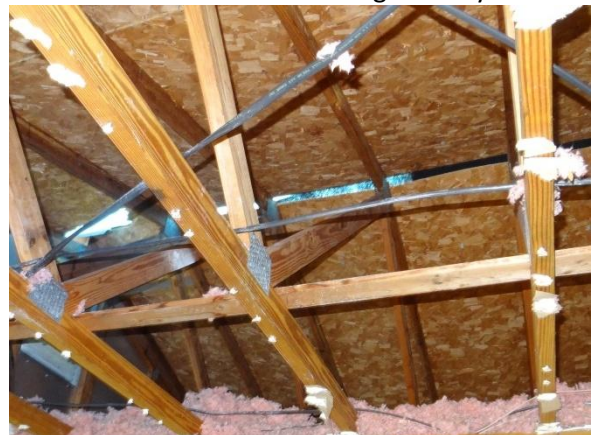
Ridge Vent provided by gap in sheathing joint
