Online Damage Report

The 11th January 2014 Wind Damage and Collapse of the Brier Creek Condominiums in Brier Creek, NC

University of Florida Wind Hazard Damage Assessment Team

13 January 2014

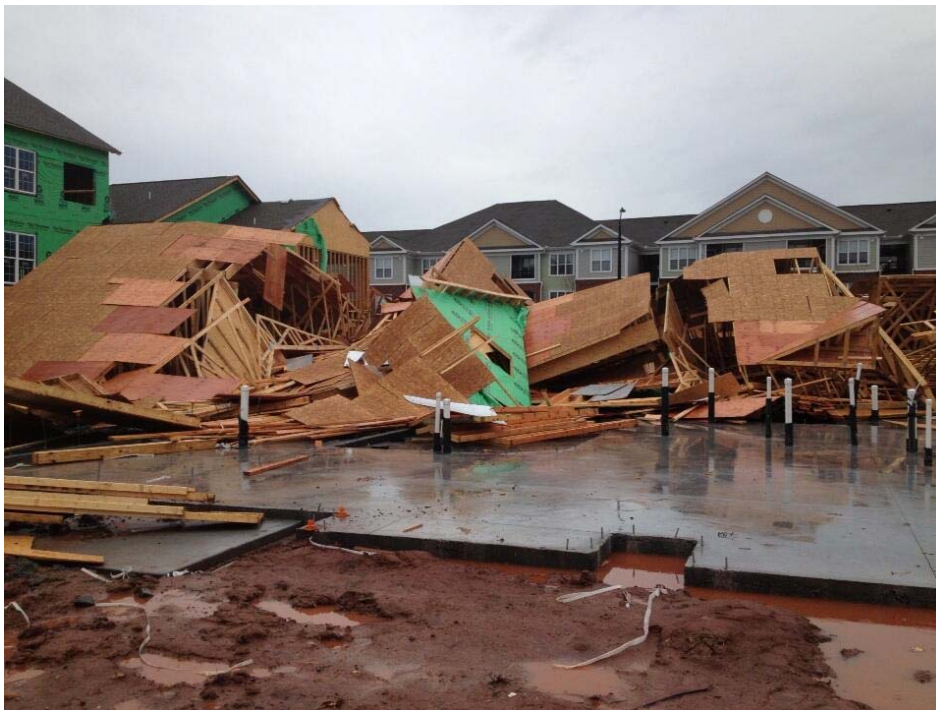
Figure 7: Courtesy of Justin Quesinberry (@JustinQberry). Note that the buildings collapsed forward onto the empty slab. The slab in the foreground was not part of the damaged buildings. The condos in the background likely sheltered the collapsed condos to some degree from the approaching wind.

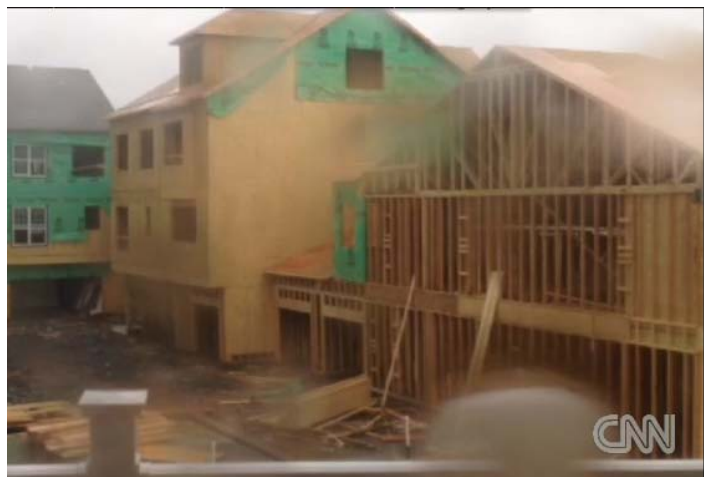
1. Significantly large lateral displacement occurs at top of first floor of the 3-story condo. Limited relative displacement observed between second and third floor levels (i.e. top 2 floors undergo rigid body motion).

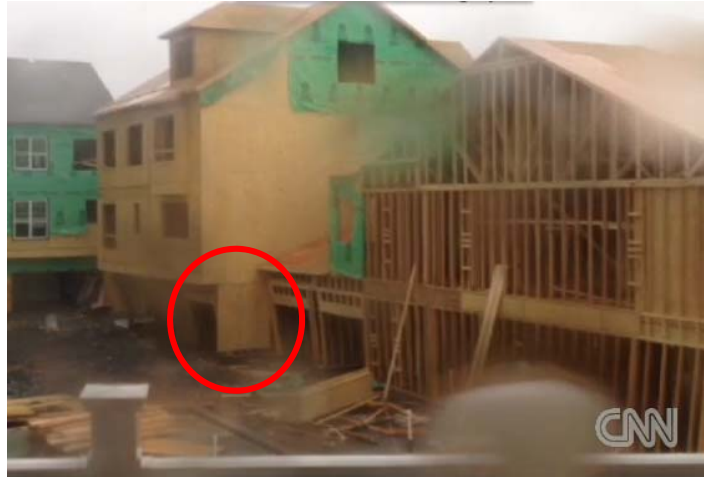
2. As lateral displacement increases collapse mechanism initiates. At the ground floor level, wood sheathing (circled) displaces independently (and without fracturing) of the 2 by 4 wood framing. The displaced sheathing appears undamaged at the corner.

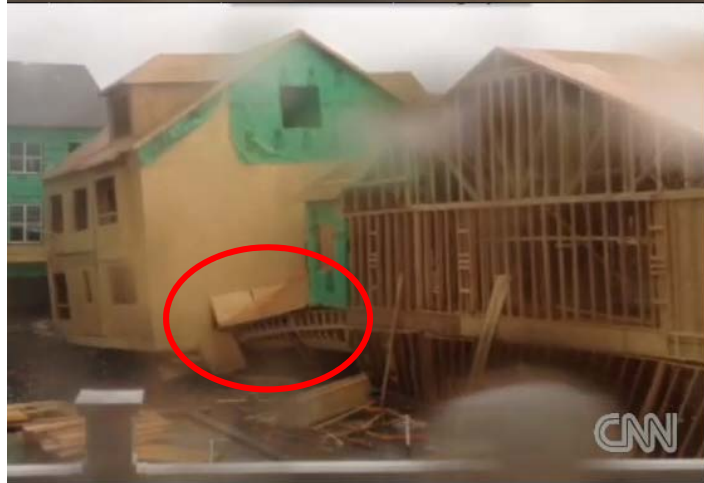
3. First floor level collapses, displacing the second, third stories and roof in rigid body motion. Additional wood wall sheathing appears to peel off of wall framing nearly intact (circled), which further reduces shear capacity of the N-S wall. Question: if wall sheathing fully or properly attached to framing, why does it fail in this manner.

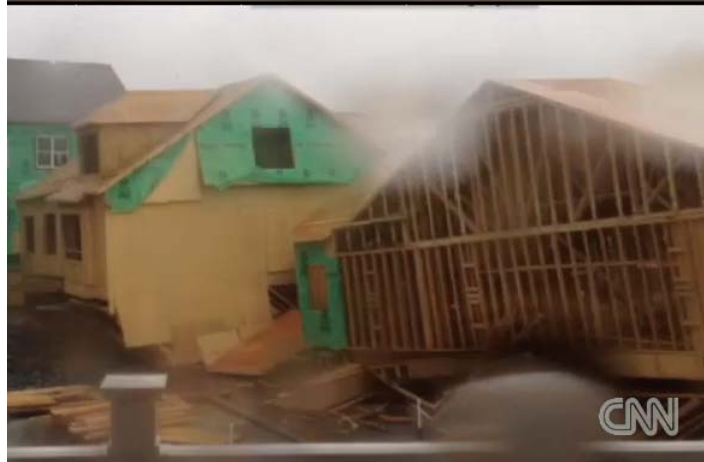
4. Failure of adjacent 2-story structure begins, possibly due to instability caused by failure of 3-story. Soft-story failure occurs at first floor level. Second floor and roof level appear to undergo some rotation as it fails.

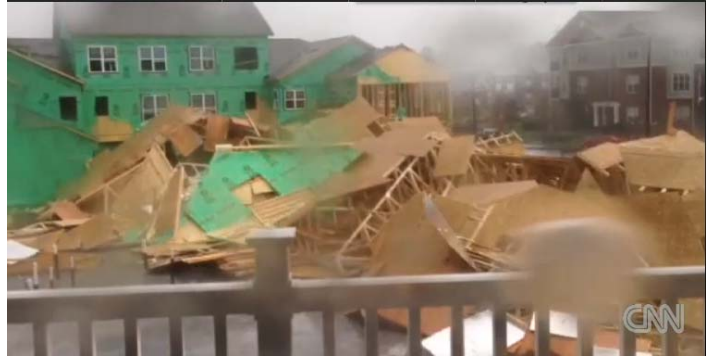
5. With the collapse of the bottom “soft” stories, the entire structures collapse on top of them and both condos are completely destroyed. Few observations of fractured wall sheathing or framing members

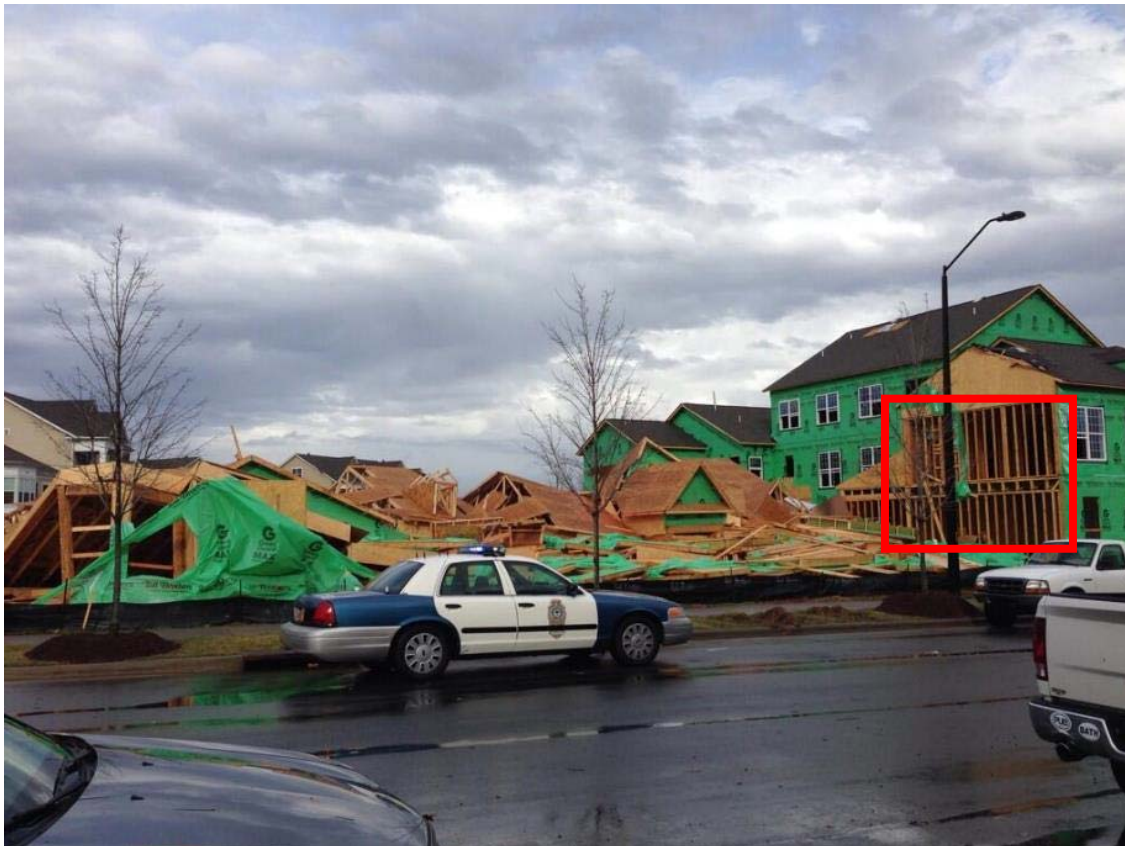
1. With the failure initiating in the bottom story of the sheathed condo, it is possible that the cause of the failure was unfinished or improper nailing of the bottom story sheathing along the side (E-W) shear walls.
2. It is also possible that the shared bottom story side (E-W) wall, between two units may not have been sheathed at the time of this wind event, in which case it would have lacked any shear capacity to transfer the applied lateral loads due to the high winds. Figure 6 appears to confirm this assumption, as it shows wall framing but no wall sheathing between the condominium units.

Figure 6 reprinted. Note the absence of wall sheathing at the North-South demising wall between adjacent buildings highlighted by the red rectangle.
