Online Damage Report

**The 17<sup>th</sup> November 2013 Illinois Tornado Outbreak**

**University of Florida's Wind Hazard Damage Assessment Team**

19 November 2013

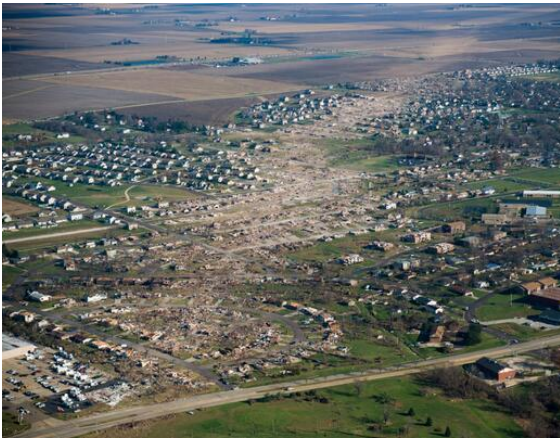
Figure 7: Aerial view of damage to Washington, IL

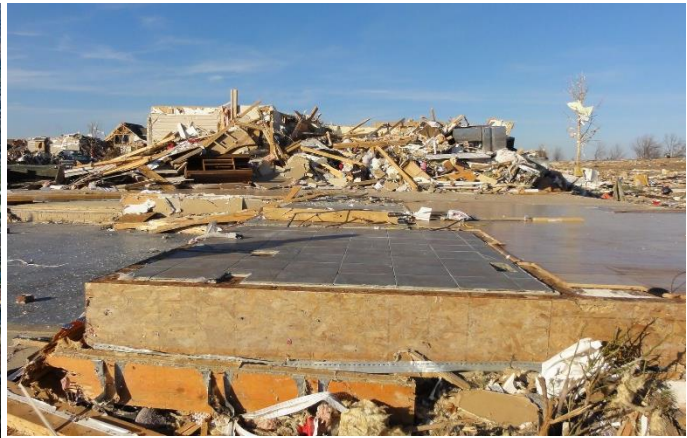
This tornado initially developed over the East Peoria County, IL at 10:59am CST and then moved northward towards Tazewell County and the city of Washington, reaching EF-4 intensity. The length of this tornado path was 46.2 miles, taking it through three counties. It caused one fatality, 122 injuries and damaged as many as 500 buildings in the city of Washington. The preliminary EF-4 rating was assigned due to the complete destruction of numerous homes in the tornado path. An aerial view of the damage path is shown in Figure 7, and an example of the EF-4 damage is provided in Figure 8.

Figure 8: Slab swept clean after tornado in Washington, IL

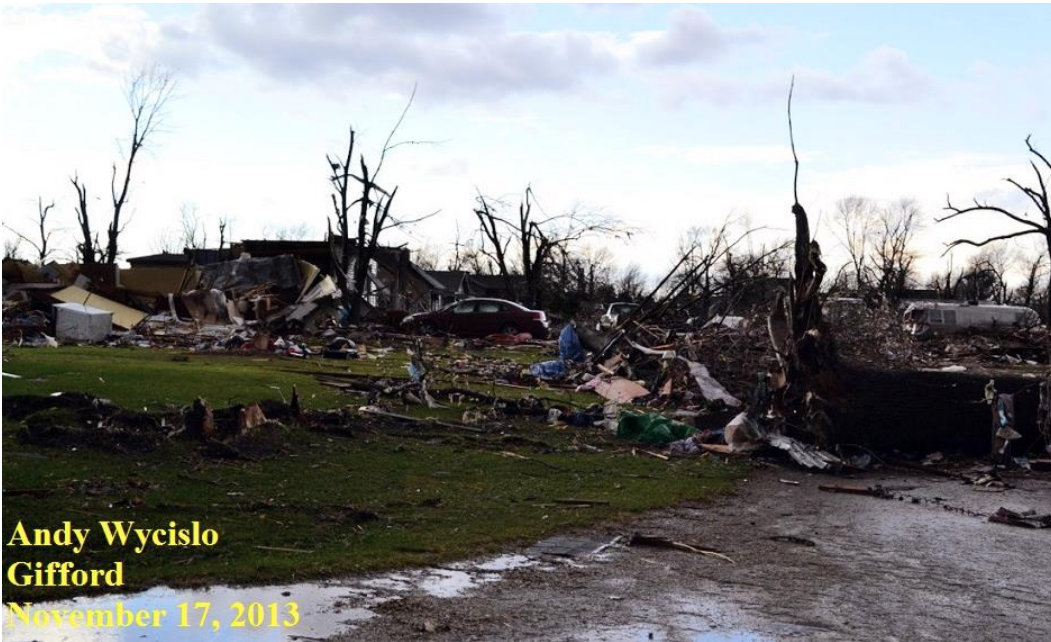
The Gifford tornado touched down at 12:45pm CST in Champaign County and tracked northeast for 24 miles, reaching a maximum EF-3 intensity in the town of Gifford, IL and causing 6 injuries before lifting in Vermillion County, IL. Figure 9 shows most exterior walls collapsed of a single-family home, indicating EF-3 tornado intensity. [Approximately 20 homes in all were destroyed.](#)

Figure 9: EF-3 damage to single family home in Gifford, IL  
(<http://www.crh.noaa.gov/ilx/swop/2013pics/wycislo111713b.jpg>)

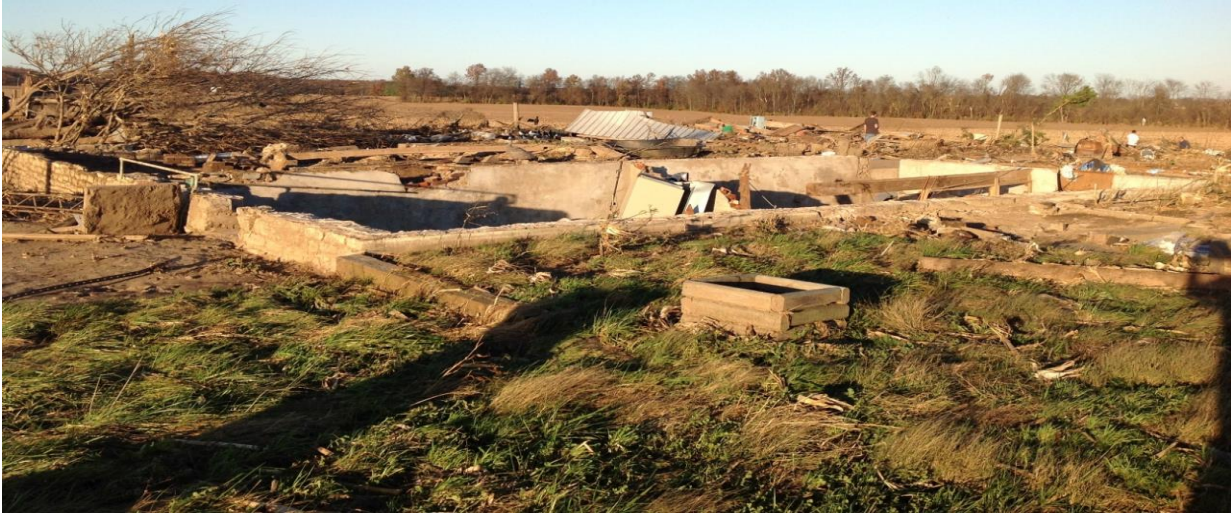
Figure 11 shows the EF-4 damage indicator for the Washington County tornado. The address of the home is 17642 Pheasant Rd, Nashville, IL 62263, but no details are available as to the year built or construction materials other than what can be seen from the photo, in which only the concrete foundation remains. Homes in the nearby town of New Minden however were mostly built in the 1930's to 1960's range.

Figure 11: The damage indicator for the EF-4 rating of the tornado through Washington County, Illinois (<http://www.crh.noaa.gov/lx/?n=survey1>)

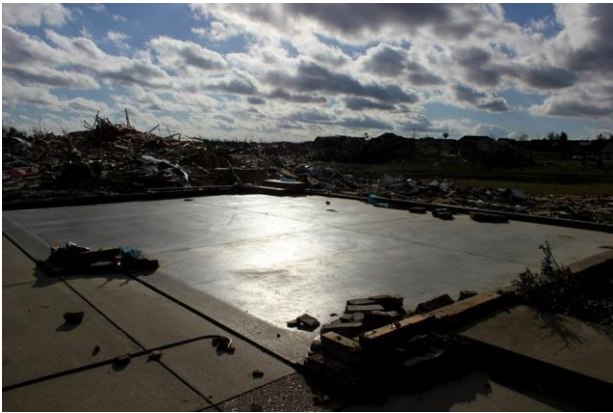
Figure 12: [Exposed foundation and Driveway of a Home in Washington, IL](#)

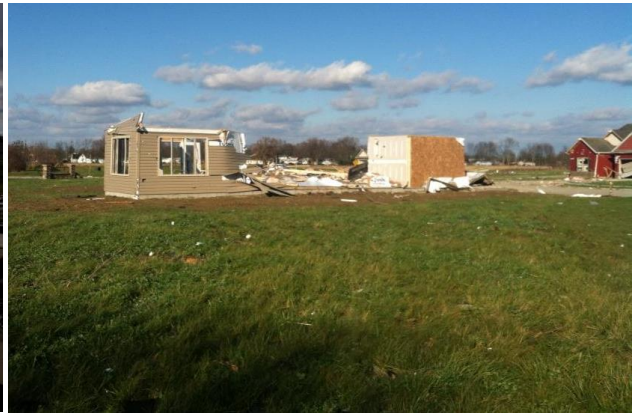
Figure 13: Home destroyed in Kokomo, IN  
(Personal Correspondence ?)

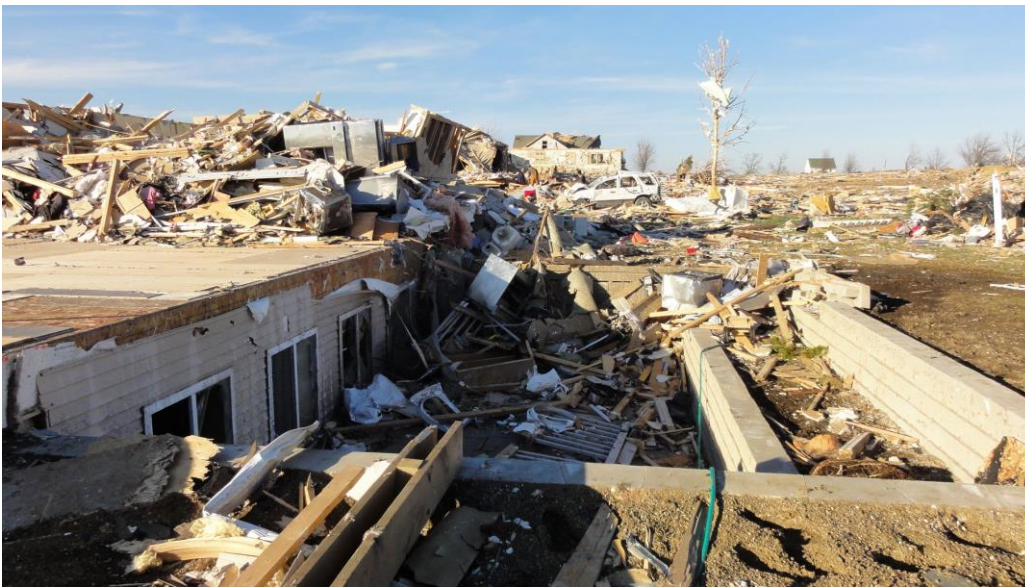
Figure 14: House swept off foundation and only basement remains of a home in Washington, IL  
(<http://www.crh.noaa.gov/ilx/?n=17nov13-tor2>)

The catastrophic damage to residential structures was reported in several places. Several houses were swept off their foundations, despite having anchor bolts with washers that fastened their wood sill plates to the concrete slabs. From this limited photographic information, it is not possible to know fastening details of the wood studs in the exterior walls. However, we suspect that the vertical wall studs were fastened using end nails (i.e. nails hammered from underside of the sill plates into the end grain of the studs), rather than using more wind-resistant metal strap connections. Although allowed in the International Residential Code, this end nailing technique for wall studs is a notoriously weak connection that provides virtually no resistance to uplift forces. End nailing at best should be considered as

temporary measure used during construction to position and hold the studs in place while the wall is being erected.

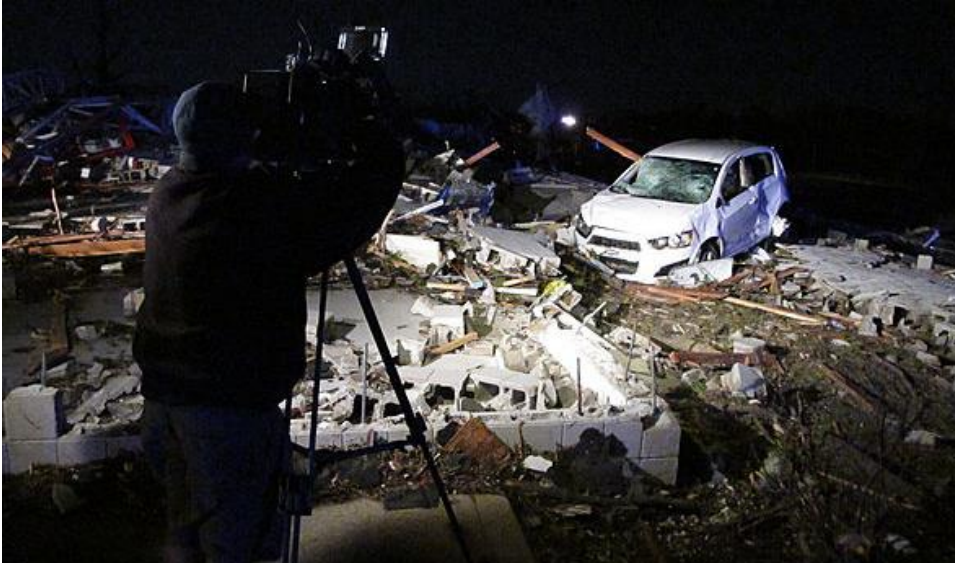
Several commercial structures were also heavily damaged, including an auto parts store shown in Figure 15. It appears this lightly reinforced (single bars at 3 – 4 ft o.c) concrete masonry building had discontinuous rebars that were not effective in resisting the wind loads, leaving the walls vulnerable to collapse once support from roof structure was removed.

Figure 15: Failed auto parts store showing discontinuous rebar in lightly reinforced CMU ([Accuweather](#))

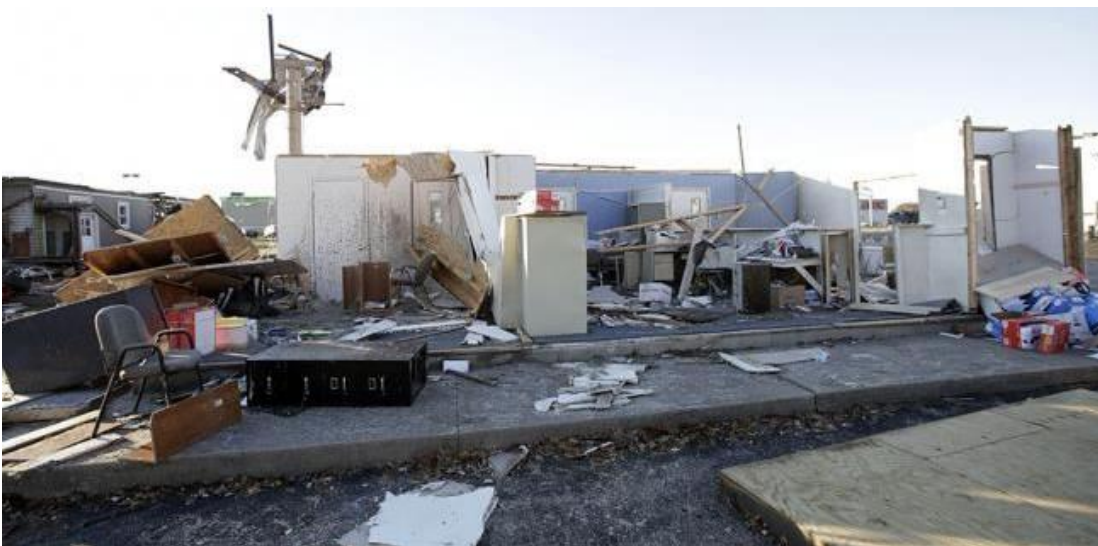
Figure 16: [Office building destroyed in Kokomo, IN](#)
