Online/Internet Damage Summary
of the 15th May, 2013 North Texas Tornado Outbreak

University of Florida Wind Hazard Damage Assessment Team

May 17, 2013

Summary of North Texas Tornado Outbreak on May 15th, 2013

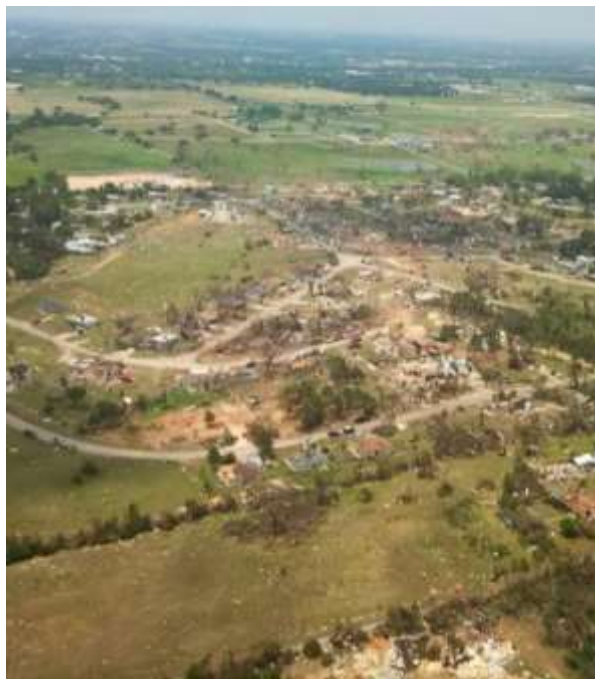
Figure 8: Aerial View of Granbury, TX

Overview photographs of damage are shown in Figures 8 and 9. Figure 9a shows damage to homes built in the mid-1990s, although exact ages are not known, at this time.

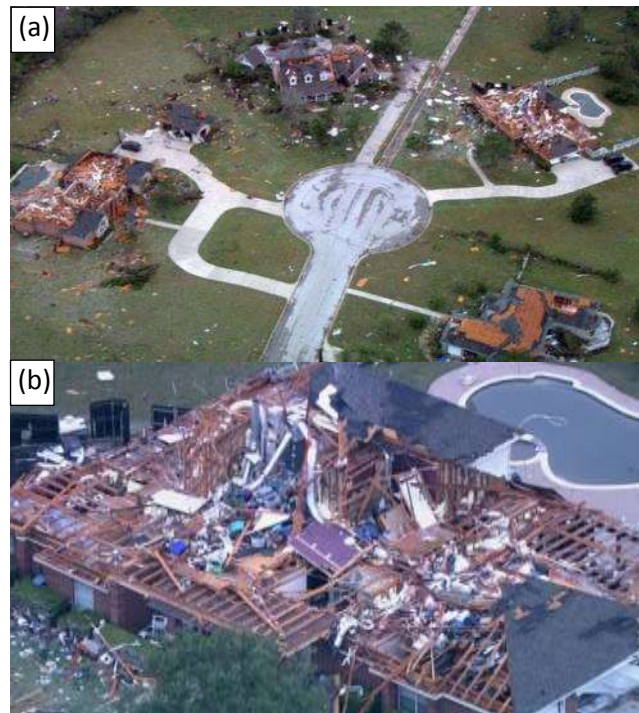
Figure 9: Observed Damage in Cleburne, TX (Credit: WFAA)

Additional photos of interest are shown in Figures 10-12. The damage shown in Figures 9 and 10 were the justification for the EF-4 rating in the Granbury tornado. Although anchor bolts were used, the use of small washers reduced the impact of this reinforcement. Further, the lack of metal ties connecting the studs to the sill plate resulted in a weak link in the vertical load path from the studs to the sill plate.

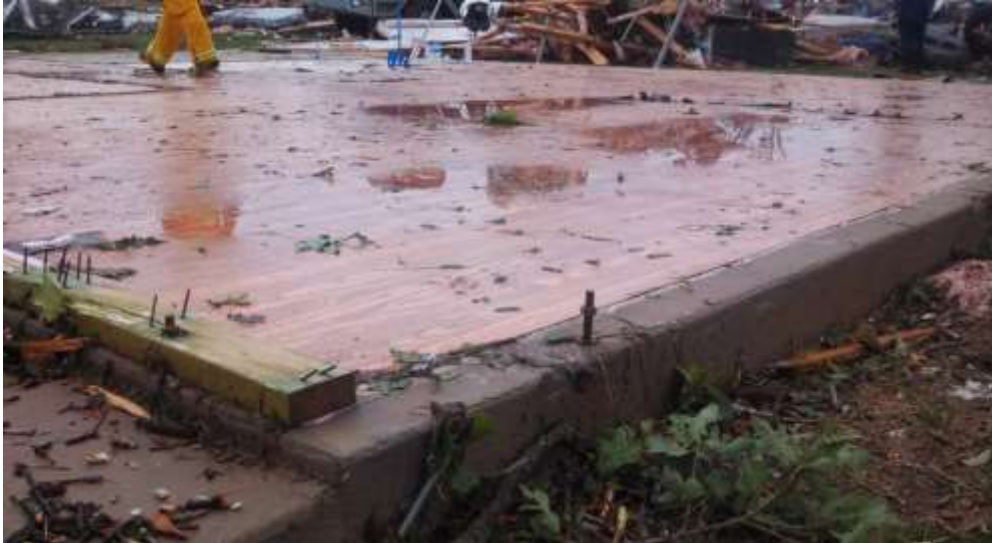
Figure 10: Complete destruction of home with anchor bolts just south of Hwy 377 & N. of Acton Highway in Granbury, TX (Image Courtesy of <http://www.srh.noaa.gov/fwd/?n=tornadoes051513>)

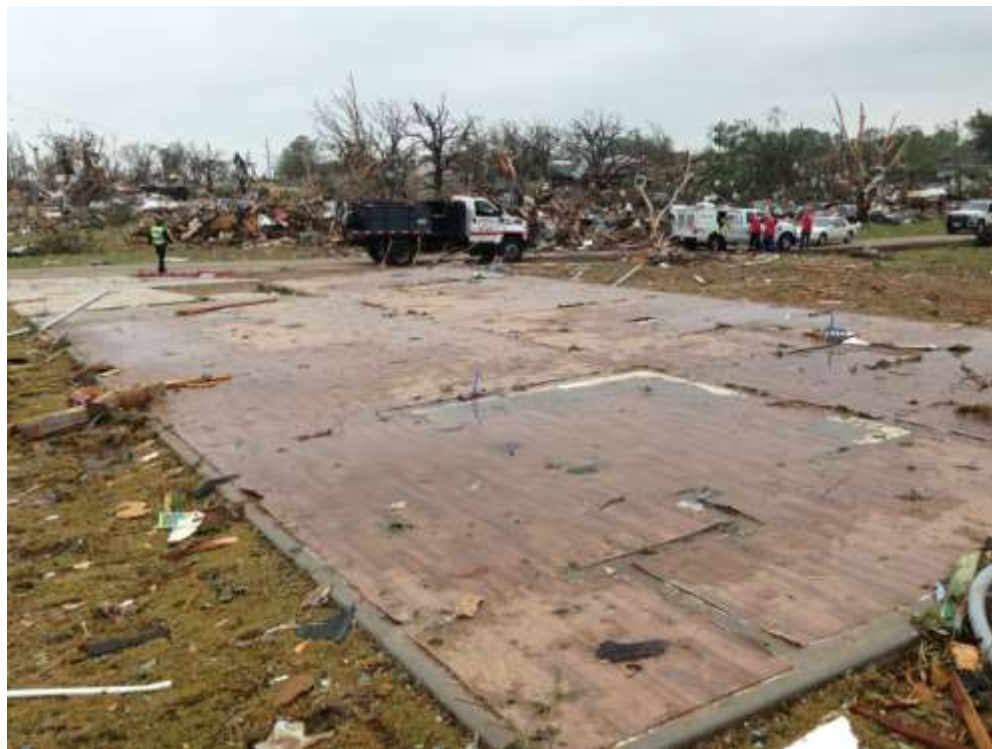
Figure 11: Complete destruction of home just south of Hwy 377 & N. of Acton Highway in Granbury, TX (Image Courtesy of <http://www.srh.noaa.gov/fwd/?n=tornadoes051513>)

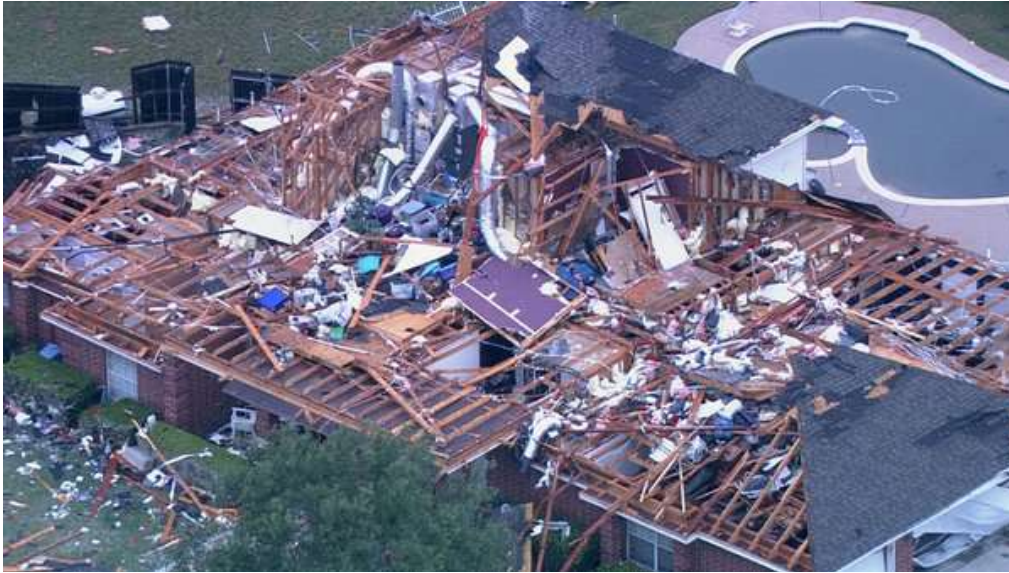
Figure 12: Damage in Cleburne, TX (Credit: WFAA)

It is interesting to note in Figure 12 that a significant portion of the upper story of this home was demolished, even though the asphalt shingle roof was only partially removed and trees, bushes and even fence panels nearby are still standing.
