Online Summary

The 1 August 2013 Tornado in Jacksonville, FL

University of Florida Wind Hazard Damage Assessment Team

9 August 2013

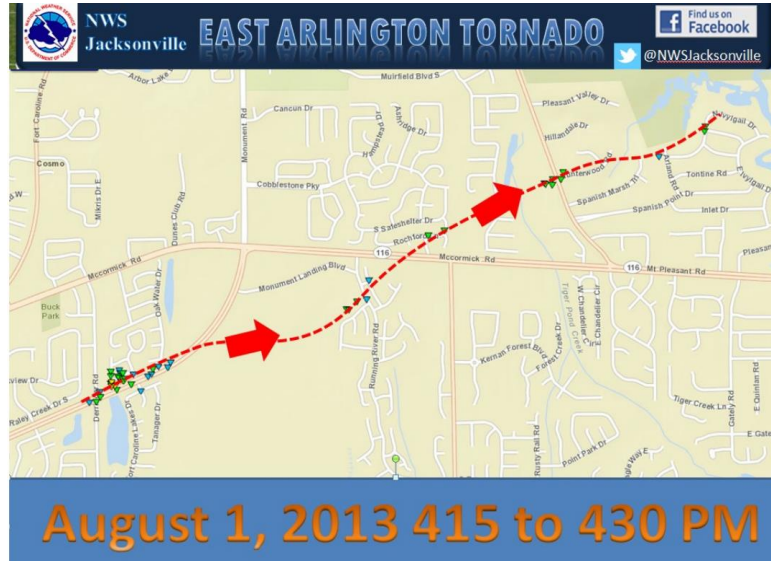
The estimated tornado track as determined by the NWS Jacksonville survey team is shown below in Figure 4. The total length of the tornado was approximately 3 miles and at its widest point the damage path from the tornado was nearly 135 yards wide (NWS).

Figure 4: Estimated Tornado Track

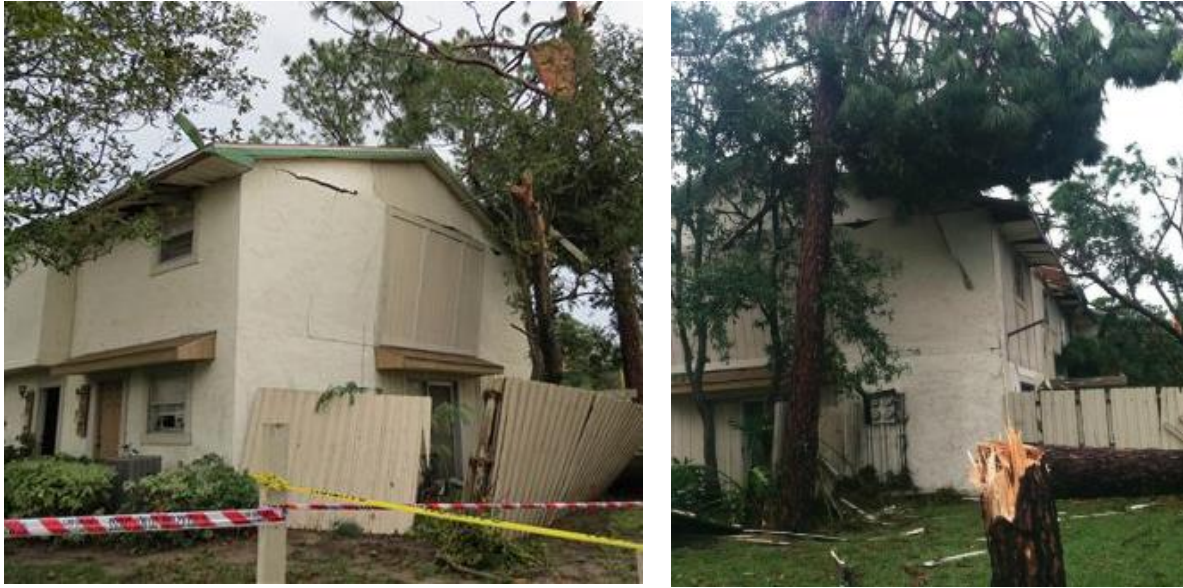
Preliminary reports from the Jacksonville Sheriff's office and social media indicated minor to substantial damage to at least 15 structures. Some of the heaviest damage was observed at the Shadowood apartments on Willowood Drive. The majority of the damage to structures amounted to walls protruding outwards and sheathing loss (Figure 6), while the more substantial damage was caused by tree fall (Figure 7). Figure 8 shows a 2 X 4 that was launched into a home on Willowood Dr as a result of the strong winds.

Figure 6: Damage to the Shadowwood apartments by Willowood Dr
(Courtesy of National Weather Service Jacksonville)

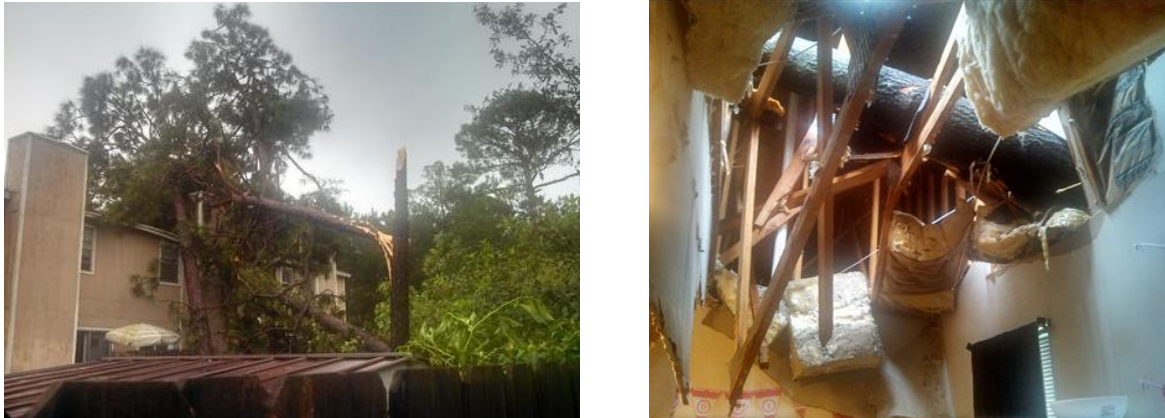
Figure 7: Damage to homes by fallen tree in neighborhoods off of Monument Road, Jacksonville, FL
(<http://www.firstcoastnews.com/topstories/article/322391/483/Roads-cleaned-homeowners-still-cleaning>)

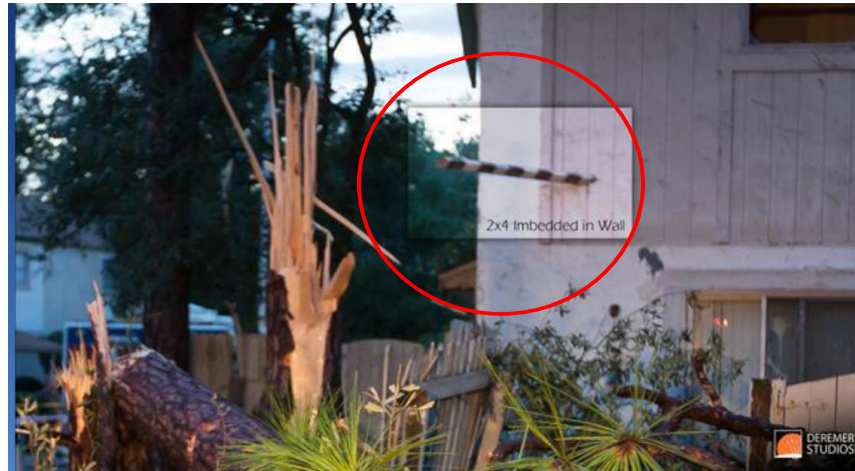
For wood-framed wall, penetration by a 2x4 member typically occurs when the 2x4 s travelling at approximately 35 mph. Without knowing how far this object had flown it is not possible to estimate the wind speed, however, FEMA 361: *Design and Construction Guidance for Community Safe Rooms* suggests that objects lifted by the wind typically achieve velocities of 0.375 times the local gust wind speed with approximately 30 feet of travel distance. On that basis the wind speed estimate would be 93 mph, which is also in the range of EF-1 intensity.

Figure 8: 2 x 4 imbedded in wall at the Shadowood apartments by Willowood Dr
(Courtesy of National Weather Service Jacksonville)
