## Summary Report

### Damage from Severe Weather on 8 June 2014 in Alachua County, Florida

### University of Florida Wind Hazard Damage Assessment Team

11 June 2014

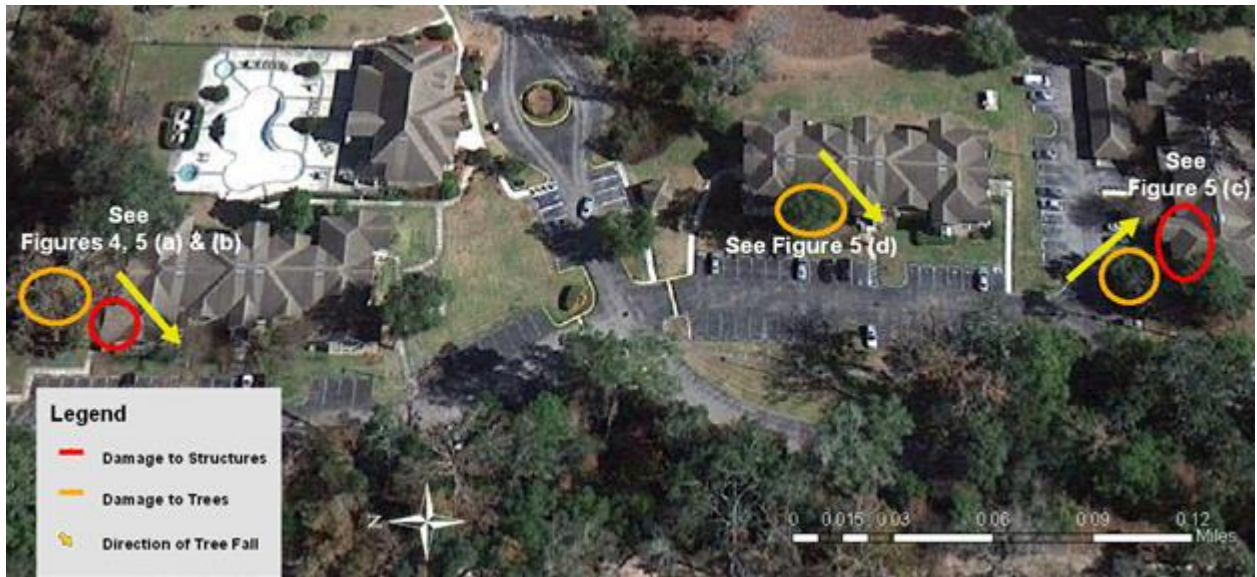
Figure 3: Damage map of the Reserves at Kanapaha apartment area

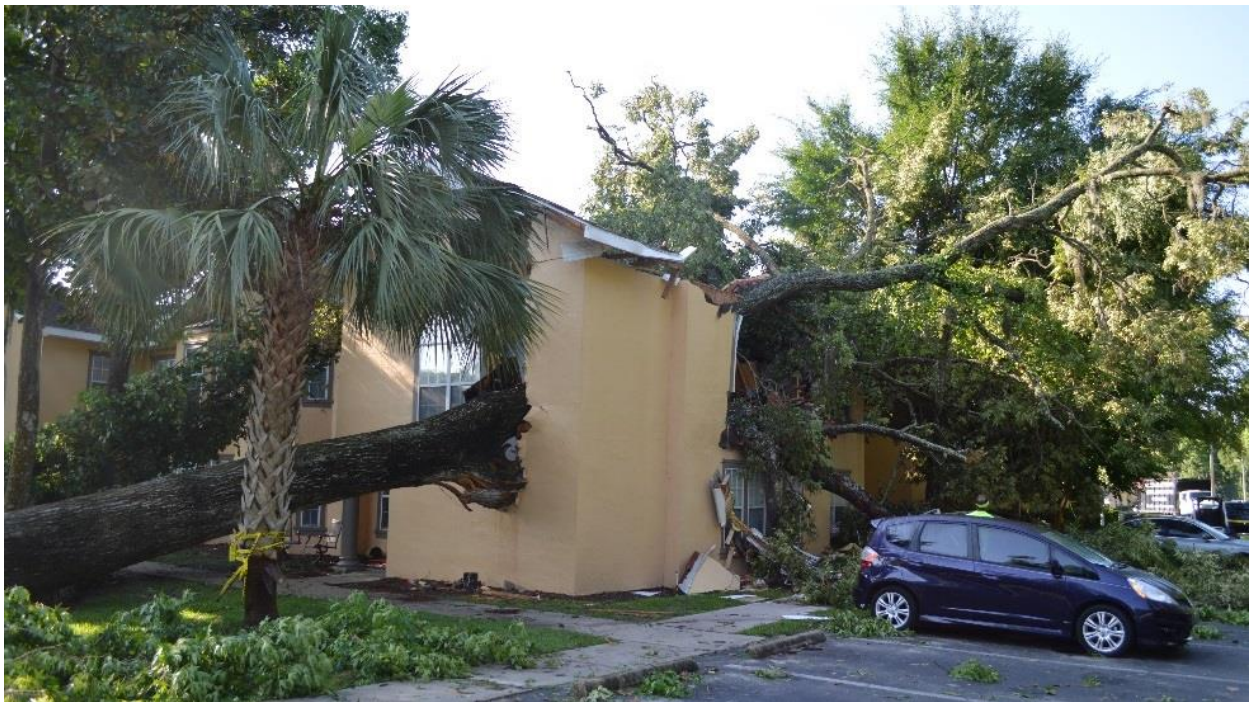
Figure 4: Damage to building 700 at the Kanapaha apartments by fallen oak tree

A massive water oak, approximately three and a half feet in diameter, collapsed during Sunday's storm. The tree tore through a two-story unit of the Reserve at Kanapaha apartments on the 4400 block of SW Archer Road near Interstate 75, located just northwest of the University of Florida main campus. According to the Property Manager of the complex, the damaged building was built in 1999. The fallen tree cut through a wood-framed gable roof, exposing the oriented strand board wood sheathing and  $\frac{1}{2}$  inch thick stucco in the exterior walls. The roof structural system consisted of metal plate connected wood (2x4) trusses, supported on light-framed wood stud walls. It is believed the roof trusses were fastened to the wall top plate using toe nails, as no metal hurricane ties were visible at the site of the damage, See Figure 4 and 5(a). There were no fatalities, although a mother and daughter, trapped inside, were later rescued by Gainesville Fire Rescue firefighters. The girl had minor injuries (Source: <http://www.gainesville.com/article/20140609/ARTICLES/140609655/1002/news?Title=Weather->

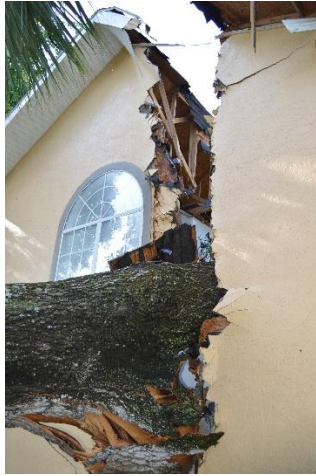
(a) Close up of tree damage from Figure 3

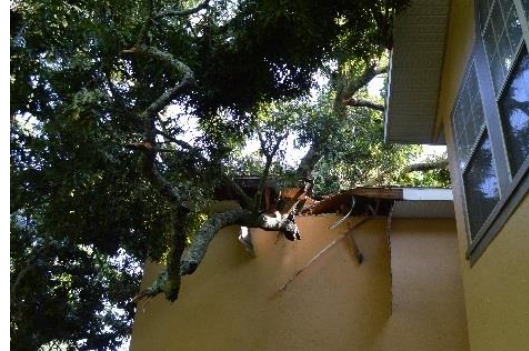
(b) Close up of tree damage from Figure 3 looking North

[service-warns-of-more-strong-thunderstorms&tc=ar](#) ). Figure 5 (b) shows the damage of the same building from an adjacent corner.

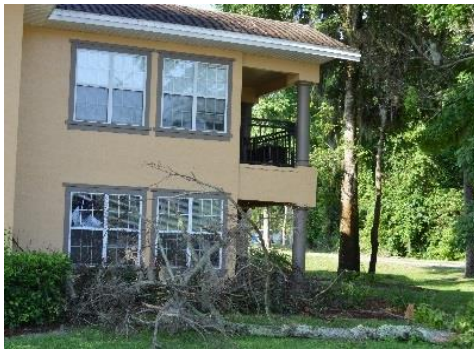
(c) Three shattered windows

Another unit approximately 200 yards away suffered minor damages, with three shattered windows from falling branches. A resident of this unit explained that she was on the porch as the storm approached, and did not see any funnel cloud or hear the roar typically associated with tornadoes.

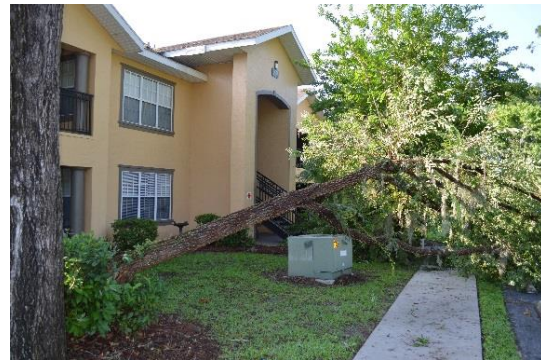
(d) Snapped oak tree about 10 inches in diameter

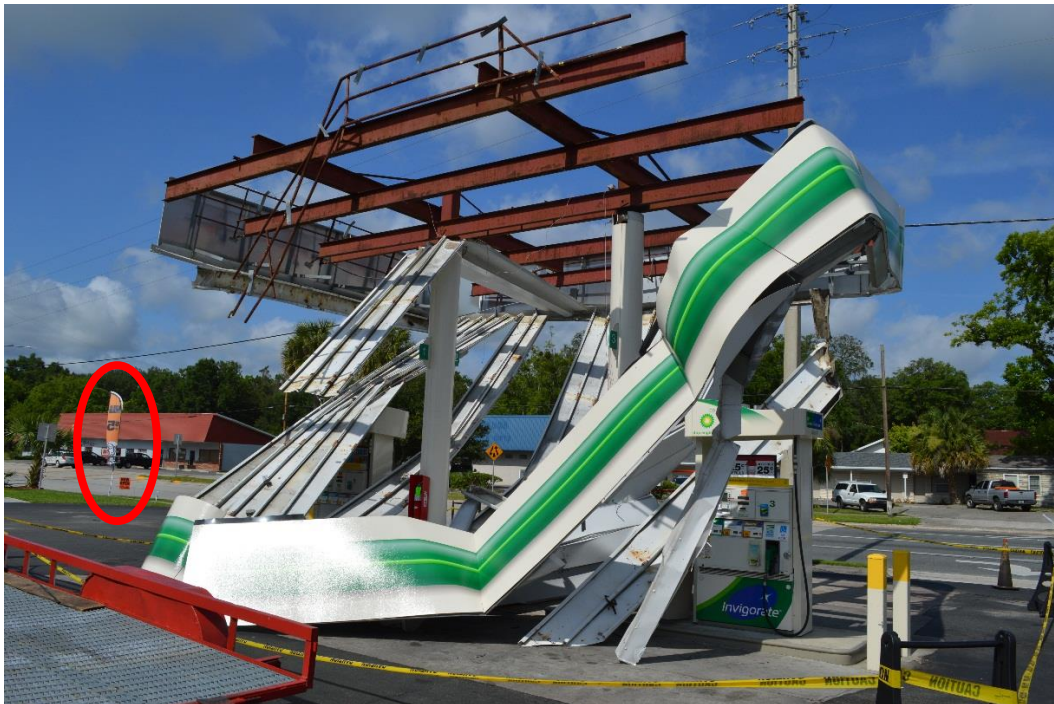
Approximately 14 miles west of the Reserve at Kanapaha apartments, the metal canopy of a BP gas station was damaged. The roof canopy measured approximately 30 ft by 30 ft in plan with a total height of 17 ft, which included a 36 in. tall vertical metal fascia installed around its perimeter. The structural system consisted of five W-section beam hung off steel cantilever beams. Located at the intersection of State Road 45 and Newberry Road, the light-weight metal panel cladding system was ripped off of the structural steel frame (Figure 6.) The damage pattern suggests it may have been impacted by a downward wind force, (possibly from downdraft associated with the leading edge of the thunderstorm). The metal panels were fastened to the bottom flanges of the roof beams at approximately 8 inches on center, and the panels fractured around the fasteners and pulled off of them. There was visual evidence of corrosion around most of the fasteners that had pulled through. The fasteners remained attached to the steel members. This was an isolated damage – we did not observe any other signs of damage to buildings or trees around the canopy, and several banners, one visible in Figure 6 below, just a few yards away remained intact. We noted a few downed branches and a couple small trees that were blown down, but there was nothing resembling a specific damage path attributable to a tornado.

Figure 6: Extensive damage to BP gas station canopy. Note the vertical banner outlined in red located on the same side of the road just a few yards away still standing undamaged.
