Online Damage Report

**The 27th April, 2014 Tornado Outbreak**

**University of Florida's Wind Hazard Damage Assessment Team**

29 April 2014

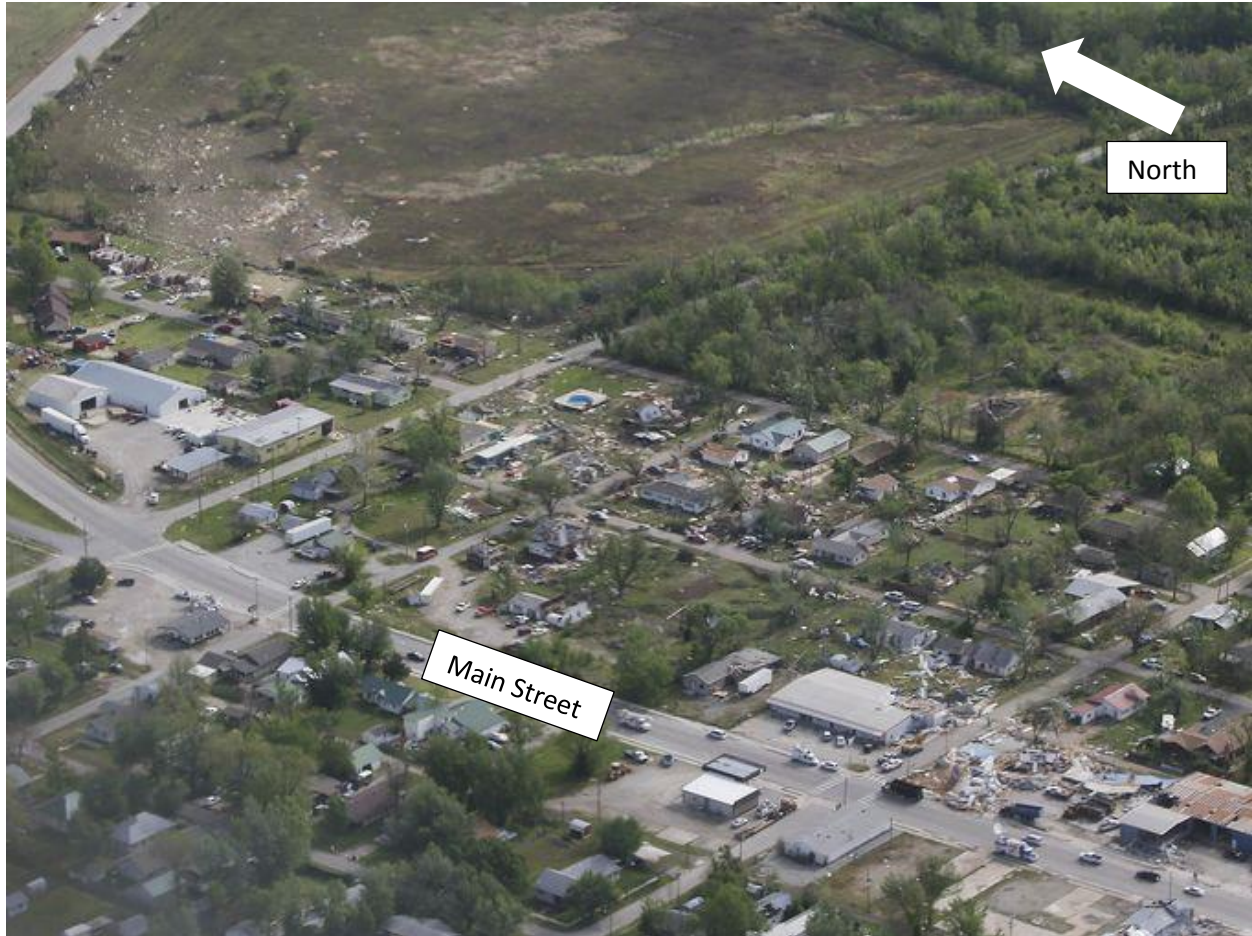
[structures](#) in the town, including five businesses and the volunteer fire department station. Approximately 45 other structures also sustained damage. One fatality was confirmed, due to a concrete wall falling onto a car, killing the driver. The National Weather Service has given a preliminary EF-2 rating to this tornado.

Figure 3. Aerial view of tornado path through Quapaw, OK.

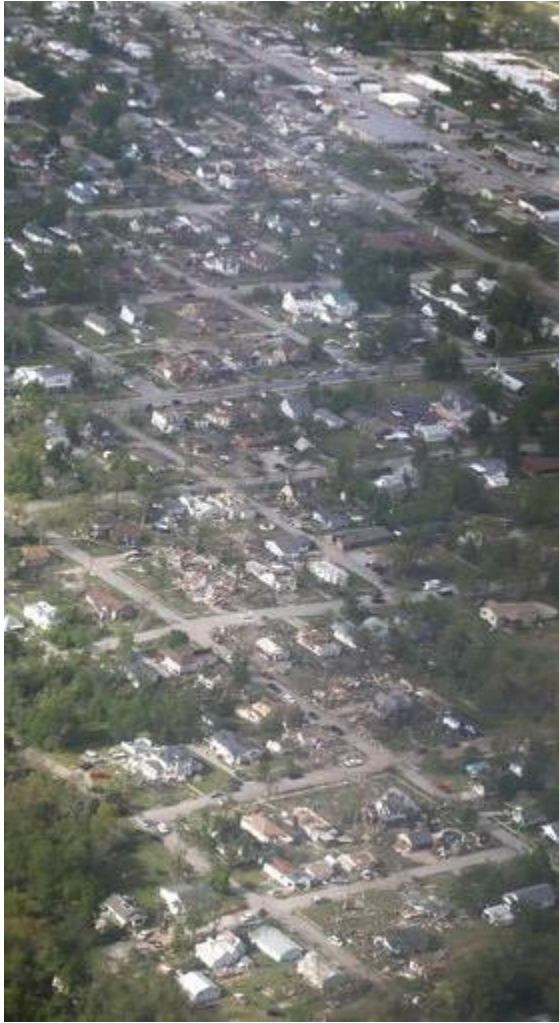
The April 27, 2014 tornado struck the town at about 5:45pm on Sunday afternoon, a time when most of the town's residents would be in their homes. The tornado damaged nearly 100 homes and businesses and caused 25 confirmed injuries. The path of the tornado through the town is visible in Figure 5. Damage to homes is shown in Figure 6 and Figure 7.

Figure 5. Aerial view of damage through Baxter Springs, KS

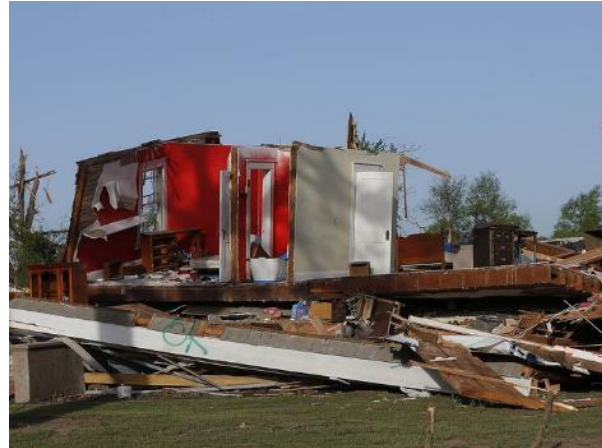
Figure 6. Degree of Damage 7 (113 mph - 153 mph). Possibly an EF2 rating.

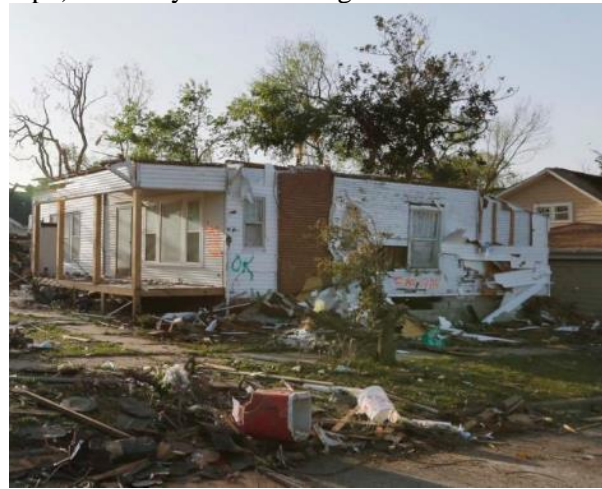
Figure 7. Degree of Damage 6 (104 mph – 142 mph). Possibly an EF2 rating.

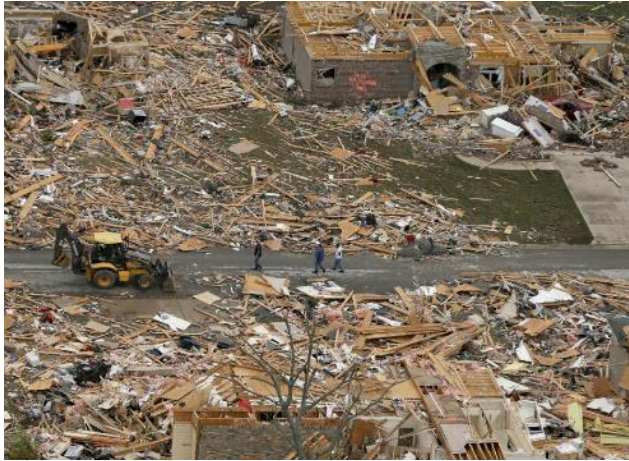
Figure 9. Severe damage in the River Plantation development east of Mayflower, AR

From photographs of the damage and available realtor reports, it appears the homes in this area are generally masonry construction with wood rafters framing the roofs. The roofs appear to consist of wood sheathing and asphalt shingles. All of the homes appear to have enclosed garages. The available photographs indicate similar wood-frame construction that was observed in damaged homes in Moore, OK last year. The use of long wood rafters with steep sloped roofs is ill-suited to resist the high uplift wind forces. In those Moore, Ok homes, surveyed by the PI last year, the rafters were toe-nailed into the wall plates, which provided insufficient capacity to resist the loads. The wind uplift loads are exacerbated by the presence of roof overhangs. For example, the roof failure of a Mayflower, AR home shown in Figure 11 suggests a combination failure mechanism, initiated by high loads on the overhang, causing roof-to-wall connections to fail and then the remaining roof section to be swept away.

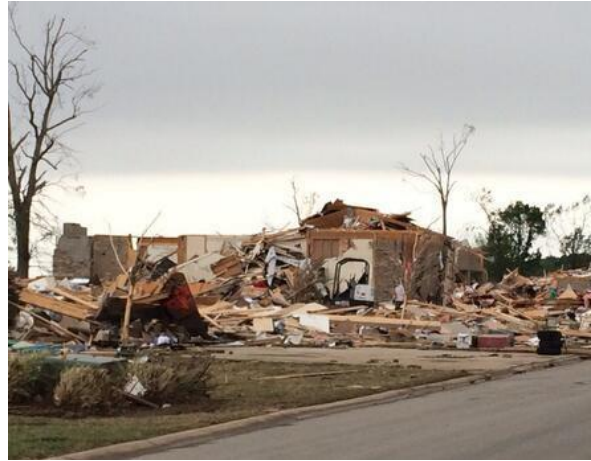
Figure 10. Roof destroyed from home in River Plantation development

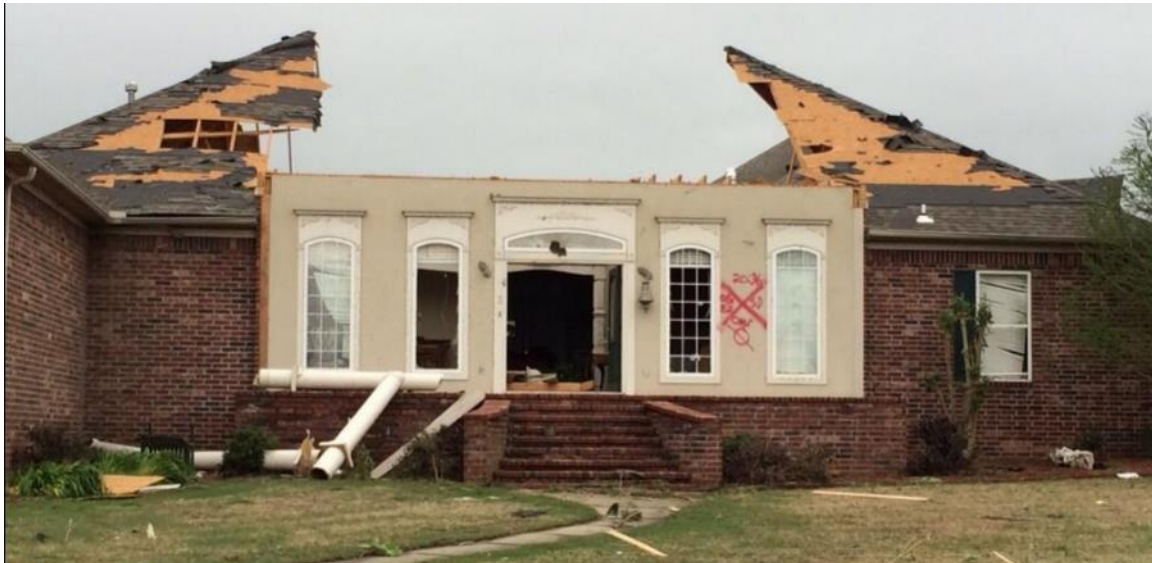
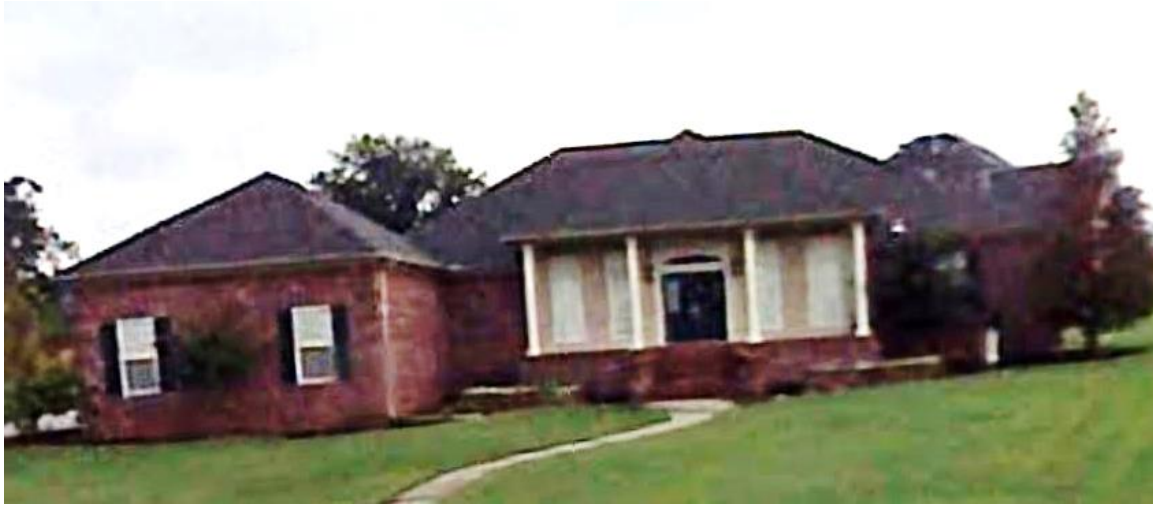
Figure 11. Before (bottom, from Google StreetView) and after (Courtesy of Twitter user @courtneyism) of a Mayflower, AR home in River Plantation.

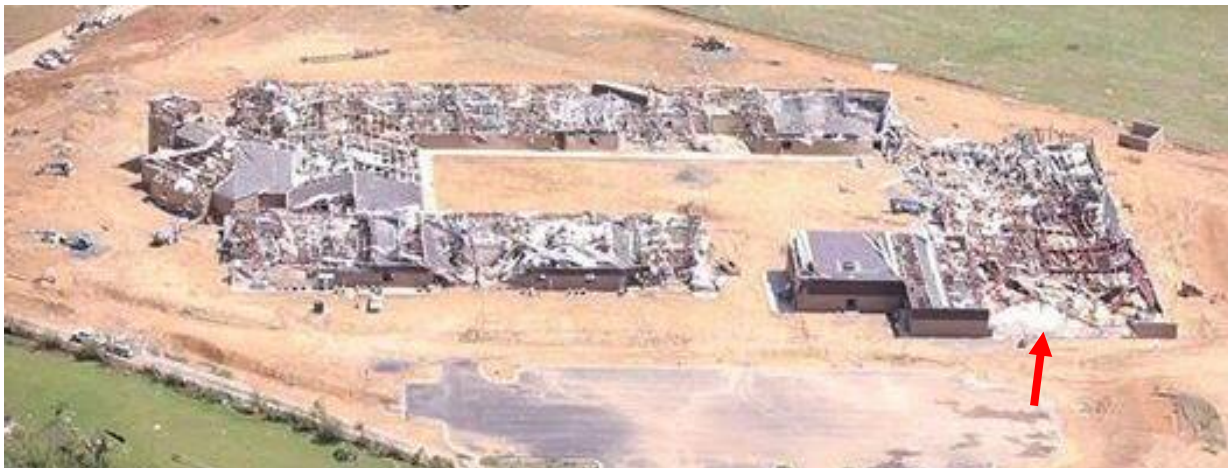
The school sustained severe damage, with the majority of the cladding removed and destroyed and significant damage to the structural members as well, as shown in Figure 14 and Figure 15. Because of the complete destruction of a large portion of the building as shown in Figure 15, this damage could be rated as high as DOD 10 using the Elementary School Damage Indicator of the EF-Scale. This would put the estimated wind speeds between 152 mph and 203 mph with an expected value of 176 mph, which would be an EF-4. A more thorough ground-based investigation would be needed to confirm this.

Figure 14. Severe damage to new Intermediate School in Vilonia, AR set to be opened Fall 2014. Red arrow indicated location and direction of photo shown in Figure 15.

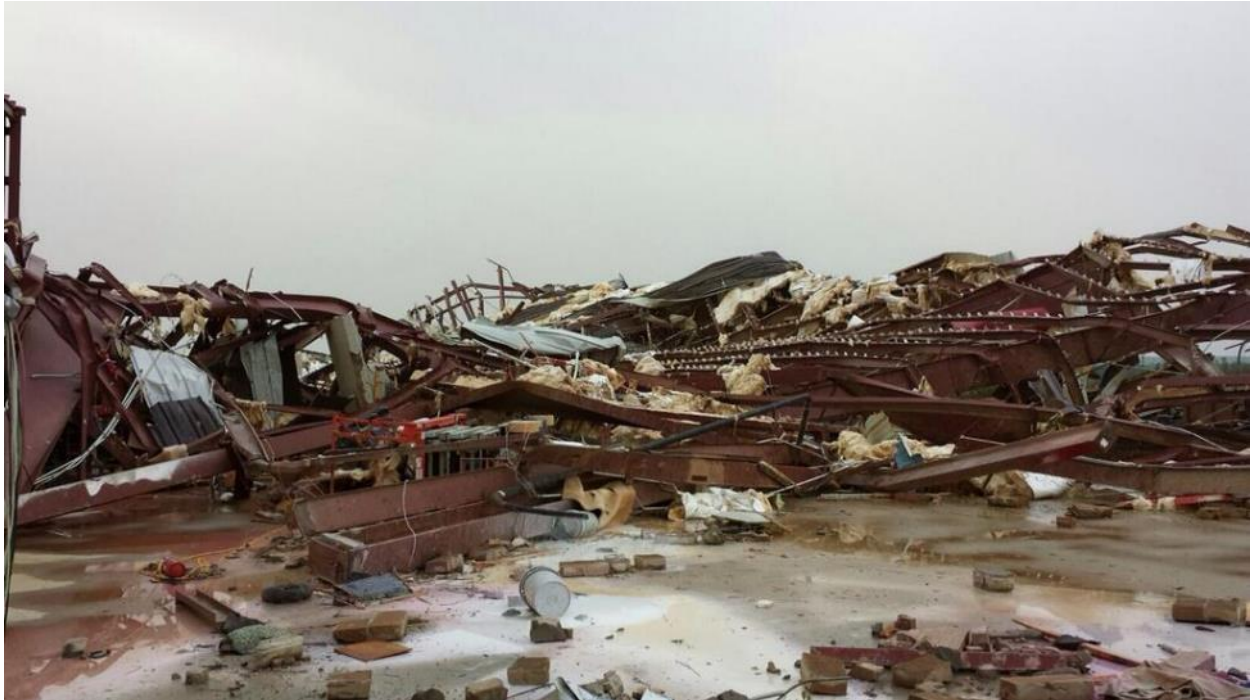
Figure 15. Collapse of structural members at the Intermediate School in Vilonia, AR.

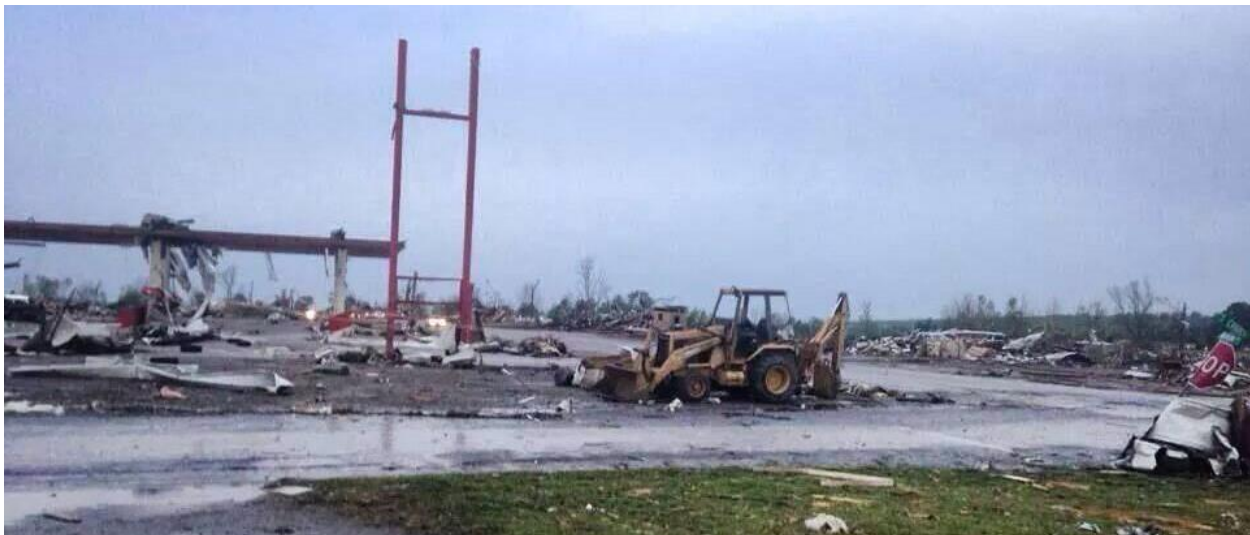
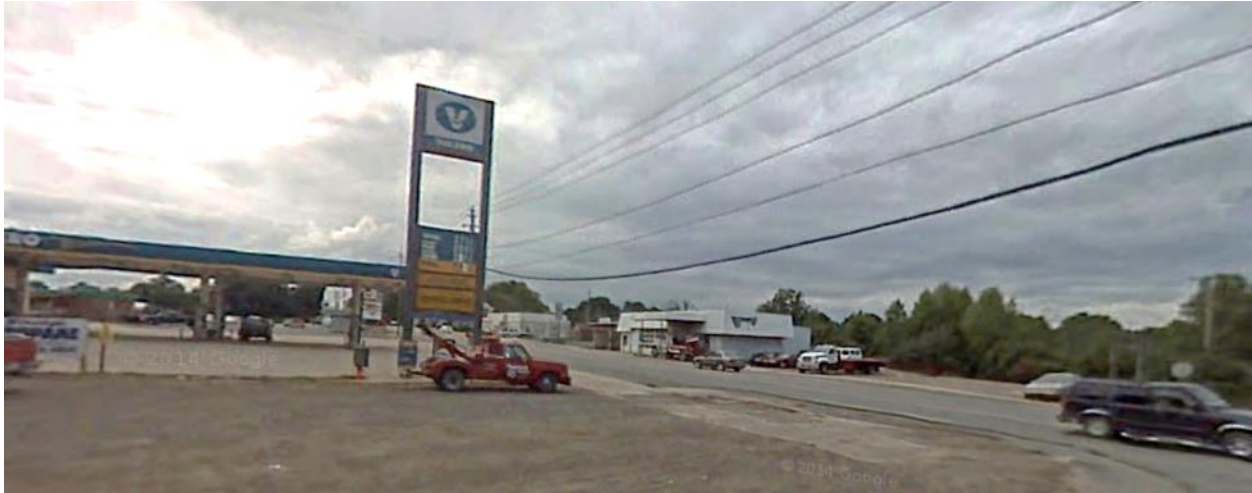
Damage to the downtown region of Vilonia included the complete destruction of the former Catfish Hook restaurant, which was reportedly reduced to only a slab. A number of homes and businesses along Main Street were also destroyed or heavily damaged, including a Valero gas station shown in Figure 16.

Figure 16. Before (top, looking North) and after (bottom, looking South) of downtown Vilonia, AR at the corner of S. Church St and Main St, looking NW.

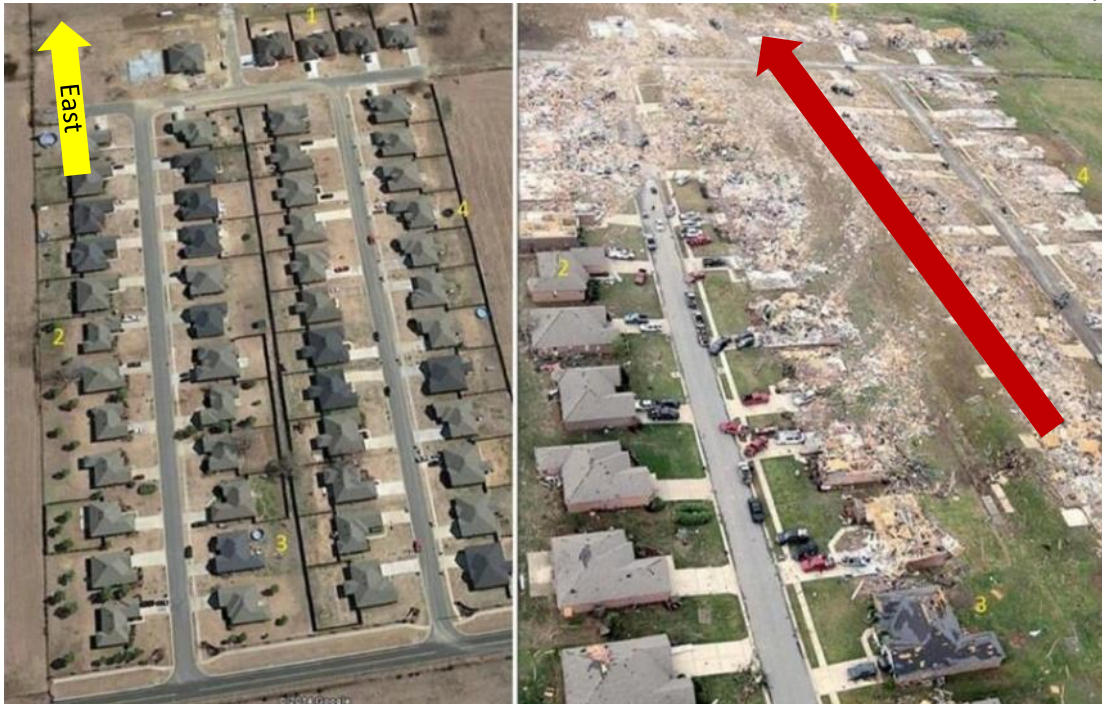
Realtor data from Zillow.com indicates the homes in this development were less than five years old. Some had just been [finished prior to the tornado](#). From the available photographs, 44 of the 53 homes in the development were destroyed by the tornado, and [nine](#) fatalities have been confirmed. With an average home value of approximately \$150,000, the damage to this development alone represents over \$6,000,000 in economic losses. Figure 17 provides a before and after view of the subdivision. Many garage doors have collapsed outward in the homes north of Clover Ridge Dr, as shown in Figure 18. Loss of the roof is noted in homes south of Clover Ridge Dr, and total collapse can be seen along Aspen Ridge Dr.

The homes here were wood-frame construction with brick façades, and wood rafters framing hip roof. Detailed photos of the damage do not show anchor bolts were used for wall-to-foundation connections, and metal roof straps were not used to tie the rafters to the walls. The damage here would be described by DOD 9 (all walls collapsed) from FR12 of the EF-Scale, which has an expected wind speed of 170 mph. The tornado would likely be rated either an EF-3 or EF-4 here, depending upon the more detailed ground observations.

Figure 17. Comparison of Parkwood Meadows subdivision before and after the tornado. The yellow arrow indicates the East direction, while the red arrow indicates the estimated tornado centerline through the subdivision. (Photo Courtesy of Twitter user @Scott\_Ar).

Our research and field surveys of previous tornadoes and hurricanes suggests that the disproportionate collapse of 44 new residential structures could have been prevented. With better engineering, homes can be made more resilient, such that we can reduce catastrophic failures and loss of life. The solutions begin with applying well-understood wind resistant techniques – roof to wall metal hurricane ties, robust wall-to-foundation ties, and independent porch structures to prevent complete failure of the roofs. Many studies have repeatedly shown that homes can be made more resistant to wind loads for less than 5% of the cost of the home. In other words, we would expect many of these homes would be still standing today if just \$3,000 in wind resistant construction were included, less than the price of a new countertop. So for a total additional cost of roughly \$160,000, the \$6,000,000 in losses from the Parkwood Meadows subdivision could have been substantially reduced.

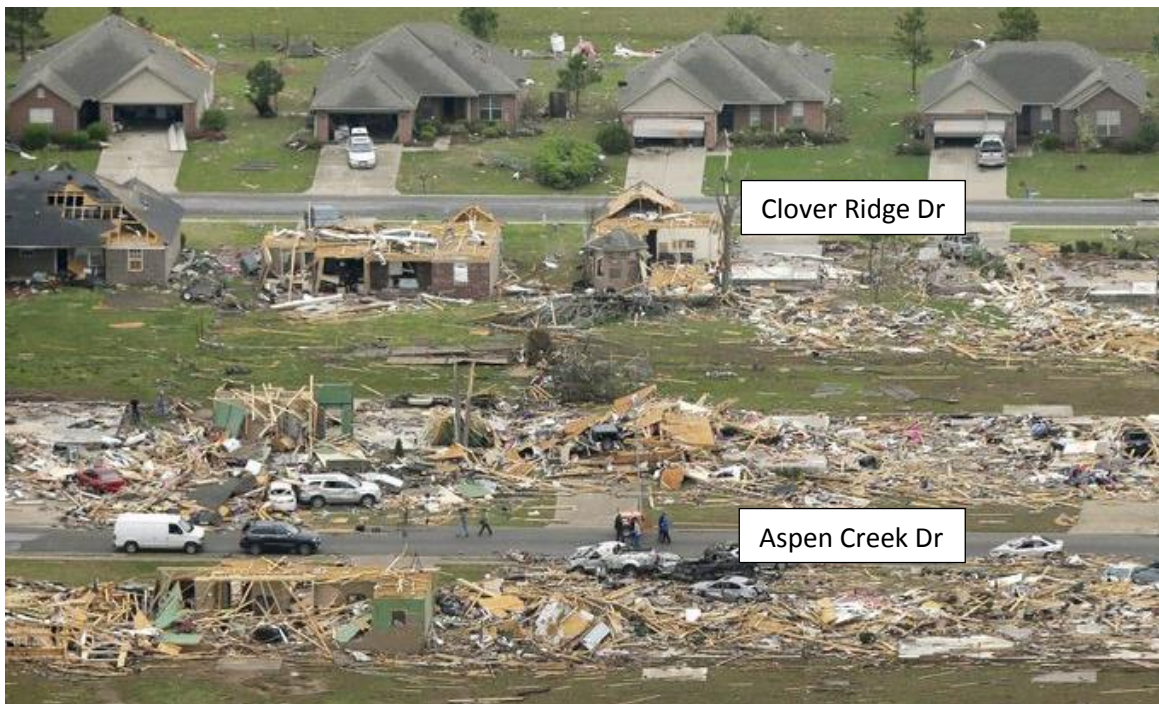
Figure 18. Looking North over the development after the tornado. Note the gradation of damage present with the garage doors collapsed outward along the north side of Clover Ridge Dr. (Photo Courtesy of USA Today)
