Summary Report on the 14 December 2013 Palm Coast, FL Tornado

University of Florida Wind Hazard Damage Assessment Team

27 January 2014

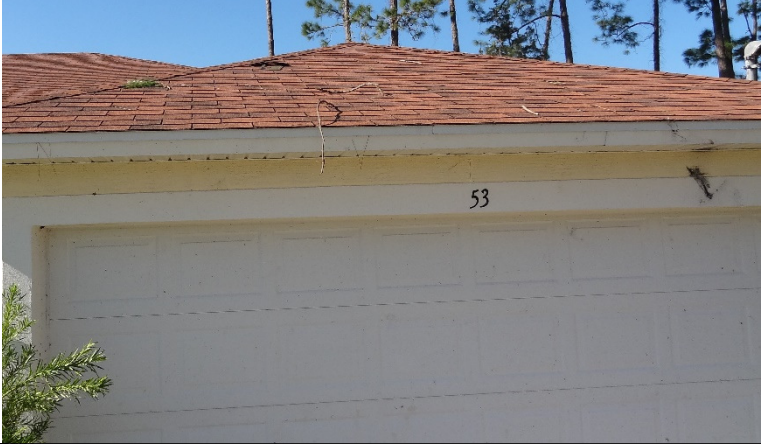
One and Two-Family Residences	
<p>DOD 1: Threshold of visible damage [53 mph – 80 mph]</p> <p>Photograph to the right depicts a home with very minor damage. A single shingle was displaced and evidence of debris impact was present just above the garage door.</p>

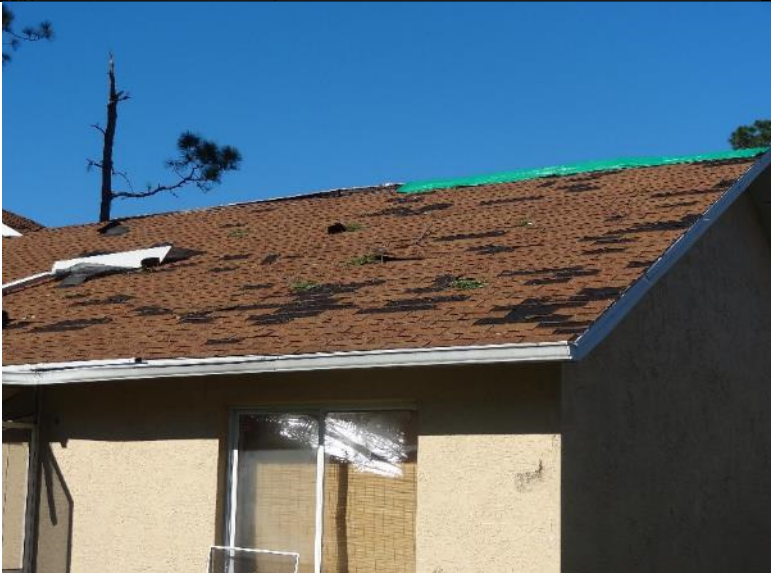
<p>DOD 2: Loss of roof covering material (<20%), gutters and/or awning; loss of vinyl or metal siding [63 mph – 97 mph]</p> <p>This was the most commonly observed DOD and the wind speed was typically chosen from the range of possible values based upon the extent of the shingle loss.</p>

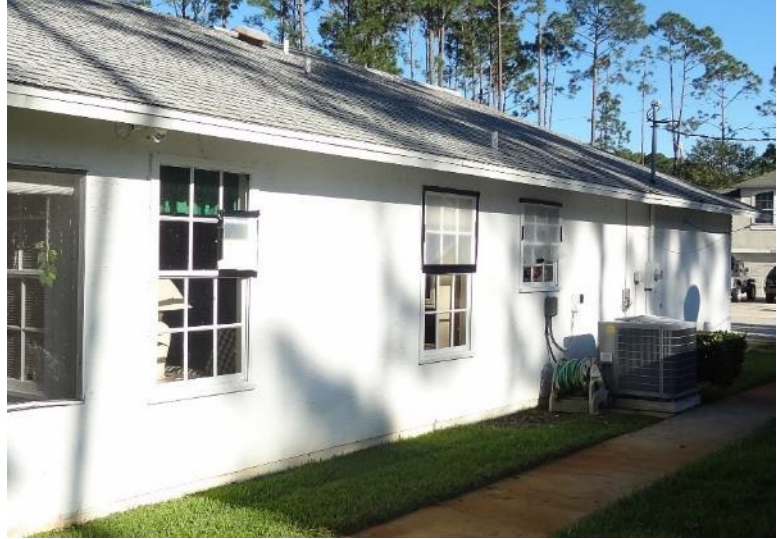
DOD 3: Broken glass in doors and windows
[79 mph – 114 mph]

When this DOD was assigned in the current study, wind speed values on the lower end were generally assigned because it did not appear impact-resistant windows were used and because there was typically very little damage to other areas of the home.

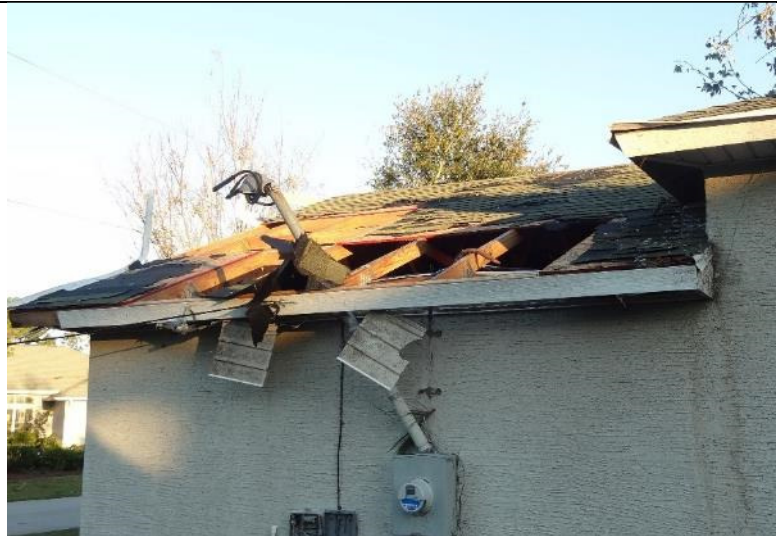
DOD 4: Uplift of roof deck and loss of significant roof covering material (>20%); collapse of chimney; garage doors collapse inward; failure of porch or carport
[81 mph – 116 mph]

This DOD was observed only three times (twice in homes built before 1994 and once to a home built after 1994), all within a relatively small area near Barring Place.

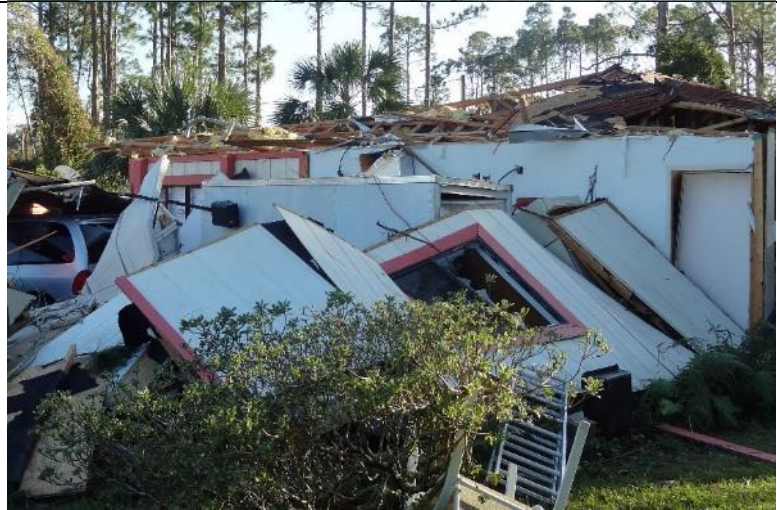
DOD 6: Large sections of roof structure removed; most walls remain standing
[104 mph – 142 mph]

This DOD was only observed once, and that to a pre-1994 home with significant termite-damage and rotted wood. As a result, the lowest possible wind speed associated with this DOD (104 mph) was used.

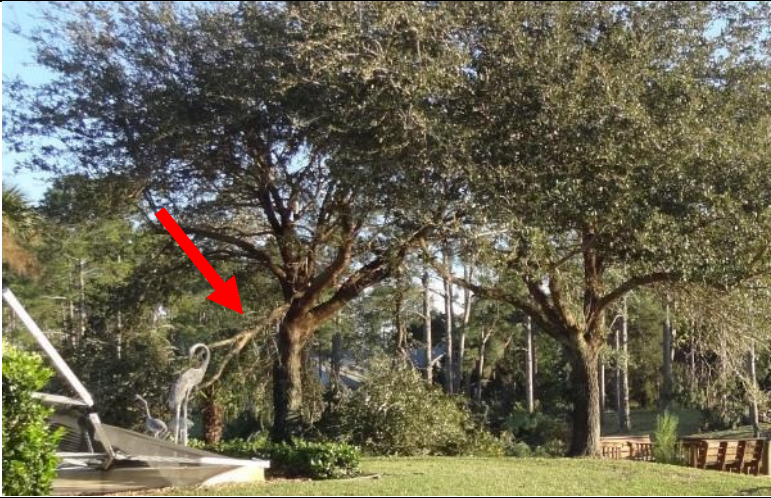
Trees (Hardwood)	
<p>DOD 2: Large branches broken (1"-3" diameter) <u>[61 mph – 88 mph]</u></p>

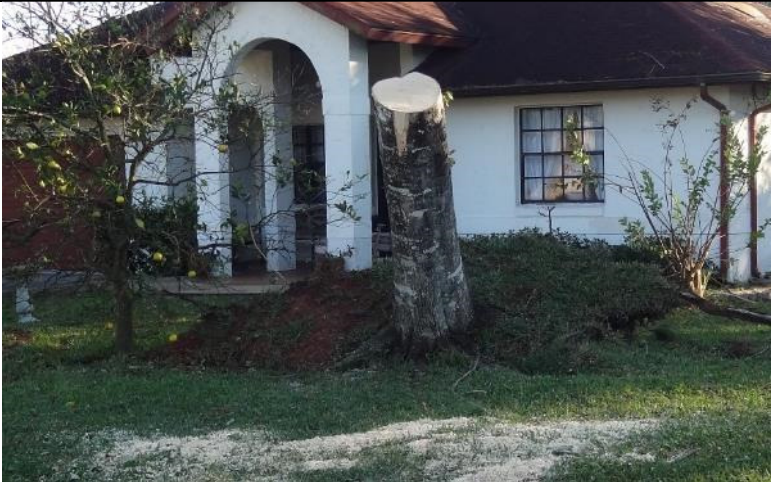
<p>DOD 3: Trees uprooted <u>[76 mph – 118 mph]</u></p> <p>Note: in picture to right, tree was removed after uprooting during cleanup.</p>

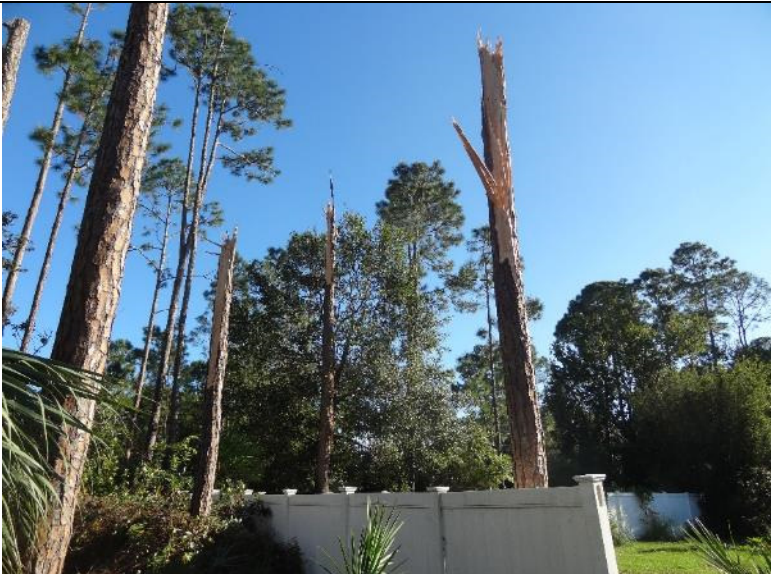
Trees (Softwood)	
<p>DOD 4: Trunks snapped <u>[88 mph – 128 mph]</u></p> <p>This DOD was observed multiple times throughout the damage path, while no observations of DOD 3 (trees uprooted) were made for softwoods. The wind speeds assigned in this study were typically much closer to 88mph. A lack of equivalent damage to other nearby indicators limited the wind speed estimates.</p>

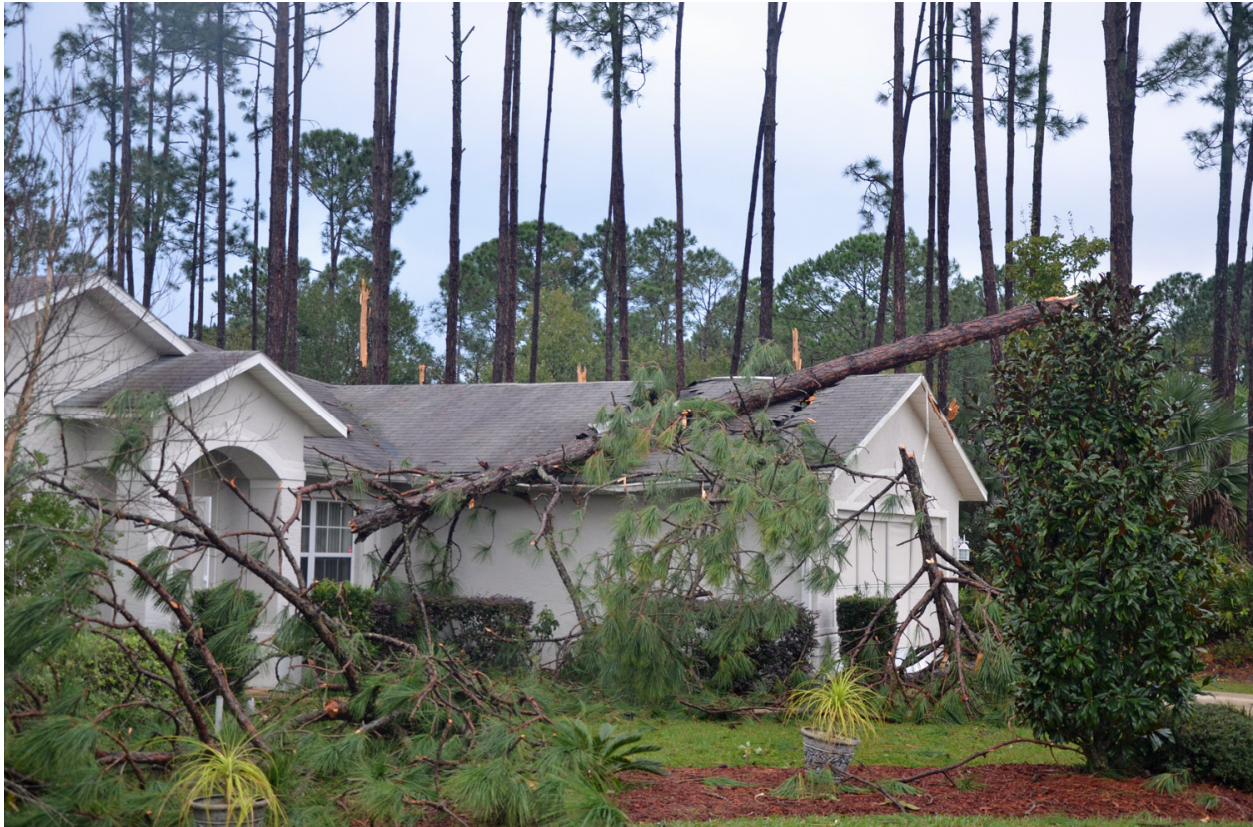
the failures of each type were observed, and in a few cases the trees fell on homes, causing extensive damage when the home would have been able to survive the wind alone with little damage (Figure 9).

Figure 9: Tree collapsed onto home which was otherwise undamaged (Photo courtesy of [FlaglerLive](#))

- (4) Trees with poor wind resistance, such as pines, increase the risk of damage to nearby homes regardless of the home's wind resistance. When located close to homes, they should be removed and replaced with local species that are more wind resistant. General guidelines concerning the proper selection and placement of trees to reduce wind hazard potential are available through the University of Florida [IFAS Extension](#) or a local Palm Coast building official.

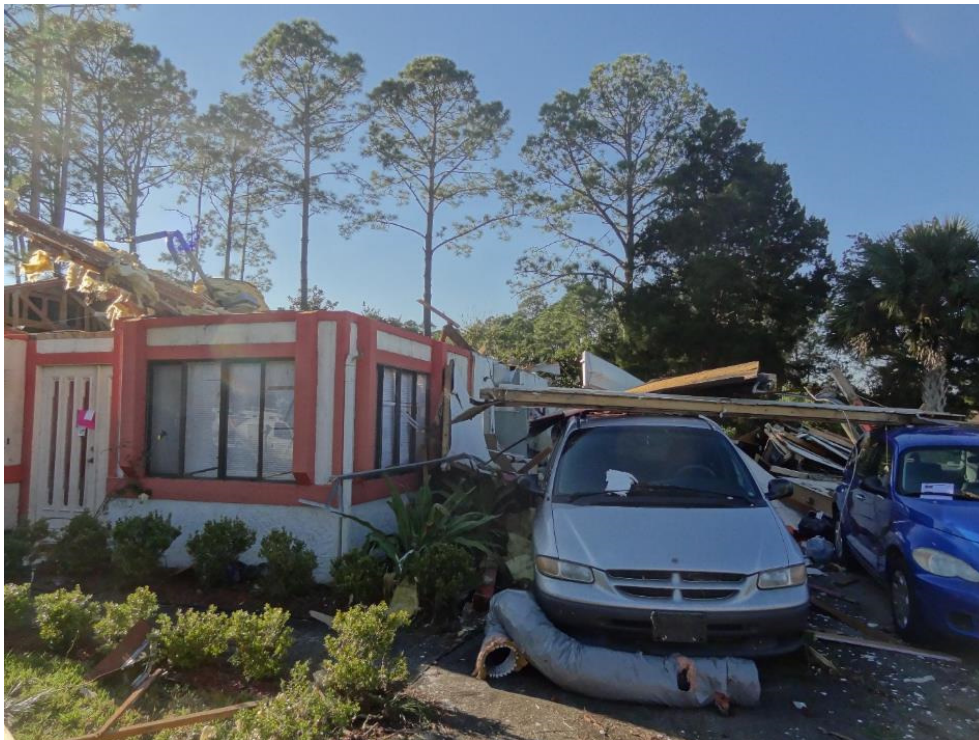
Maintenance of a home is very important however, particularly for wood-frame construction, as the 1988 home with a Degree of Damage of 6 (Figure 11, Figure 12), had obvious termite damage in the structural garage door header which likely caused premature failure of the garage door, then failure and removal of large portions of the roof due to the buildup of internal pressures, and finally collapse of the garage walls. Due to the observed condition of the wood, it is possible that the minimum wind speed value for a DOD of 6 (104 mph) may still be an overestimate of the true wind speed here as none of the surrounding trees or structures had damage that indicated wind speeds close to this value.

Figure 11: Removal of large portions of roof and collapse of walls to 1988 home with significant termite damage

- (2) Maintenance of a home is very important for maintaining its wind resistance. If termite damage is noted in a home, care should be taken to not only eradicate them, but to replace or secure any damaged structural components.

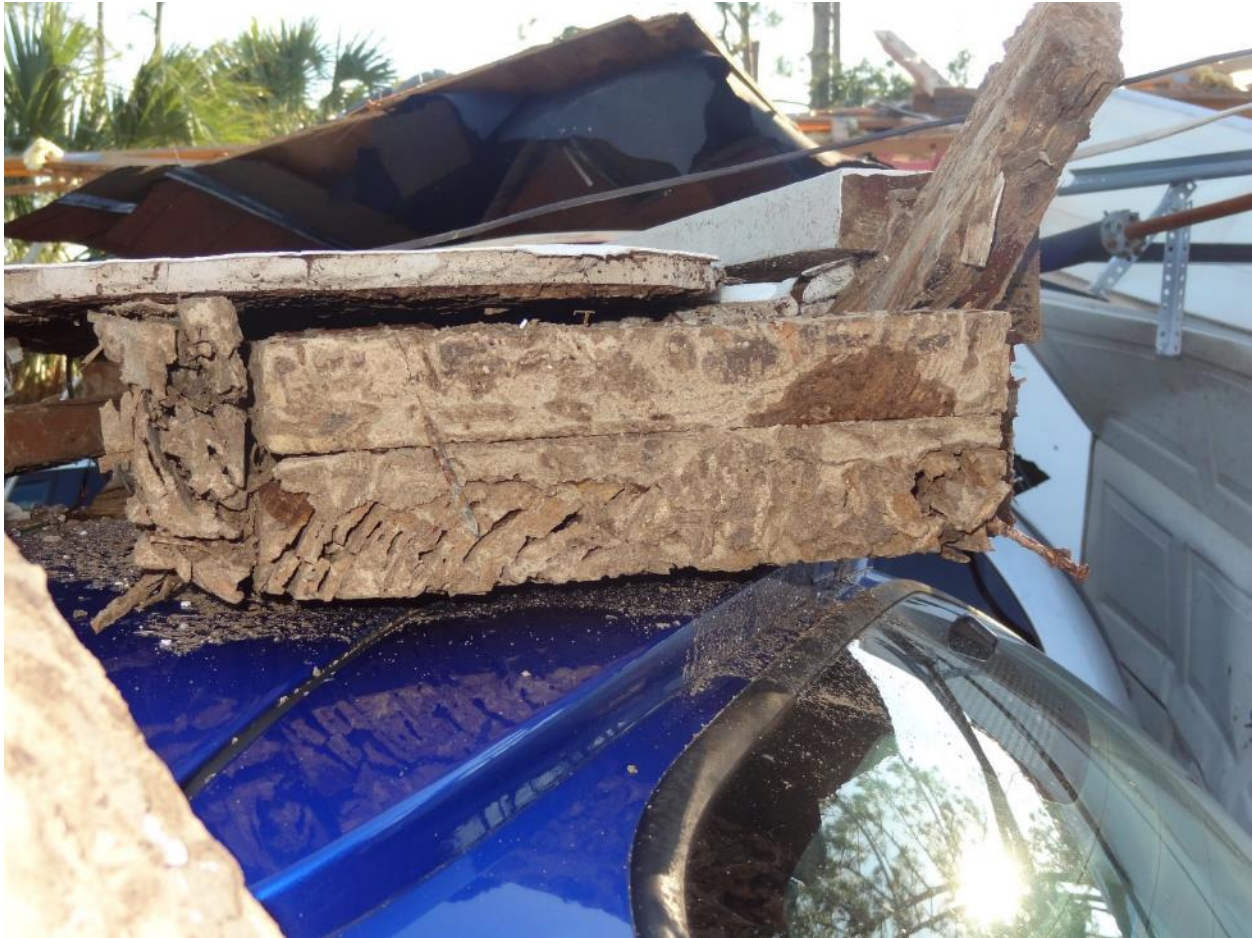
Figure 12: Termite damage to structural wood header over garage door opening.

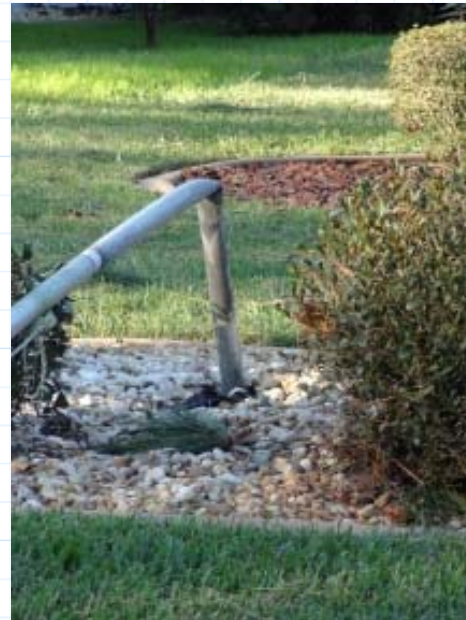
A flag pole was noted collapsed along the tornado path, located as shown in Figure 1. The buckled state of the flag pole is shown in Figure 2. The flag pole had buckled at the base and when found was pointing opposite the direction the tornado was traveling.

Figure A-2: Flag pole buckled at base. Note that portion of pole below ground has been pulled out of ground

The estimated wind speed need to bend this flag pole, assuming a 4 ft x 6 ft flag was in use at the time, is approximately 60 mph.

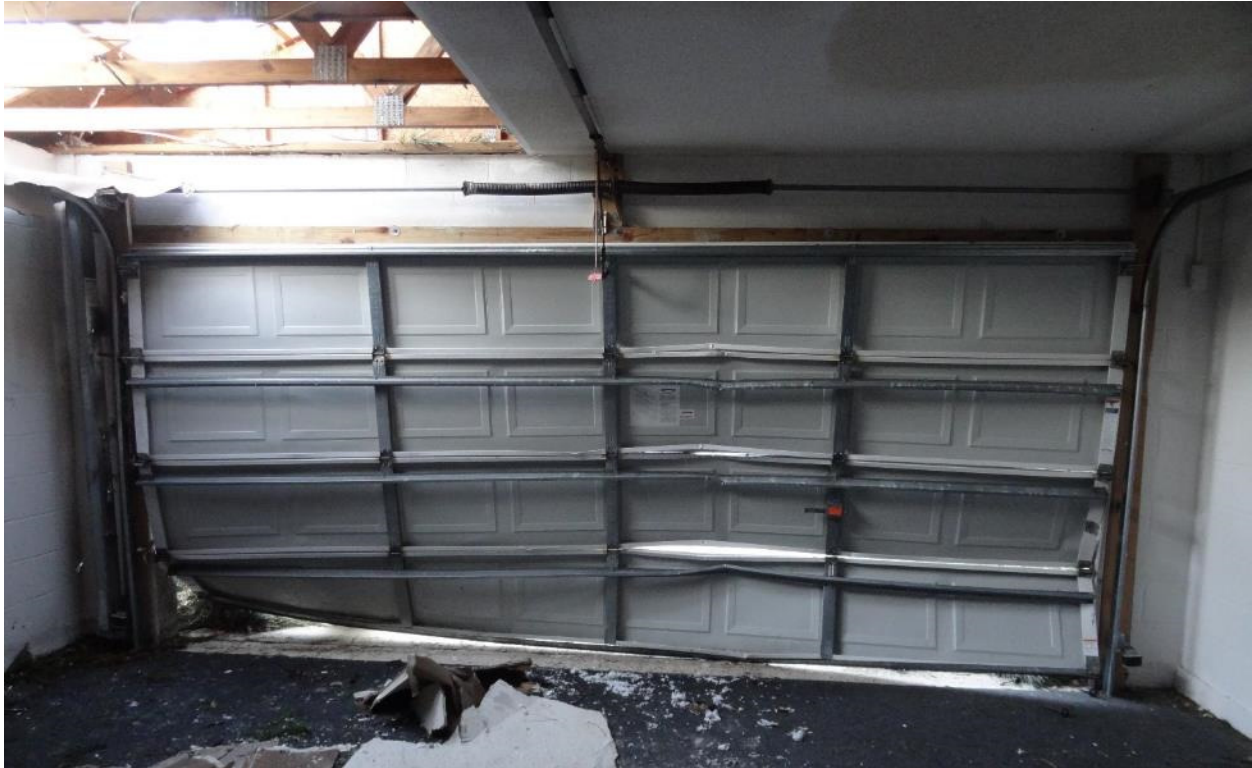
The garage door buckled at a home at 30 Barring Pl. Upon inspection of the garage door (shown in Figure B-1), it was noted that a sticker was affixed to it providing the garage door wind rating (Figure B-2).

Figure B-1: Buckled garage door at 30 Barring Pl

Using methodology and pressure coefficient values from ASCE 7-10 Components and Cladding, the wind speed required to buckle the garage door rated for 25 psf is approximately 92 mph.

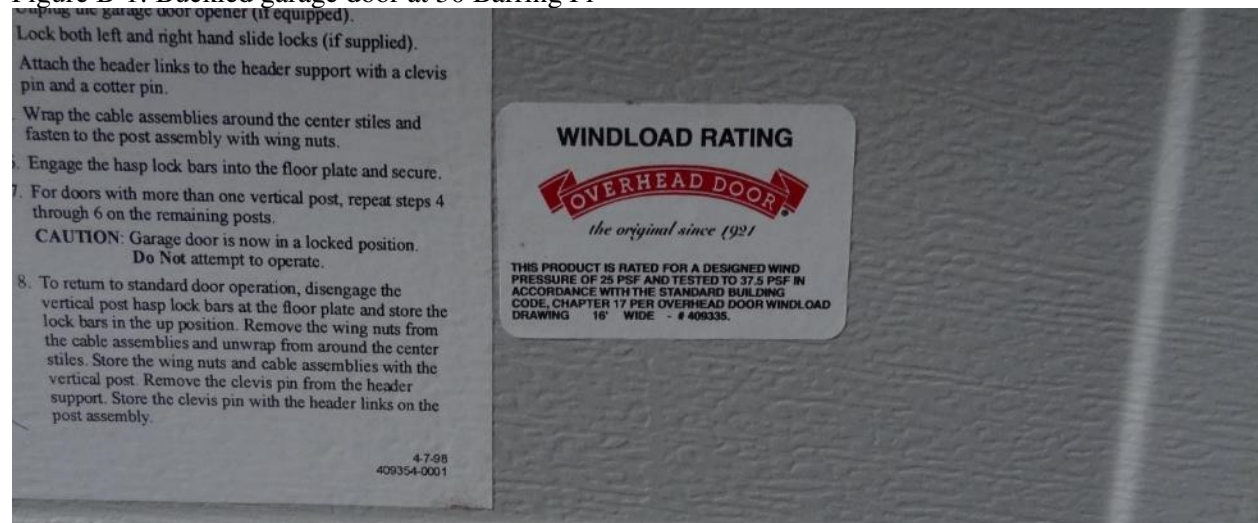
Figure B-2: Wind load rating of 25 psf obtained from the buckled garage door
The outline of the house is provided in Figure A-3 from the county appraiser website.

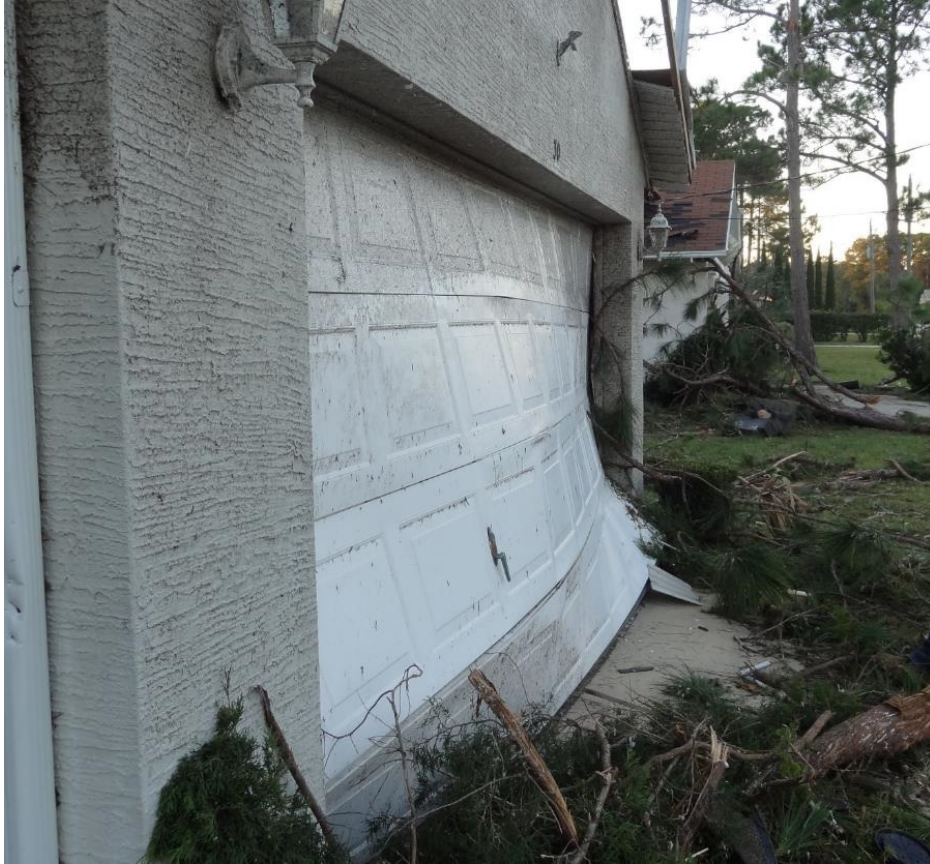
Figure B-4: View of buckled garage door from outside
