Online Damage Report

The 27th April 2014 Tornado Outbreak

University of Florida's Wind Hazard Damage Assessment Team

30 April 2014

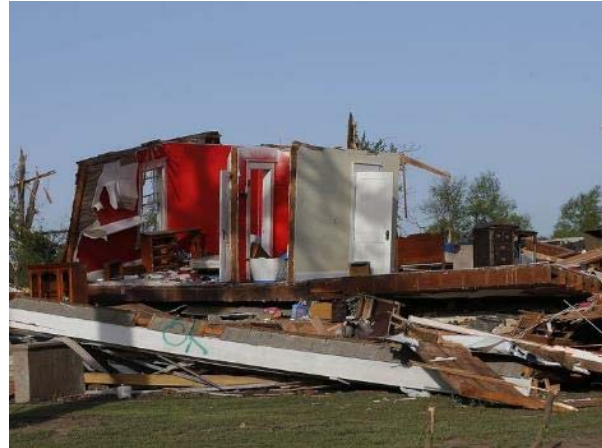
Figure 6. Degree of Damage 7 (113 mph - 153 mph). Possibly an EF2 rating. (AP Photo/Orlin Wagner)

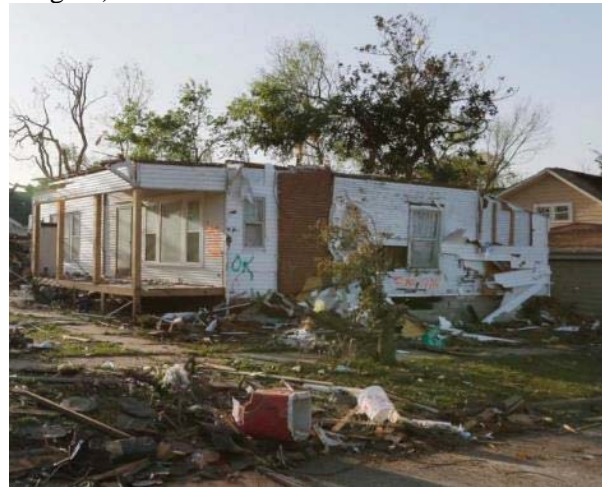
Figure 7. Degree of Damage 6 (104 mph - 142 mph). Possibly an EF2 rating. (AP Photo/Orlin Wagner)

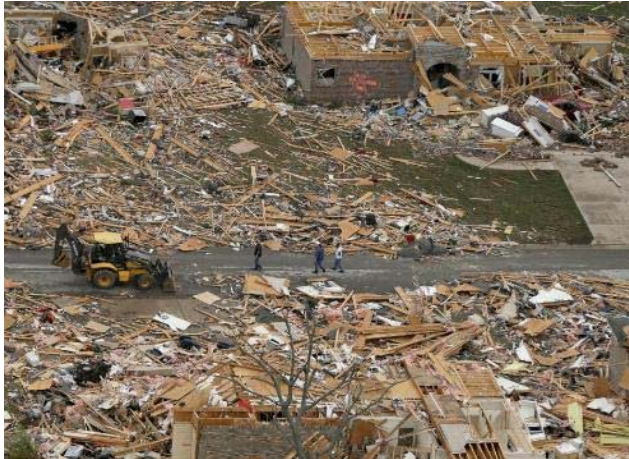
The April 27, 2014 tornado entered Mayflower around 8:30pm and caused three fatalities, two in the relatively new River Plantation subdivision. The River Plantation subdivision is located just east of the Arkansas River and contains approximately 100 luxury homes, all less than 15 years old. The area sustained heavy damage as shown in Figure 9 and Figure 10. As of the time of this report the number of damaged or destroyed homes here is not known. The exact location of the fatalities is also not yet known.

Figure 9. Severe damage in the River Plantation development east of Mayflower, AR

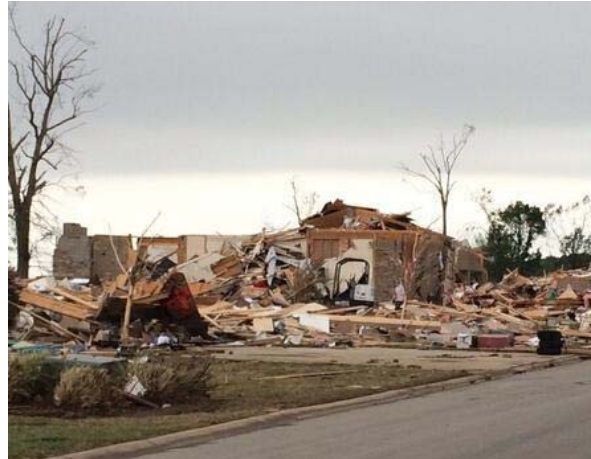
Figure 10. Roof destroyed from home in River Plantation development

From photographs of the damage and available realtor reports, it appears the homes in this area are generally masonry construction with wood rafters framing the roofs. The roofs appear to consist of wood sheathing and asphalt shingles. All of the homes appear to have enclosed garages. The available photographs indicate similar wood-frame construction that was observed in damaged homes in Moore, OK last year. The use of long wood rafters with steep sloped roofs is ill-suited to resist the high uplift wind forces. In those Moore, Ok homes, surveyed by the PI last year, the rafters were toe-nailed into the wall plates, which provided insufficient capacity to resist the loads. The wind uplift loads are exacerbated by the presence of roof overhangs. For example, the roof failure of a Mayflower, AR home shown in Figure 11 suggests a combination failure mechanism, initiated by high loads on the overhang, causing roof-to-wall connections to fail and then the remaining roof section to be swept away.

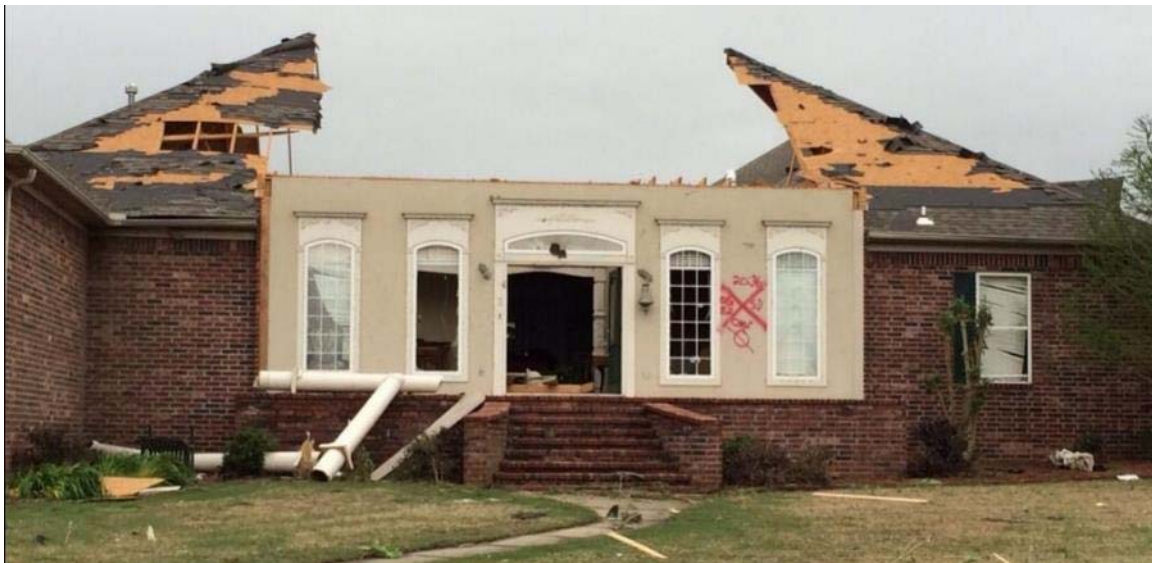
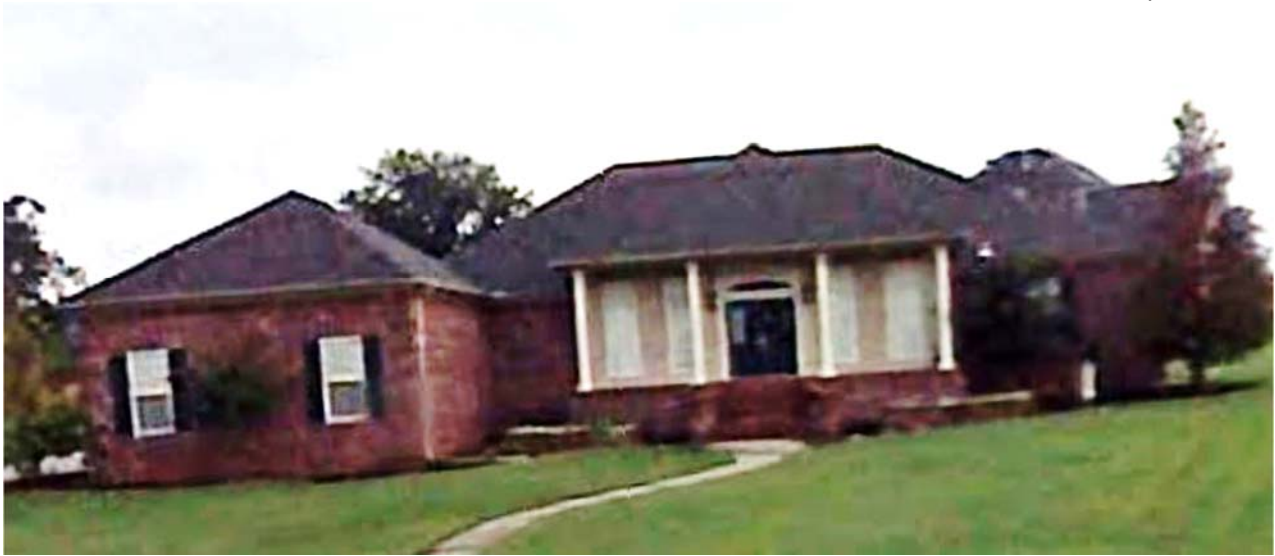
Figure 11. Before (bottom, from Google StreetView) and after (Courtesy of Twitter user @courtneyism) of a Mayflower, AR home in River Plantation.

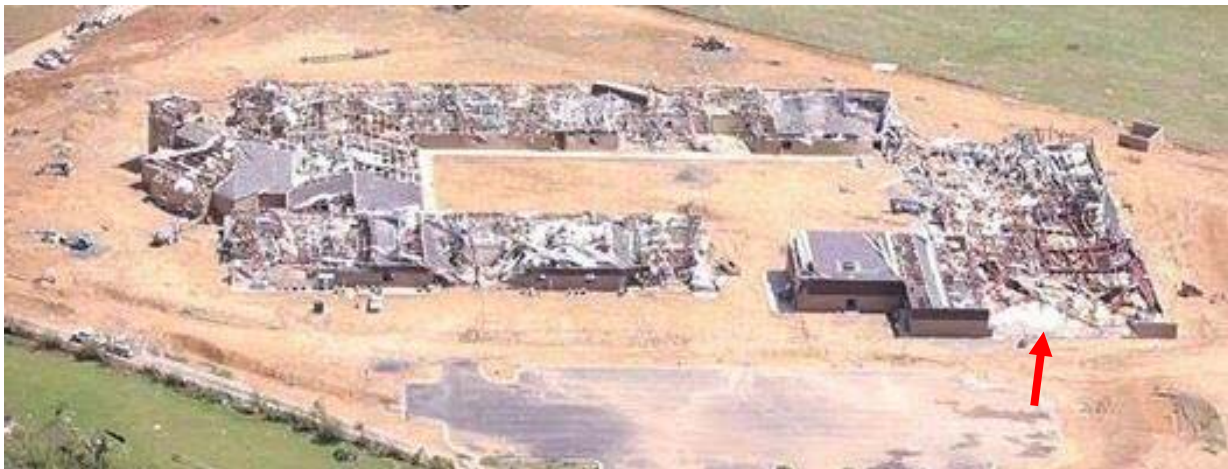
The school sustained severe damage, with the majority of the cladding removed and destroyed and significant damage to the structural members as well, as shown in Figure 14 and Figure 15. Because of the complete destruction of a large portion of the building as shown in Figure 15, this damage could be rated as high as DOD 10 using the Elementary School Damage Indicator of the EF-Scale. This would put the estimated wind speeds between 152 mph and 203 mph with an expected value of 176 mph, which would be an EF-4. A more thorough ground-based investigation would be needed to confirm this.

Figure 14. Severe damage to new Intermediate School in Vilonia, AR set to be opened Fall 2014. Red arrow indicated location and direction of photo shown in Figure 15.

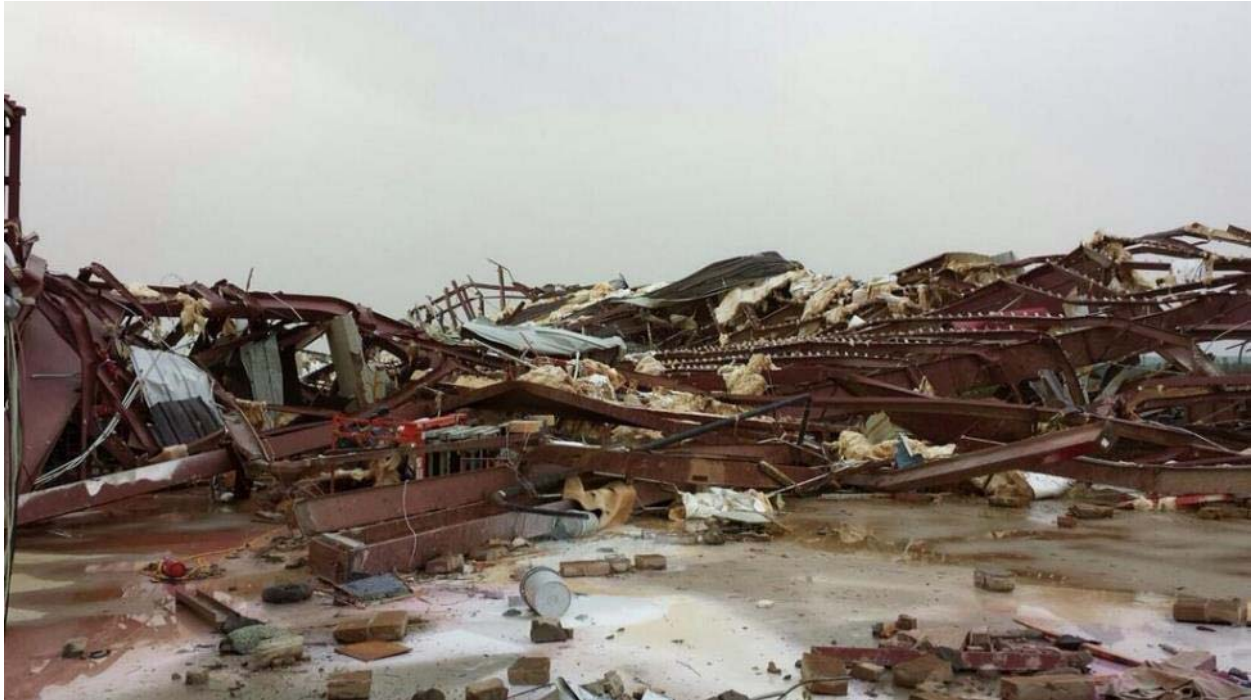
Figure 15. Collapse of structural members at the Intermediate School in Vilonia, AR.

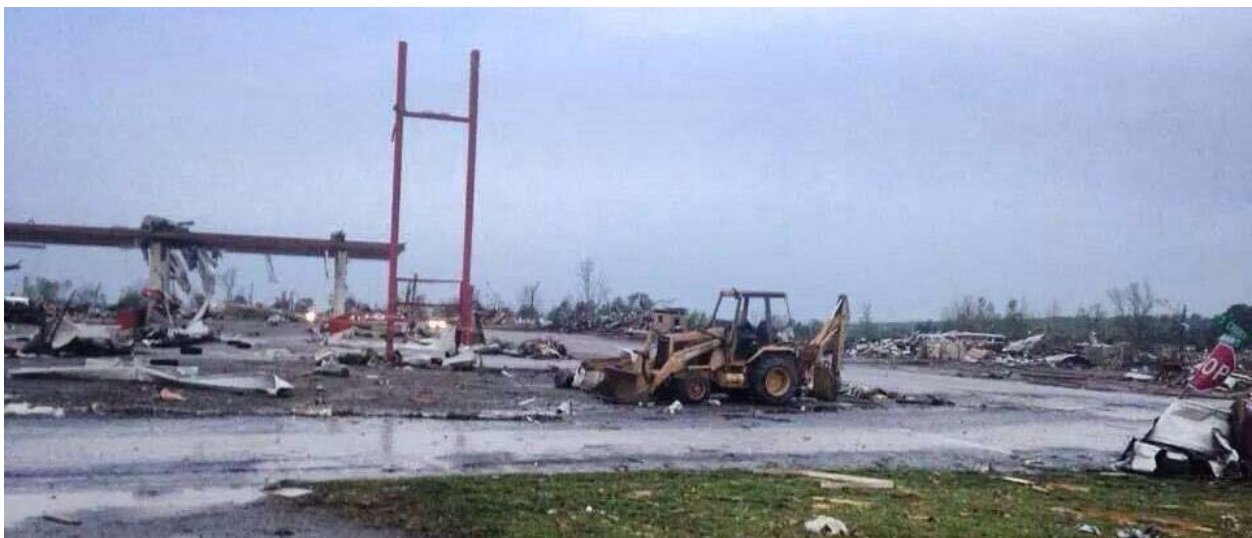
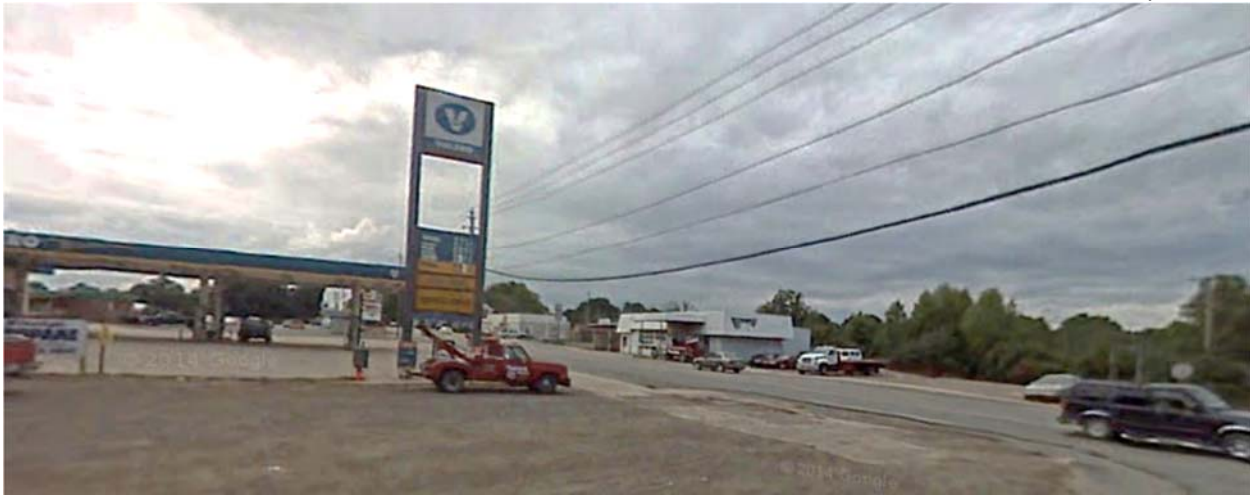
Damage to the downtown region of Vilonia included the complete destruction of the former Catfish Hook restaurant, which was reportedly reduced to only a slab. A number of homes and businesses along Main Street were also destroyed or heavily damaged, including a Valero gas station shown in Figure 16.

Figure 16. Before (top, looking North) and after (bottom, looking South) of downtown Vilonia, AR at the corner of S. Church St and Main St, looking NW.

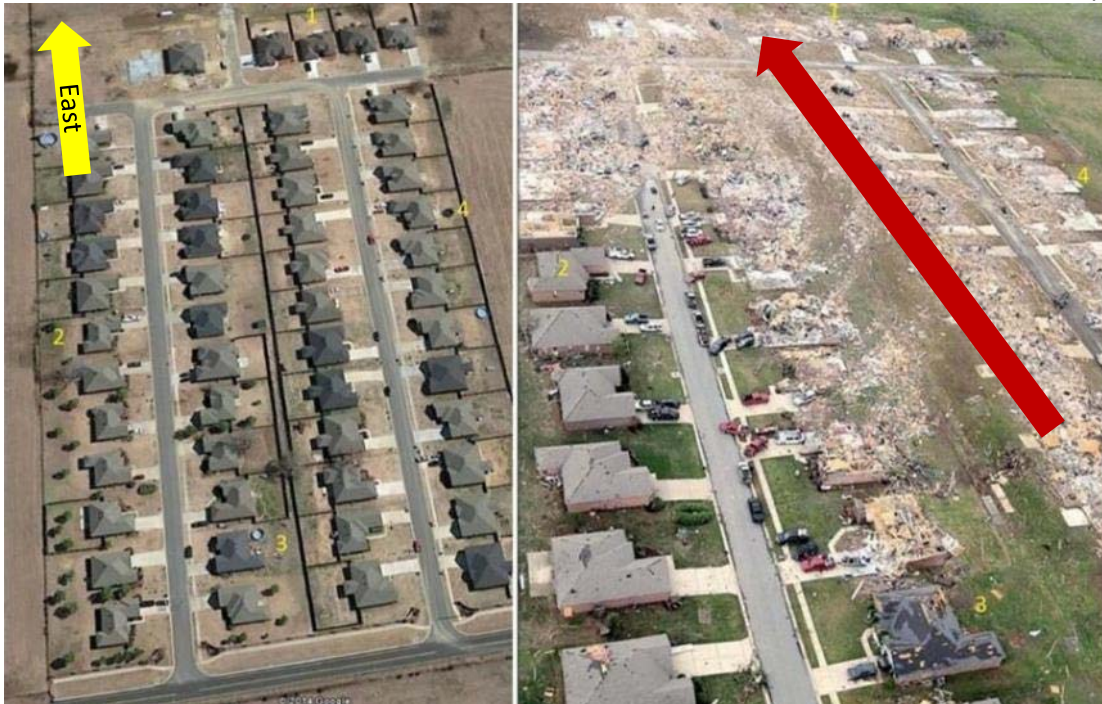
Realtor data from Zillow.com indicates the homes in the Parkwood Meadows subdivision were less than five years old. Some had just been [finished prior to the tornado](#). From the available photographs, 44 of the 53 homes in the development were destroyed by the tornado, and [nine](#) fatalities have been confirmed. With an average home value of approximately \$150,000, the damage to this development alone represents over \$6,000,000 in economic losses. Figure 17 provides a before and after view of the subdivision. Many garage doors have collapsed outward in the homes north of Clover Ridge Dr, as shown in Figure 18. Loss of the roof is noted in homes south of Clover Ridge Dr, and total collapse can be seen along Aspen Ridge Dr.

The homes here were wood-frame construction with brick façades, and wood rafters framing hip roof. Detailed photos of the damage do not show anchor bolts were used for wall-to-foundation connections, and metal roof straps were not used to tie the rafters to the walls. The damage here would be described by DOD 9 (all walls collapsed) from FR12 of the EF-Scale, which has an expected wind speed of 170 mph. The tornado would likely be rated either an EF-3 or EF-4 here, depending upon the more detailed ground observations.

Figure 17. Comparison of Parkwood Meadows subdivision before and after the tornado. The yellow arrow indicates the East direction, while the red arrow indicates the estimated tornado centerline through the subdivision. (Photo Courtesy of Twitter user @Scott_Ar).

The solutions begin with applying well-understood wind resistant techniques – roof-to-wall metal hurricane ties, robust wall-to-foundation anchors with large washers, structurally robust garage doors. Some techniques could include designing independent roof structures over open porches, so that its failure will not propagate the failure into the main roof structure. Time and again, engineering studies and contractor estimates have shown that single-family homes can be made more resistant to wind loads by adding less than 3 to 5% of the construction of the home. Putting that into perspective in terms of the Parkwood Meadows homes, an up-front investment of \$3,000 (2% increase per house) could have made the difference between some houses that stood up and total destruction of those 44 homes. So for a total additional cost of roughly \$160,000, the estimated \$6,000,000 in losses from the Parkwood Meadows subdivision could have been substantially reduced.

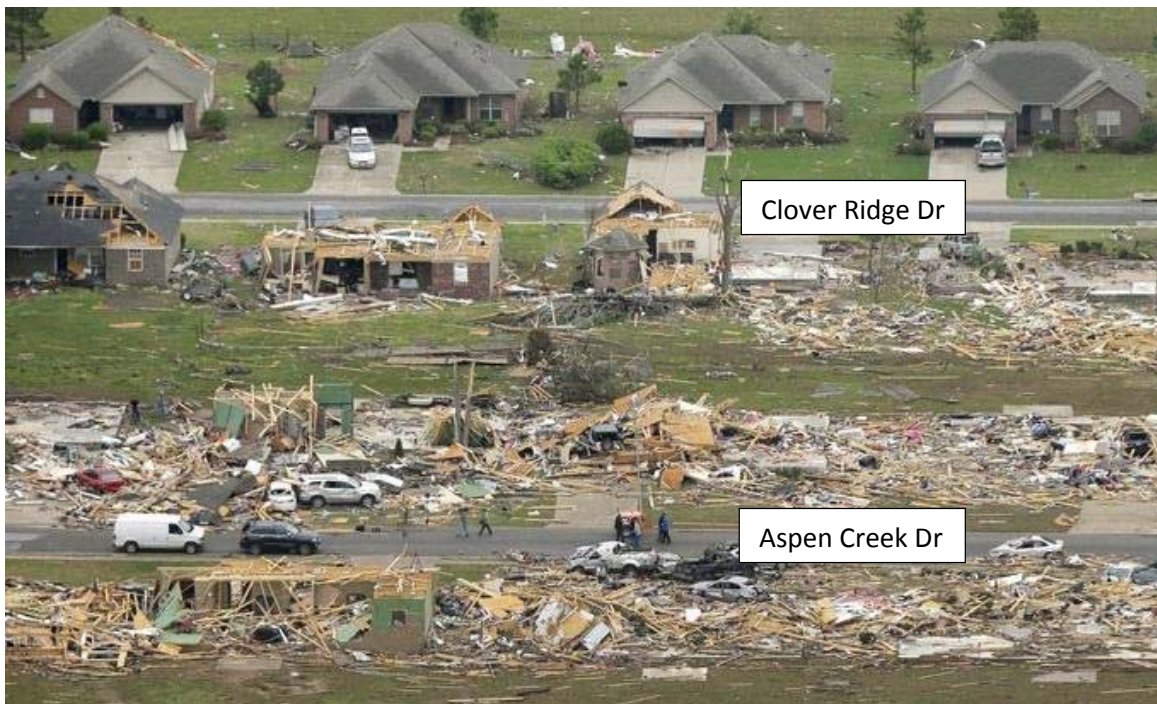
Figure 18. Looking North over the development after the tornado. Note the gradation of damage present with the garage doors collapsed outward along the north side of Clover Ridge Dr. (Photo Courtesy of USA Today)
