Online Damage Summary of  
June 16-18, 2014 Tornado Outbreak

University of Florida Wind Hazard Damage Assessment Team

June 20, 2014

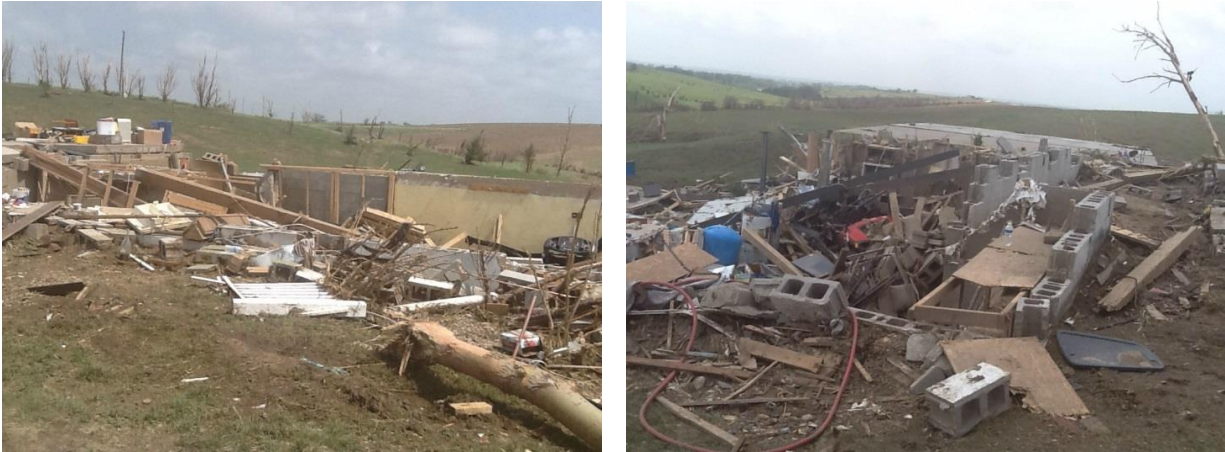
At 3:42PM EST on June 16, 2014, a tornado touched down about 7 miles southwest of Stanton and traveled northeast for over 12 miles. The tornado passed just west of Stanton, NE, narrowly missing a direct impact, but did cause significant damage to approximately seven homes outside the town. Severe damage was observed to several farm homes about 5 miles north of the town of Stanton from the same tornado, leading to the EF-4 rating that was assigned. Images from the NWS survey of EF-4 and EF-3 damage are provided in Figure 4. Both homes were two-story with basements, and were constructed before 1920 with unreinforced masonry (Zillow, 2014).

Figure 4: EF-4 damage (left) and EF-3 damage (right) 5 miles north of Stanton, NE (Source: NWS Toolkit, Omaha Office)

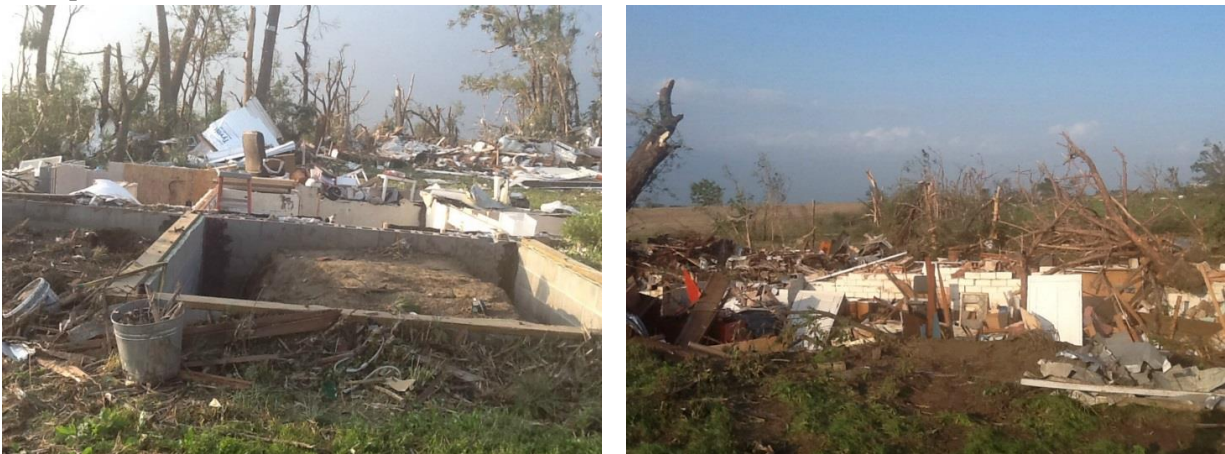
At 3:40PM EST on June 16, 2014, a tornado touched down approximately 10 miles south of Wakefield and move NNE for over 16 miles, passing about 2 miles to the east of the town itself. Over two dozen homes were heavily damaged or destroyed by the tornado, which was given a preliminary rating of EF-4 following the NWS survey. Construction here was similar to that in Stanton, primarily consisting of unreinforced masonry walls with wood frame roofs. The wood sill plates in Figure 5 (left), indicate at least a portion of one home was wood-frame.

Figure 5: EF-4 damage 4 miles SSE of Wakefield, NE to two homes built in the early 1900's. (Source: NWS Toolkit, Omaha Office)

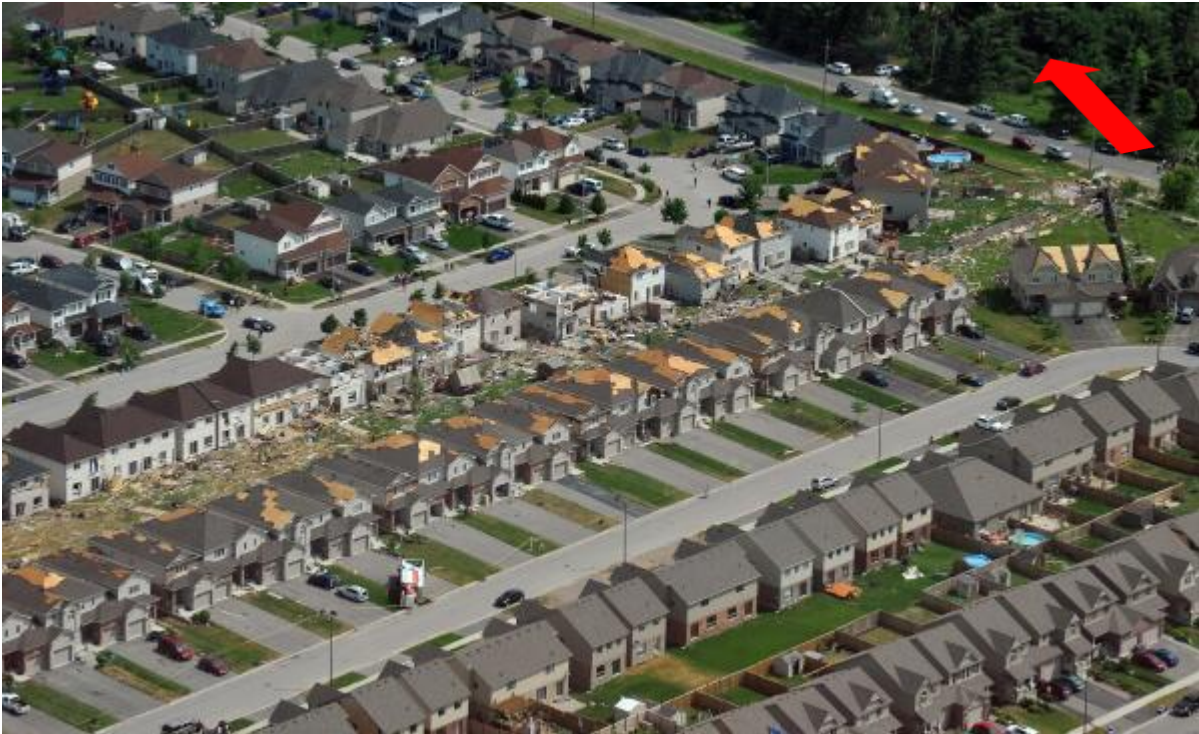
The damaged structures were built in 2010, and were primarily 2-story wood-frame structures with garages and hip roofs with asphalt shingles. An aerial view of the damage path is shown in Figure 6. The tornado moved roughly West-to-East through the neighborhood, fortunately without causing any fatalities. The survey team noted about ten homes with failure of the entire roofs, many of which were linked to garage door failures. Garage doors are a known weakness that, when they fail, propagate failure to the rest of the structure, particularly the roof, due to the resulting increase in internal pressures.

Figure 6: Aerial view of damage to Angus, Ontario from EF-2 tornado. North is approximately indicated by the red arrow. (Photo Courtesy of Ian McInroy)

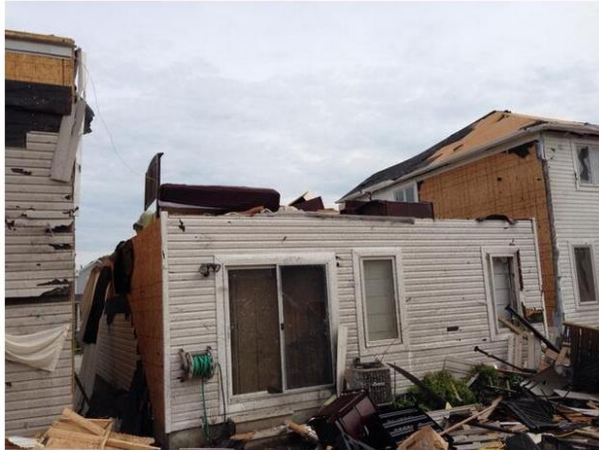
Roof failure can destroy houses downwind which may have been otherwise safe. This one did. #Angus #tornado #onstorm

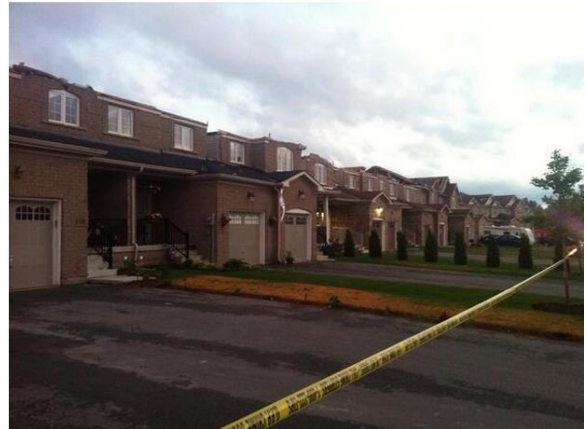
Wind tunnel tests show rows of houses have higher wind loads than 1. "@StormhunterTWN: Many roofs off here. #angus pic.twitter.com/BxRG5s05IG"

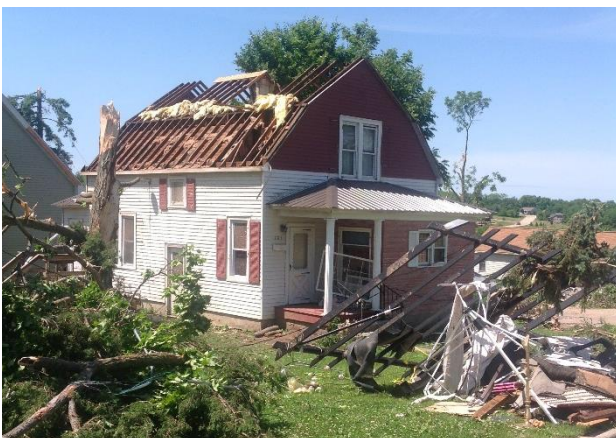
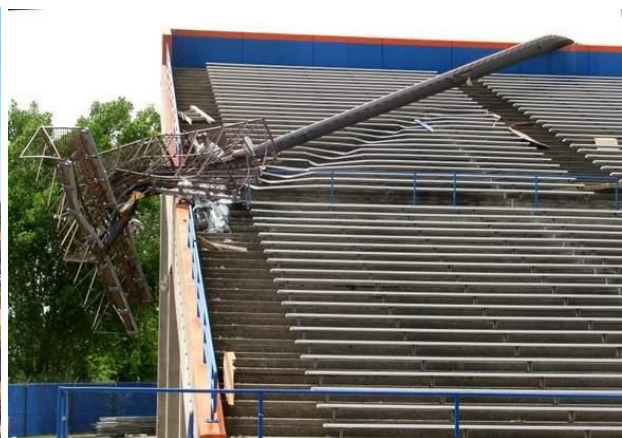
At 3:45PM UTC on June 17, 2014 a tornado touched down in a corn field about half a mile outside of Platteville, WI and traveled through the city for 3.82 miles. Significant roof damage was observed to several homes, several commercial and educational buildings suffered moderate damage, including the University of Wisconsin – Platteville campus. The damage along the path was given a maximum rating of an EF-2. There were no fatalities and 5 injuries. The tornado caused damage to several commons, as well as Southwest Hall, the Engineering Hall, and the Greenhouse and Pioneer Stadium (Figure 8, left). The damage primarily consisted of broken windows, uplift of roof cover and downed trees.

Figure 8: EF-2 damage from to farmhouse (left), light tower knocked down at Pioneer Stadium on UW-Platteville campus (right) in Platteville, WI (Source: NWS Toolkit, Omaha Office, [Green Bay Press Gazette](#))

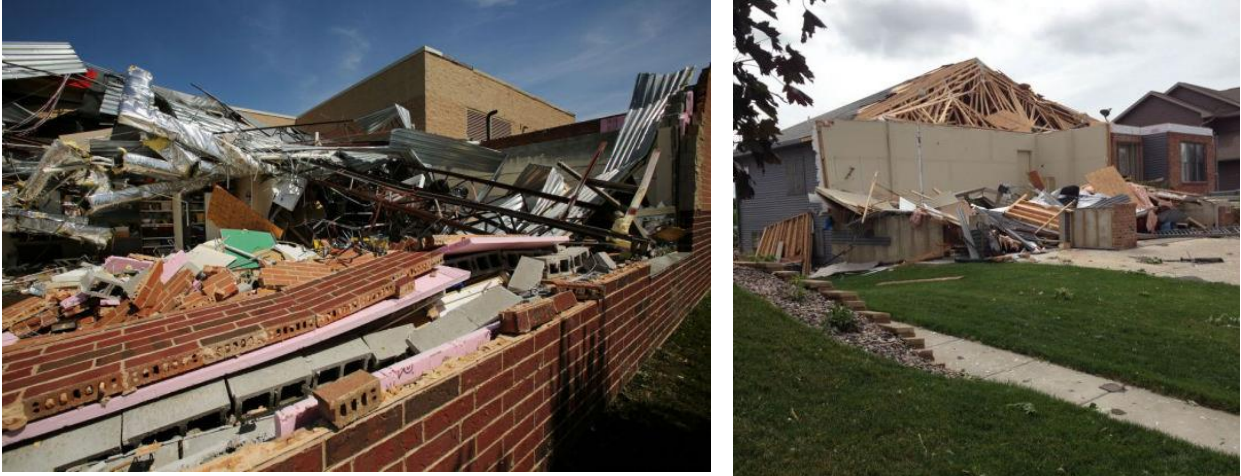
The June 17<sup>th</sup>, 2014 EF-3 tornado, as confirmed by the National Weather Service, destroyed or severely damaged dozens of homes in Verona, WI, and heavily damaged the County View Elementary School. Portions of the exterior wall, constructed with unreinforced masonry and brick façade, collapsed inward. Portions of the roof, constructed with bar joists and metal roof deck, also collapsed, although it is unclear whether the wall or roof collapsed first. Relatively new homes nearby (built post-2009) also suffered significant damage (Figure 9, right), with 19 deemed uninhabitable. The damaged homes were wood-frame construction with wood trusses.

Figure 9: Collapse of classroom wall at County View Elementary school (left) and wall and roof failure at a nearby home (right) (Source: [Wisconsin State Journal](#)).

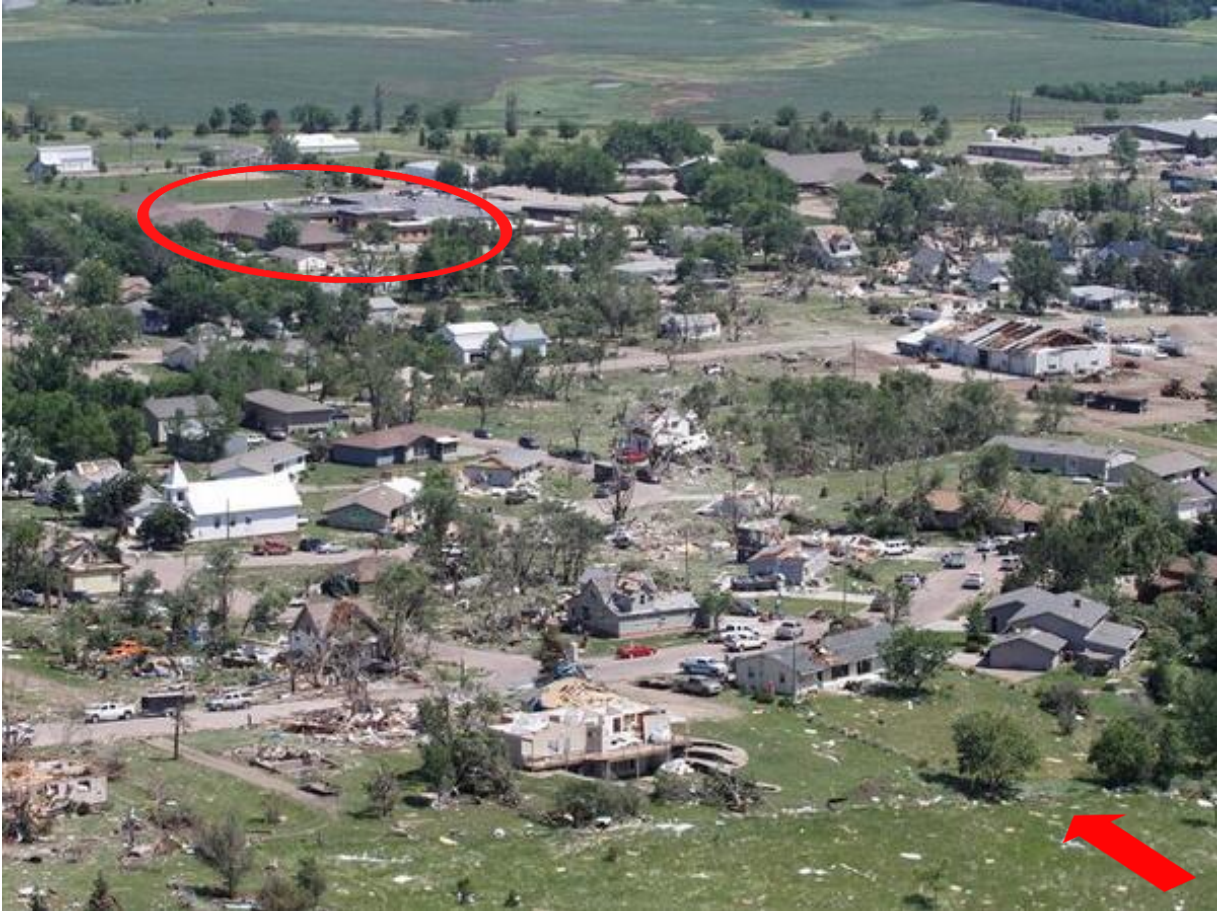
A tornado was reported in Wessington Springs, SD around 10:30 PM EST on June 18, 2014. The path of the tornado took it through the SE corner of the town, destroying 23 homes, damaging 20 others, and damaging 10 businesses ([Argus Leader, 2014](#)). Fortunately only two injuries and no fatalities were reported, possibly a by-product of the 20 minutes of lead time the town had before the tornado struck. Over half of the homes in Wessington Springs were built before 1950, as it primarily grew in the early 1900's when a railroad was constructed through the town. An aerial view of the damage is provided in Figure 10.

Figure 10: Aerial view of the EF-2 damage in Wessington Springs, SD from a tornado on June 18, 2014. The red arrow indicates North in this view. The red oval gives the location of Wessington Springs High School, which narrowly avoided a direct hit. (Source: [Argus Leader.com](http://www.argusleader.com))

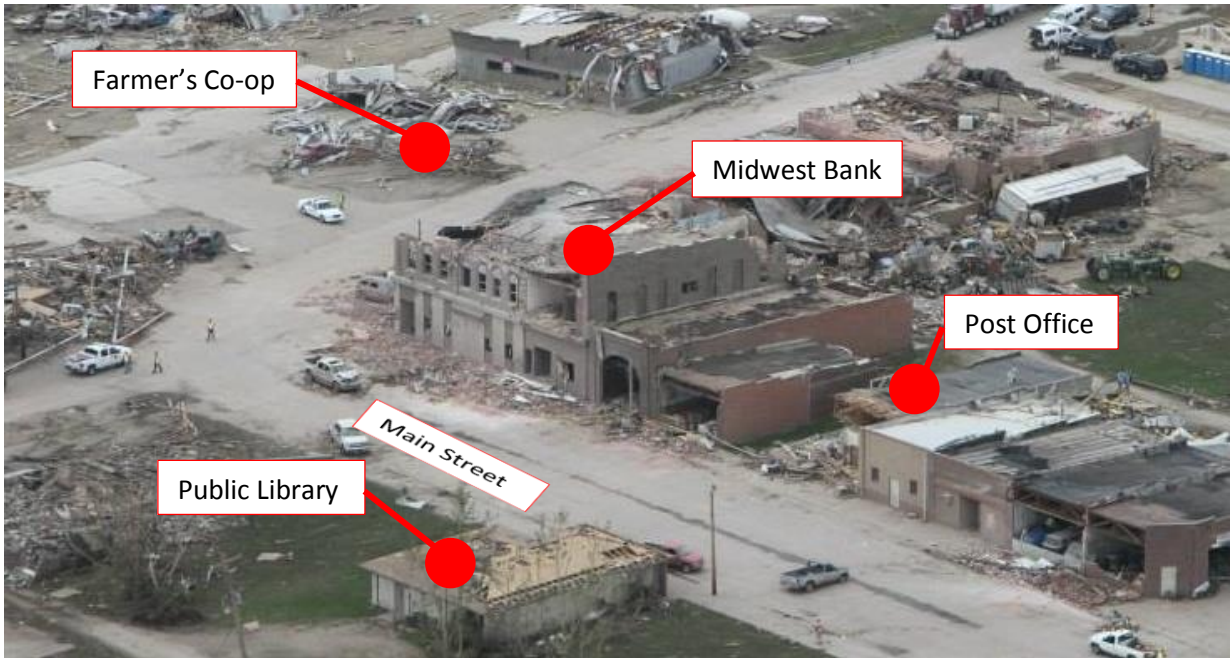
Figure 13: Damage to Pilger Public Library, Midwest Bank, post office, and empty lot where Farmers co-op used to be. View is looking southwest. (Source: [NEMA](#))

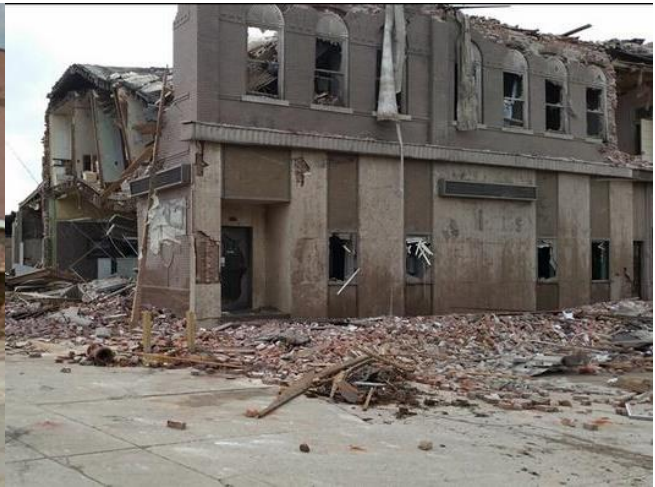
(b) Midwest Bank (after) looking NW

As shown in the figures above, significant damage was sustained in the business sector. One failure mechanism that seemed to occur regularly was the total collapse of one or multiple walls, even without the failure of the roof. For example, in the Midwest Bank building, a room wall on the east side collapsed on the second story, while the entire length of the wall on the south side collapsed in both stories as shown in Figure 15. The bank was established in the year 1900 according to sources ([BestBranch.com](#)). Exterior walls appear to consist of a brick wall only, while wood rafters form the roof and floor joists between the first and second floors. A lateral load path does not appear to exist between perpendicular exterior walls, or between the exterior walls and the roof. In the age in which this structure was built, gravity was often relied upon and little positive reinforcement was included. This undoubtedly contributed to the collapse of multiple exterior walls in this bank. Interestingly, this same failure mechanism can be noted in several buildings along Main Street, mostly on the east face. This is an indication that significant suction pressures from the wind flow in the tornado developed on these walls, causing them to fail outward.

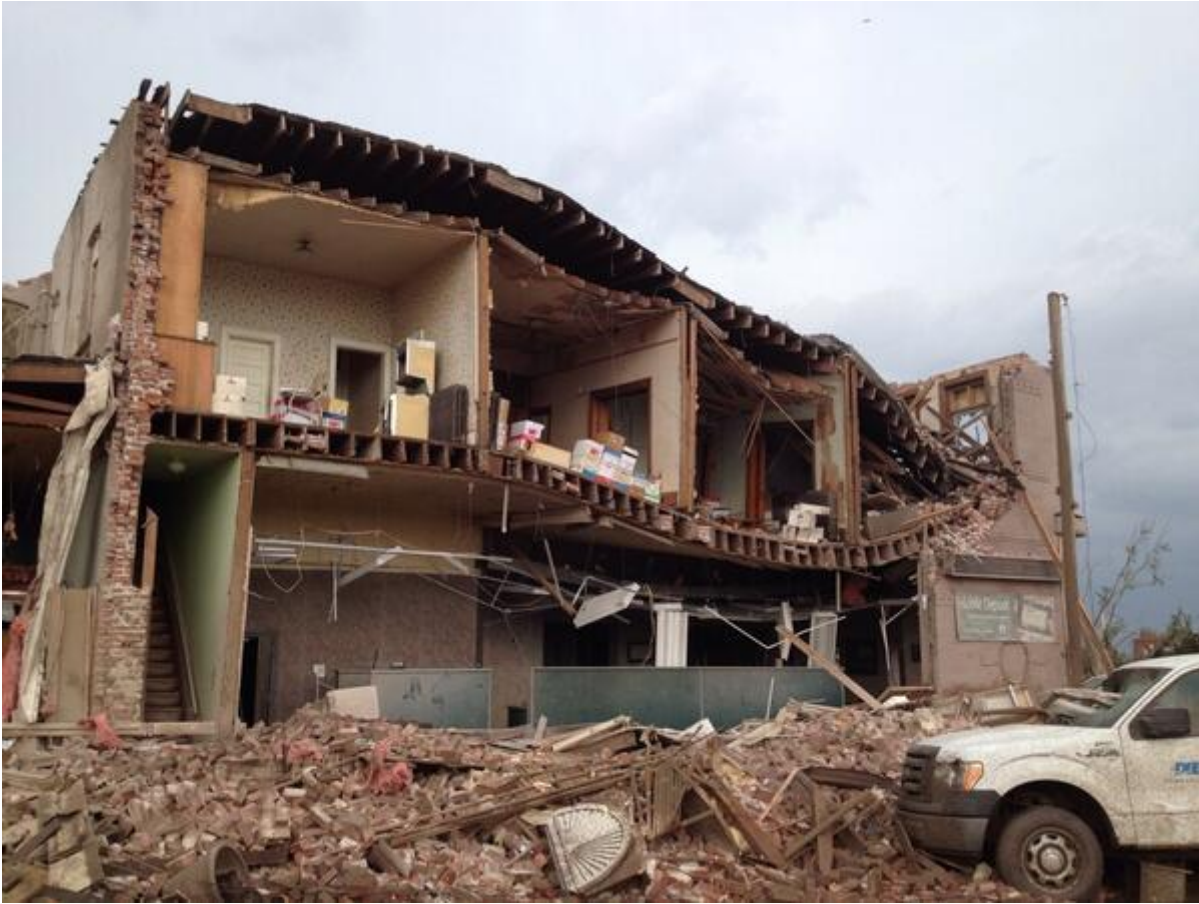
Figure 15: Total collapse of exterior wall along south side of Midwest Bank. Note the clean failure edge, suggesting little if any positive attachment existed between the south wall and the perpendicular east-west walls, or between the roof and the walls.

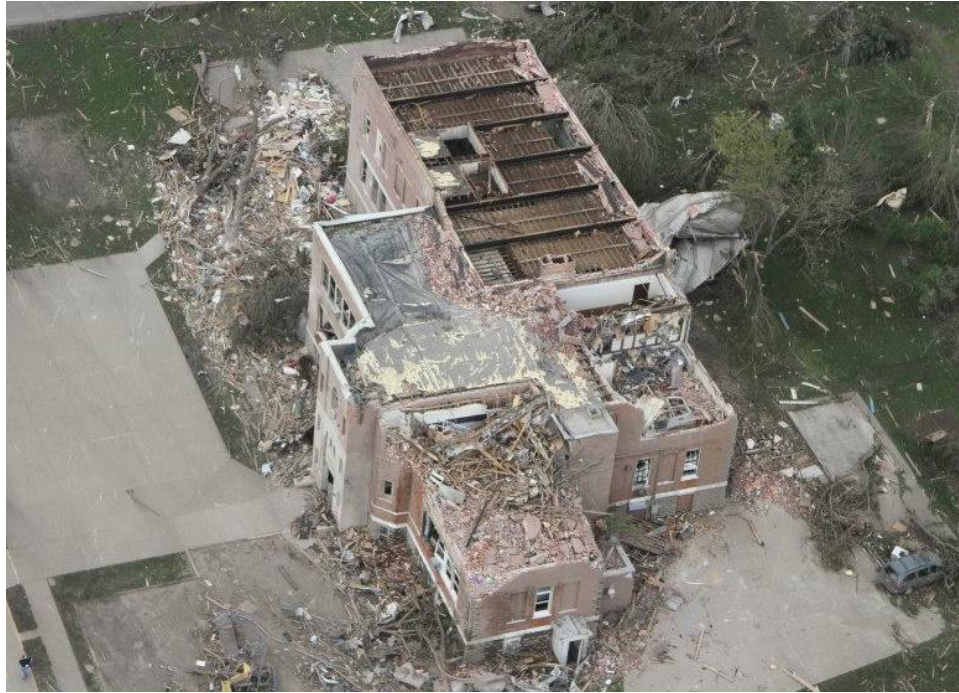
The Pilger Middle School sustained heavy damage, but the main structure appears to have remained mostly intact. The majority of the damage seems to be to the windows and opening, possibly due to the large debris cloud likely associated with the tornado from the earlier damage it caused in the town. Large piles of debris can be seen along the south face of the school. An aerial view of the damage is provided in Figure 16, where it can also be seen that significant damage was sustained in the second story of the east wing of the building, including possibly the collapse of exterior walls. Most of the roof covering was also removed throughout the building, although it is unknown what the roof covering originally consisted of.

Figure 16: Aerial view of Severe Damage to Pilger Middle School (Source: [NEMA](#))

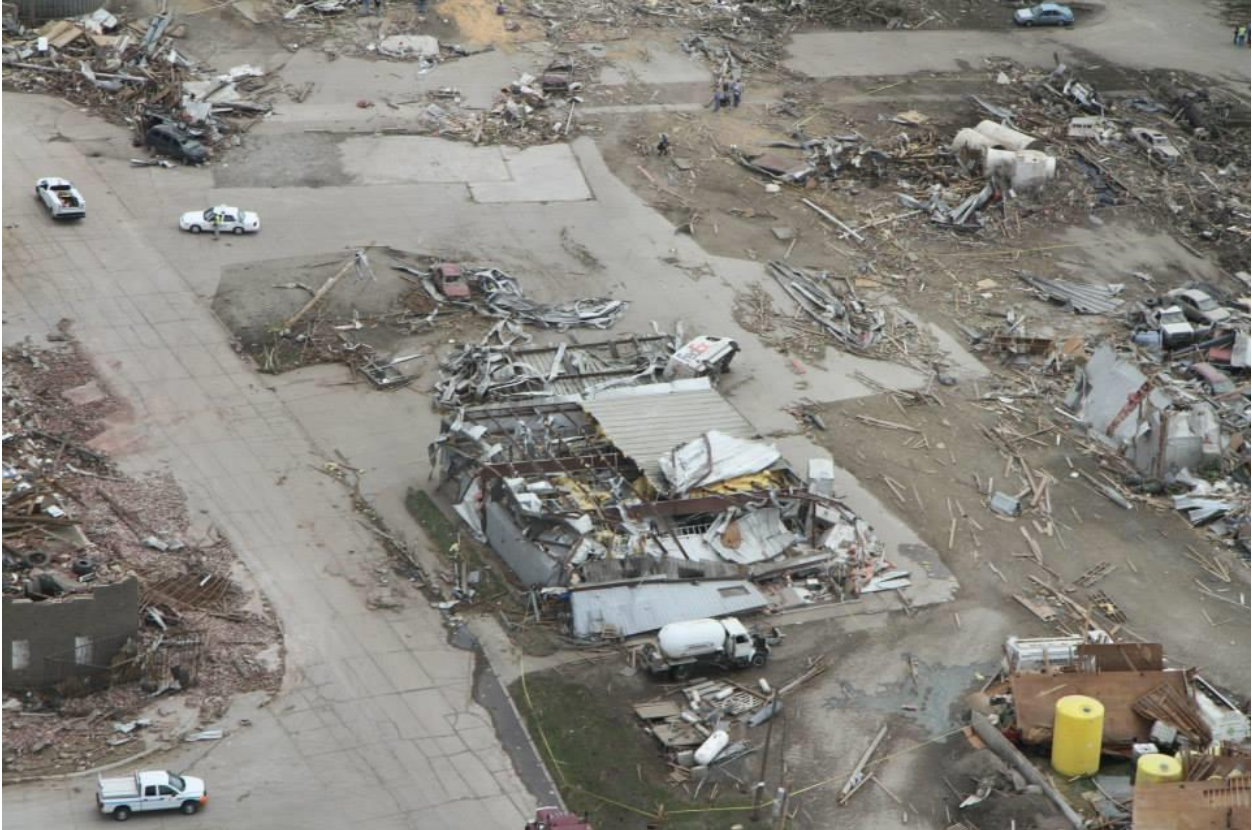
Damage to the Farmer's Co-op was also extensive, and perhaps the most significant to Pilger's economy, since it was the town's largest employer ([NPPD, 2014](#)). In fact, three of Pilger's top employers, Farmer's Co-op, Village of Pilger (which lost its roof during the tornado), and the Pilger Middle School, all sustained heavy damage. The workforce employed by these three employers accounted for approximately 25% of the town's total labor force. Damage to the Farmer's Co-op included the destruction of all of its storage silos, the partial or total collapse of all of its buildings, including a steel-frame warehouse building, and the loss of equipment. An aerial view of the damage can be seen in Figure 17.

Figure 17: Looking east at damage to Farmer's Co-op in Pilger, NE after EF-4 tornado (Source: [NEMA](#))
