Online Damage Report

The 6 May 2015 Great Plains Tornado Outbreak and Flooding

University of Florida's Wind Hazard Damage Assessment Team

11 May 2015

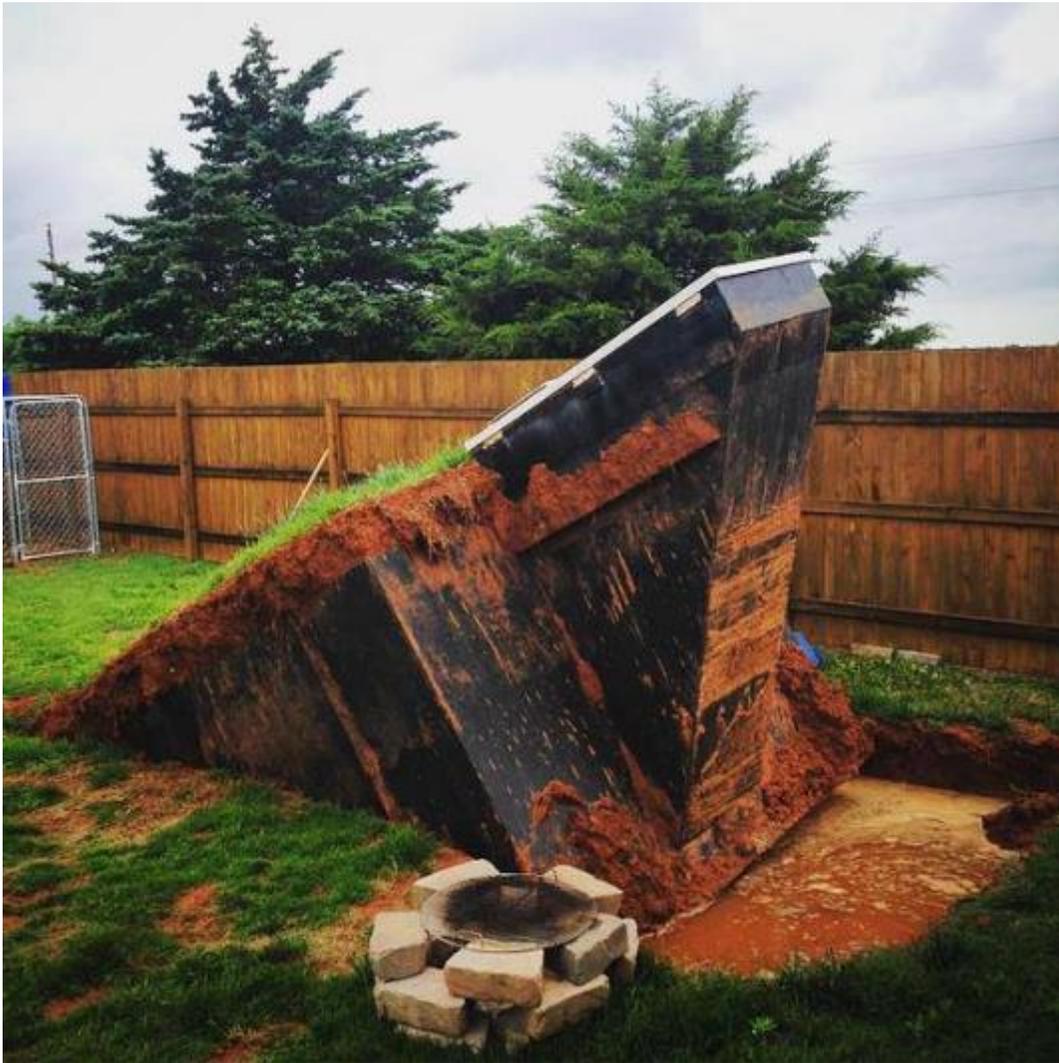
Underground Storm Shelter Lifted out of the Ground Due to Heavy Rainfall
(Image Courtesy: [KOCO News](#))

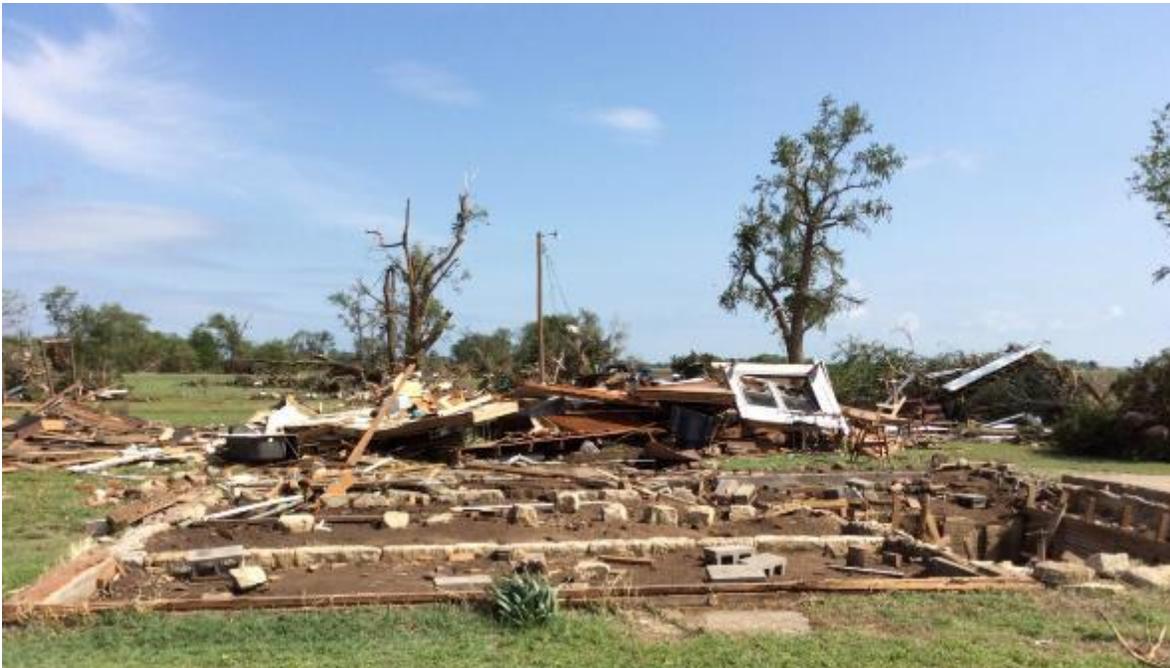
Figure 3: Damage to House NE of Mount Hope (Source: NWS)

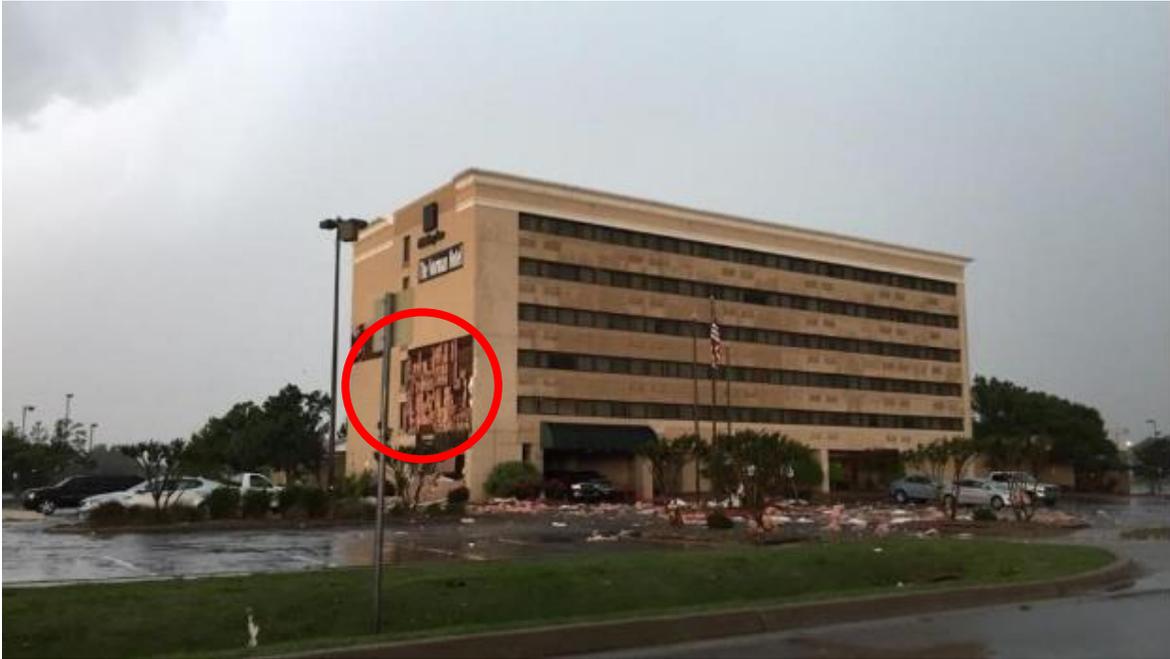
Figure 4: Damage to the façade of the Norman Hotel in Norman, OK, indicated by the red circle. It is unclear what specific material is used for the façade. (Source: [Weather Channel](#))

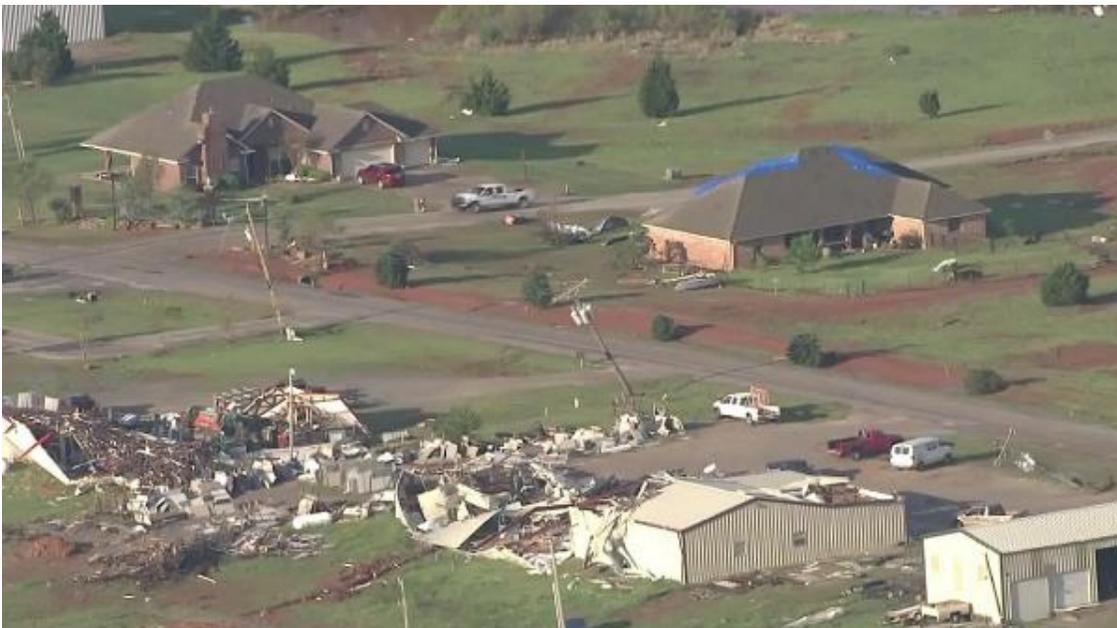
Figure 5: Roof removed from wood-frame structure near Chickasha, OK (Source: [WSB-TV](#)). Homes across the street are relatively undamaged.

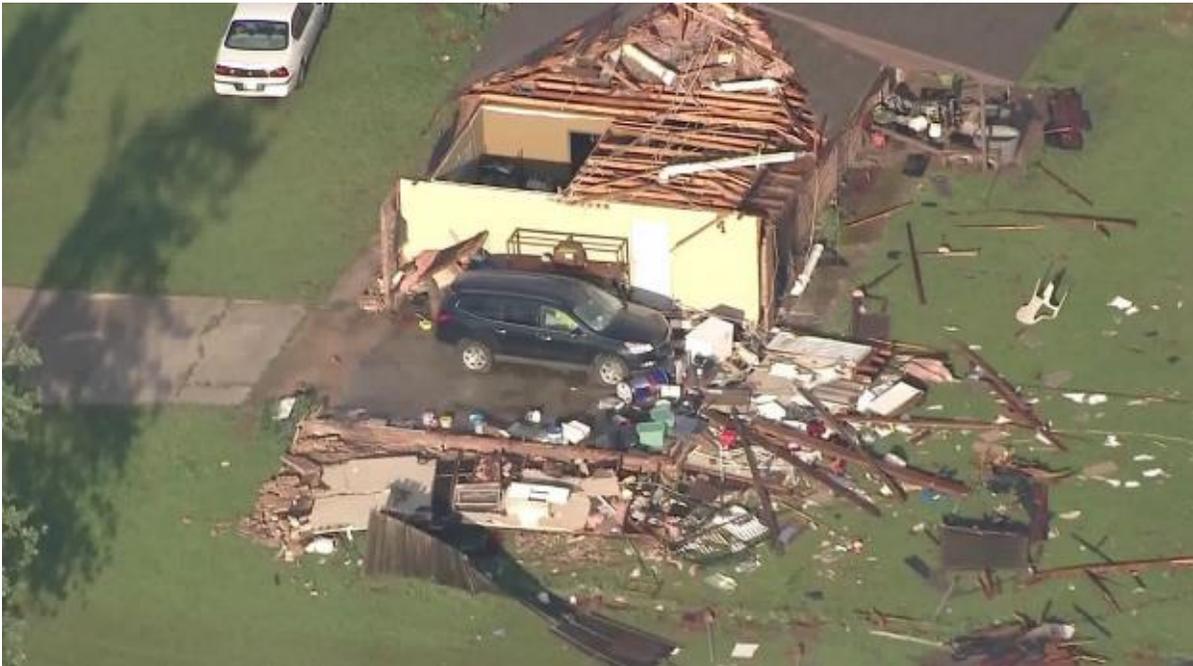
Figure 6: Garage failure of wood-frame structure near Chickasha, OK (Source: [WSB-TV](#))

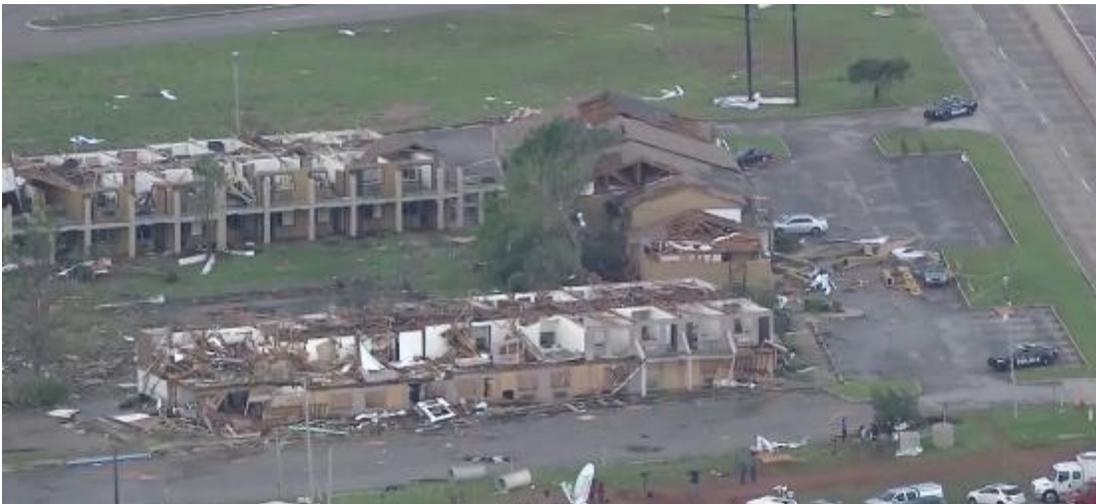
Figure 7: Apartment building damaged in Oklahoma City, OK. Most of the roof and much of the walls in the top story were removed. (Source: [KFOR-TV](#)).

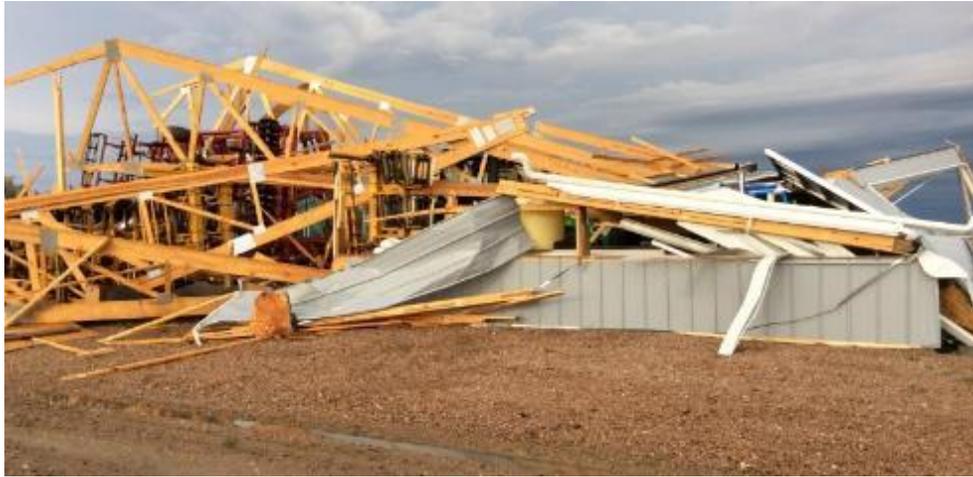
Figure 8: A metal-clad building with wood post frame construction destroyed in Roseland, NE (Source: [NWShttp://media.graytvinc.com/images/Roseland+Tornado.jpg](http://media.graytvinc.com/images/Roseland+Tornado.jpg))

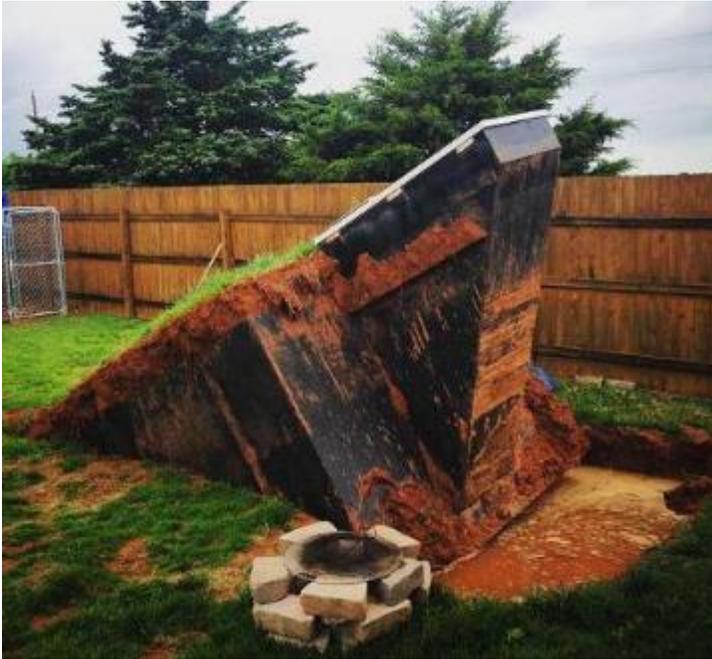
(a) This storm shelter was located in Noble, OK (OKCFox.com) and was installed in August 2014. It appears to be a steel storm shelter approximately 6 ft in height and covered with at most 1 foot of soil and sod. The water visible in the hole left by the shelter indicates that water table nearly reached ground level as the shelter lifted. The residents of the home were not in the shelter at the time it lifted. There is no evidence of any anchorage devices beyond the self-weight of the shelter itself.

Figure 10: Three storm shelters came out of the ground in the Oklahoma City, OK region due to the heavy rains. (a) and (b) occurred on May 6, (c) occurred on May 10. (d) is the location of the fatality in an underground storm cellar that also occurred on May 6.

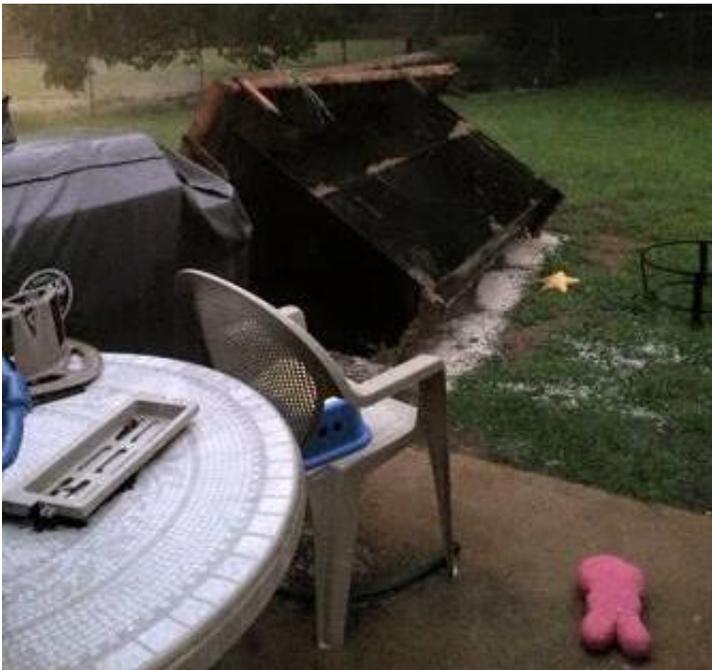
(b) This storm shelter was located in Mustang, OK ([KOCO 5 News](http://KOCO5News.com)) and also lifted during the heavy rains in Oklahoma on May 6. No details are available at this time on the shelter other than what is apparent from this photo. It appears to be a steel storm shelter also, about 6 ft in height, with minimal ground cover over the top. The residents were not in the shelter as it lifted and no anchorage devices are observable. The shelter appears to rely on self-weight alone to resist the buoyancy forces of the rising water.

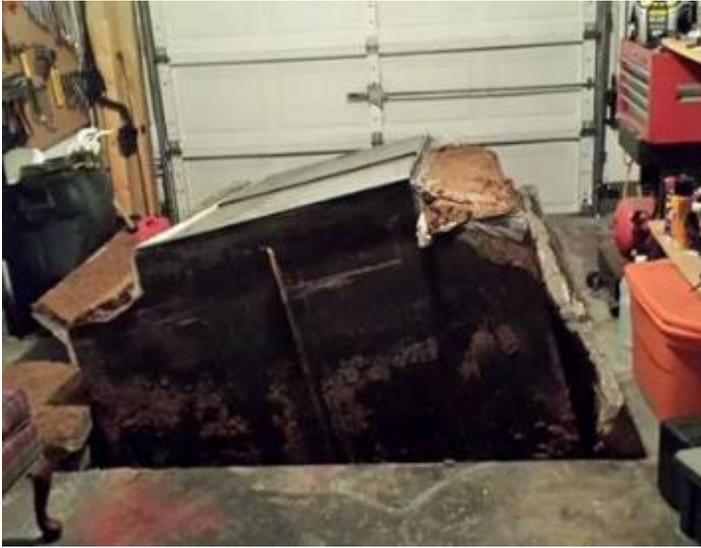
(c) This is an indoor underground storm shelter located in S.E. Oklahoma City, OK ([KOCO 5 News, Damon Lane](#)). The shelter appears to be structurally isolated from the concrete slab foundation of the garage. No evidence of anchorage is visible, but more photos would be needed to fully ascertain this fact. The photo was taken May 10th, after several more days of heavy rainfall in the Oklahoma City, OK area.

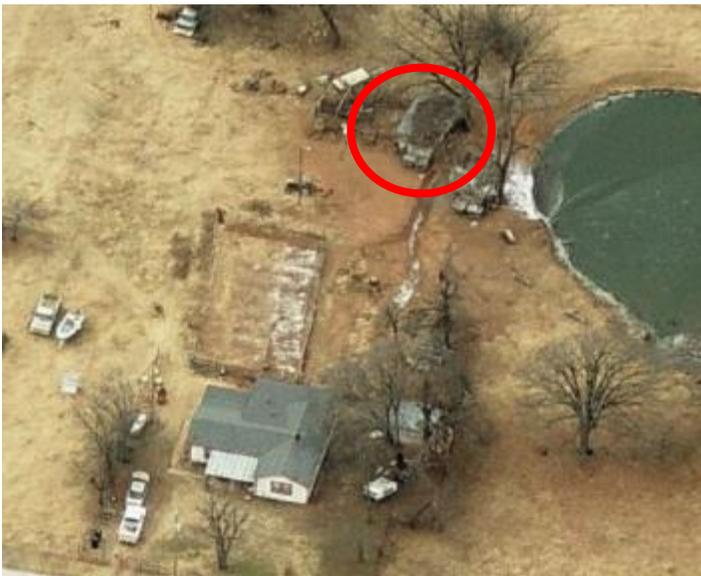
(d) Aerial view of the home and accessory building where a woman was trapped inside an underground storm cellar and killed. The entrance to the cellar was located at the front of the building highlighted in red. Note the pond adjacent to the storm cellar location. The home was located near the intersection of S Midwest St and SE 164th in Oklahoma City, OK ([KOCO 5 News](#)). The cellar does not appear to be a designed tornado shelter in accordance with ICC 500 or FEMA P-361.
