Online Damage Report

The 25 September 2015 Johns Island Tornado

28 September 2015

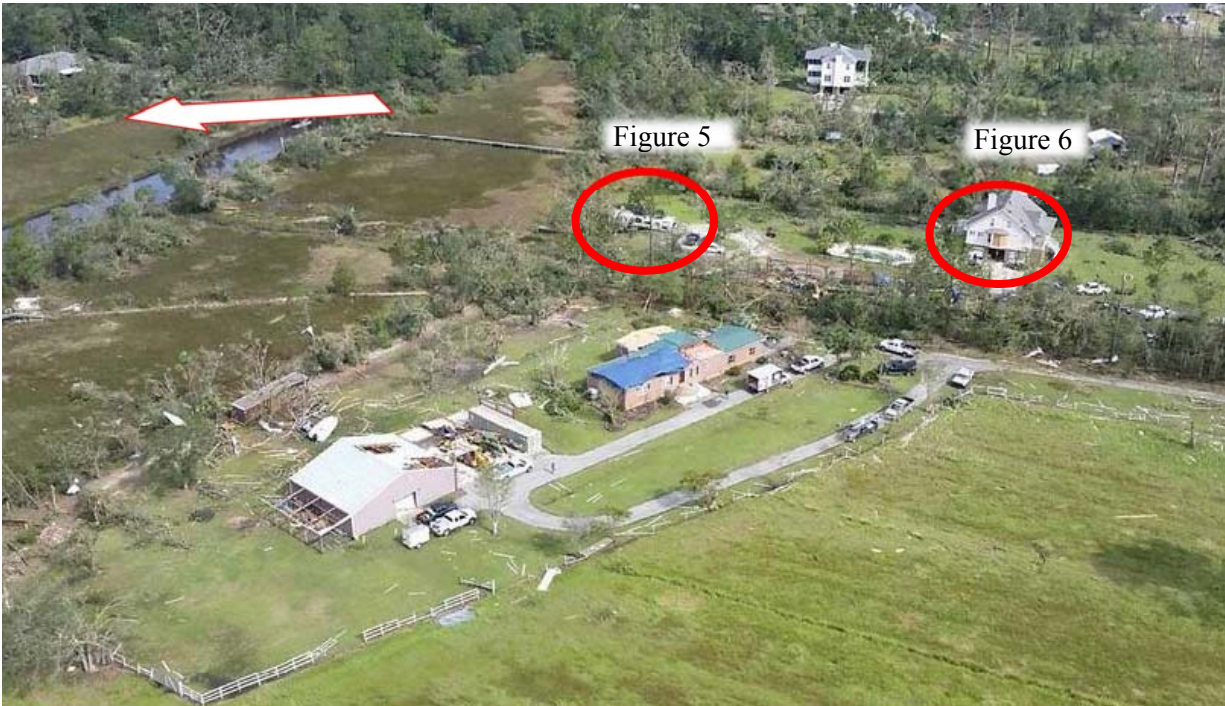
Figure 4: Aerial view of damage along Old Pond Rd. Roof damage was observed to two commercial buildings and a nearby home suffered damage to a bay window, garage door and roof covering. A camper was flipped in the same property. Approximate direction of tornado is indicated by white arrow. (Photo from ABCNews4.com)

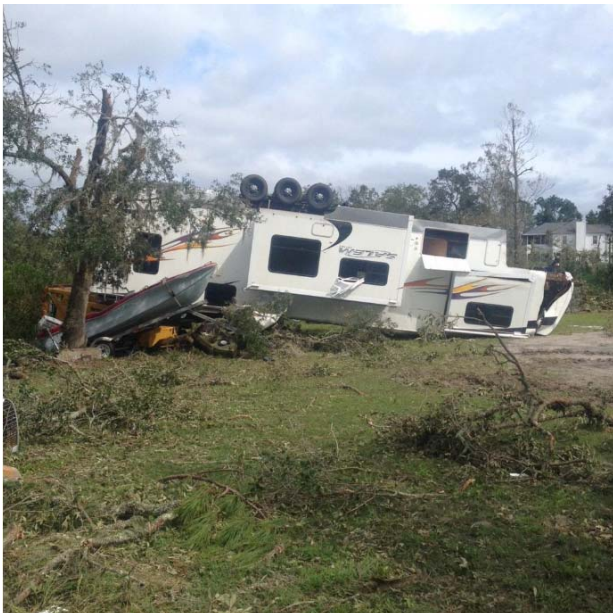
Figure 5: Toppled camper on property along Old Pond Rd (Photo Courtesy of [Karla Mata](#)).

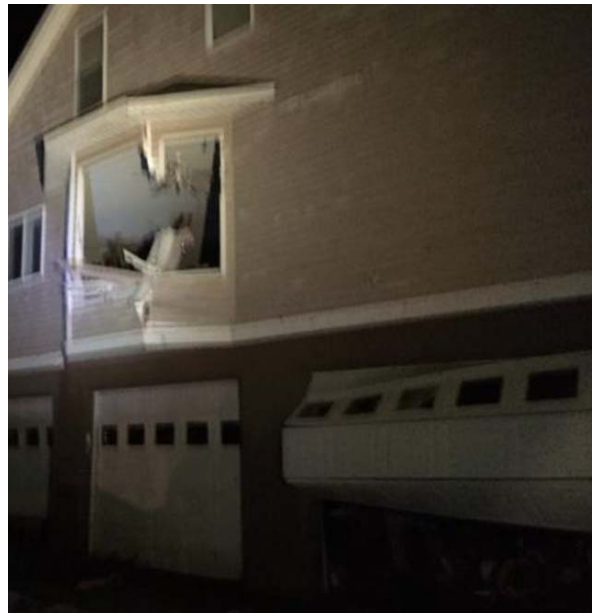
Figure 6: Bay window breached and garage door blown out in home along Old Pond Rd. Photo courtesy of [Stephanie Maxwell, WSOC Channel 9](#)

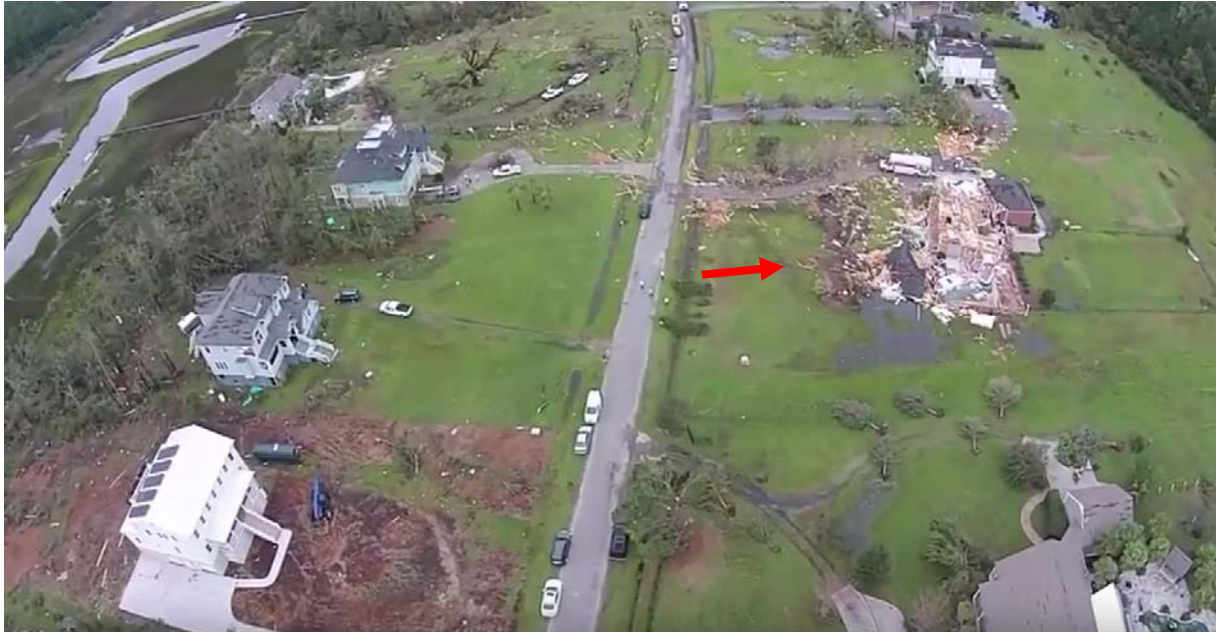
The worst damage caused by this tornado occurred along Sonny Boy Lane where a one-story home was completely destroyed (Figure 8). The roof and attic structure were ripped away and the debris deposited throughout the neighborhood. The aerial view shows several downed trees around nearby homes, but no other major damage on them. Roof covering loss is observable in several homes and there were also many reports of broken windows in these homes. The extent of the damage to the destroyed home is apparent from a ground view photograph, showing the front elevation with the partially removed roof structure resting on the ground (Figure 8.) Our report draws sharp focus on this home to answer questions regarding the size of the tornado, strength of construction and effectiveness of building codes.

Figure 7: Aerial view of damage to homes along Sonny Boy Ln. The red arrow indicates the approximate location and direction of the photo shown in Figure 8. Photo taken from [Charleston County Government aerial survey](#).

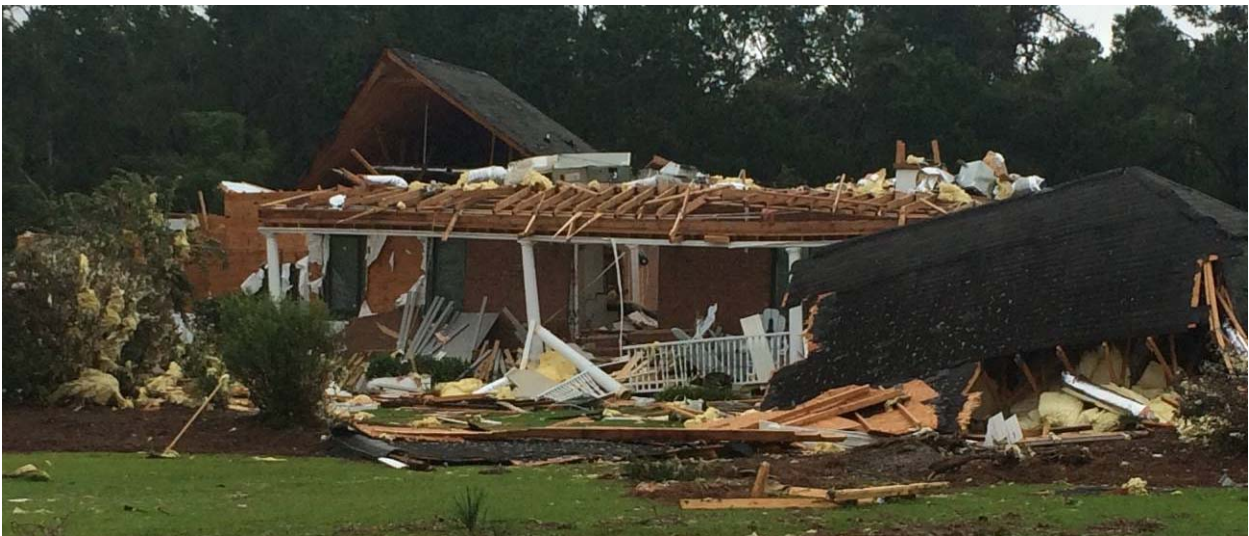
Figure 8: Ground view of destroyed home along Sonny Boy Ln. Photo courtesy of [Bryan Luhn, WCBD Channel 2](#).

The destroyed home shown in Figure 7 and Figure 8 was located at 727 Sonny Boy Ln. While the other houses suffered EF0 or EF1 damage, this structure exhibited quite severe damage (DOD 6 - large portions of roof structure removed), making it an EF2 level damage. By this context, estimated wind speed would be between 111 and 135 mph.

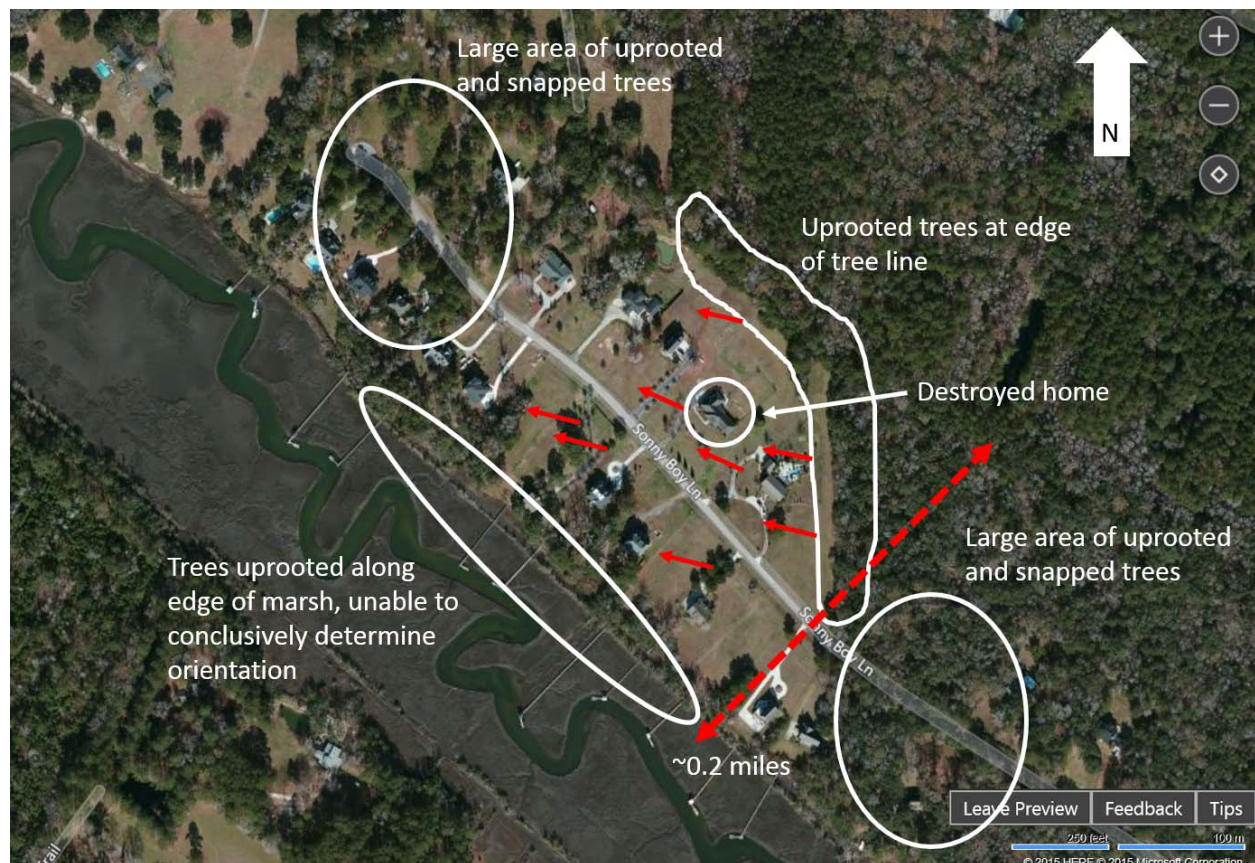
The level of damage this home sustained is starkly greater than that occurring on the surrounding homes – making one consider whether the tornado vortex was shortlived on the ground or that it skipped over other homes. No other homes along the road had any significant structural damage, there were only reports of roof cover loss and a few cases of windows or doors failing ([Post and Courier](#)). An overview of the damaged area given in Figure 9 shows large areas of tree damage both to the east and to the west of the destroyed home, with relatively consistent tree-fall orientations along both sides of Sonny Boy Ln. If a tornado had passed down Sonny Boy Ln, we would have expected to see fallen trees pointing in opposite directions on opposite sides of the tornado path. An [aerial video](#) of the damage shows that this was not the case and indeed, looking at the overall patterns and locations of damage, it appears implausible that any sized vortex could have passed directly over the destroyed home without encountering at least some of the other homes. This leads us to consider other explanations.

Figure 9: Overview of Sonny Boy Ln showing major areas of fallen or snapped trees and general tree-fall orientations (red arrows) along Sonny Boy Ln.

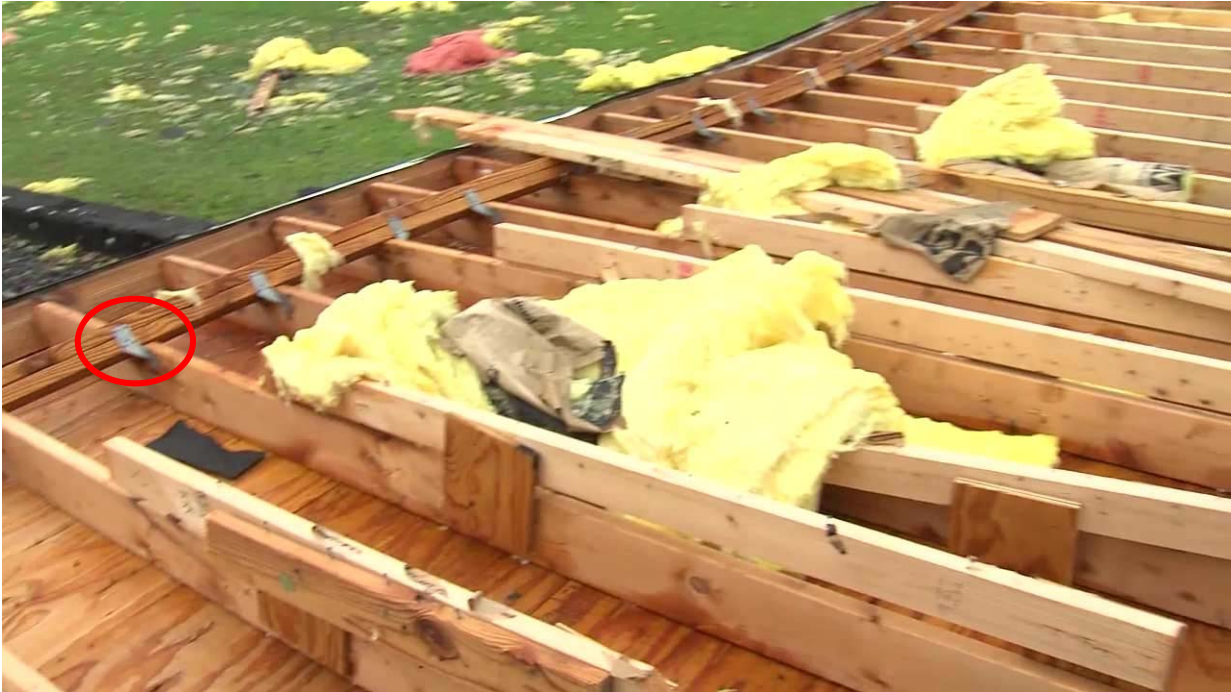
Figure 10: Hurricane straps present between rafters and wall top plate. However, the wall top plate separated cleanly from the wall structure and failed along with the roof, indicating the load path between the wall plate and vertical studs may have been the critical failure point resulting in the observed damage to this home (Photo courtesy of ABCNews4.com).

We concluded there was nothing unusual in shape and orientation of the house, topographic or exposure effects, or special meteorological phenomena to account for the mode of failure, and we are left to suspect there may be a structural deficiency in the vertical load path. The evidence for this is visible in the “clean” separation of the wall double-top plate from the vertical studs Figure 10. That is, neither the rafter nor the studs themselves were fractured, the connection merely separated. The common construction of the stud walls is to nail it into the end of the vertical studs – nails are installed into the end grain of the wood members and the withdrawal capacity of this connection is very low. Thus, while the metal hurricane straps provide a robust connection of the rafters to the top plate (using a nail group of 3-4 nails, loaded in shear), if the vertical studs are not directly engaged by the metal tie, the weak connection between horizontal wall plate to vertical stud remain in the load path and lead to this failure. Common design practices for addressing this connection can be found [here](#). A far stronger connection for attaching the horizontal top plates to the vertical wall studs is by using through metal straps and/or through overlapping the wall sheathing on to the top plates such that the sheathing and its fasteners form the connection.

- The top rafters were connected to the top plate with hurricane straps but there is no evidence of positive attachment of the horizontal top plate to the vertical wall studs, either through metal straps or overlapping of the exterior sheathing.
- Rafters meeting at the peak of the roof were toe-nailed together rather than connected with metal plates or straps.

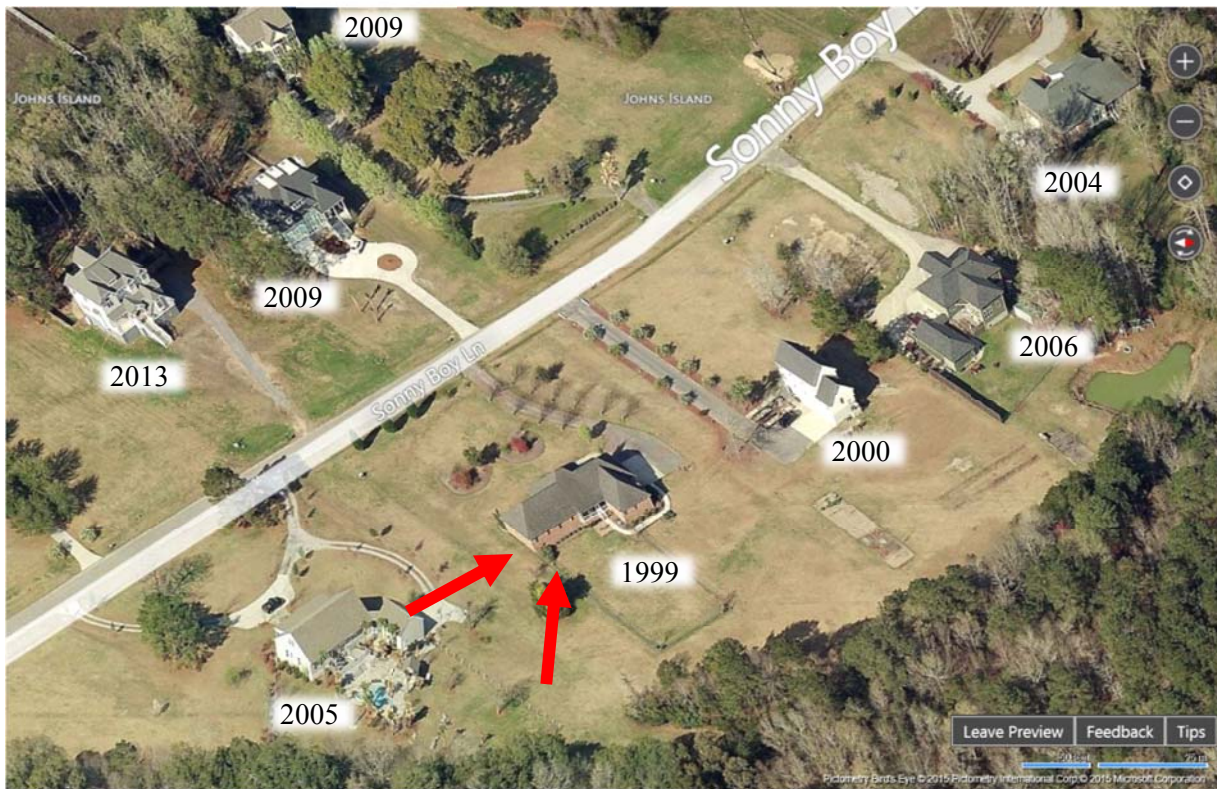
Regardless of the exact cause of failure in this home, the lack of damage to surrounding homes is still surprising. The [Charleston County tax assessor database](#) indicates that the destroyed home was built in 1999. The year built of surrounding homes are shown in Figure 11. The destroyed home was the oldest home on the street, and one of two (out of 8) that were built prior to South Carolina’s adoption of the International Building Code in 2001. The second-oldest home, located immediately north-west of the destroyed home, was built in 2000 and had a roof span approximately half that of the destroyed home. Assuming these homes had similar construction, the shorter roof span would result in much lower wind uplift loads (suction) on the roof structure. This alone could explain the difference in structural performances of these two homes.

Figure 11: Birds eye view of the destroyed home. Solid red arrows indicate the range of wind directions the home was exposed to during the passage of the tornado based on the debris and treefall patterns (see Figure 7). The white arrow with red outline indicates the approximate direction of travel of the tornado as it passed this area. The exact path of the tornado center is not known however.
