## Southeastern US Tornado Outbreak 21-22 January 2017

**Destruction of Albany Baptist Church in Albany, GA**

**University of Florida's Wind Hazard Damage Assessment Group**

## EXECUTIVE SUMMARY

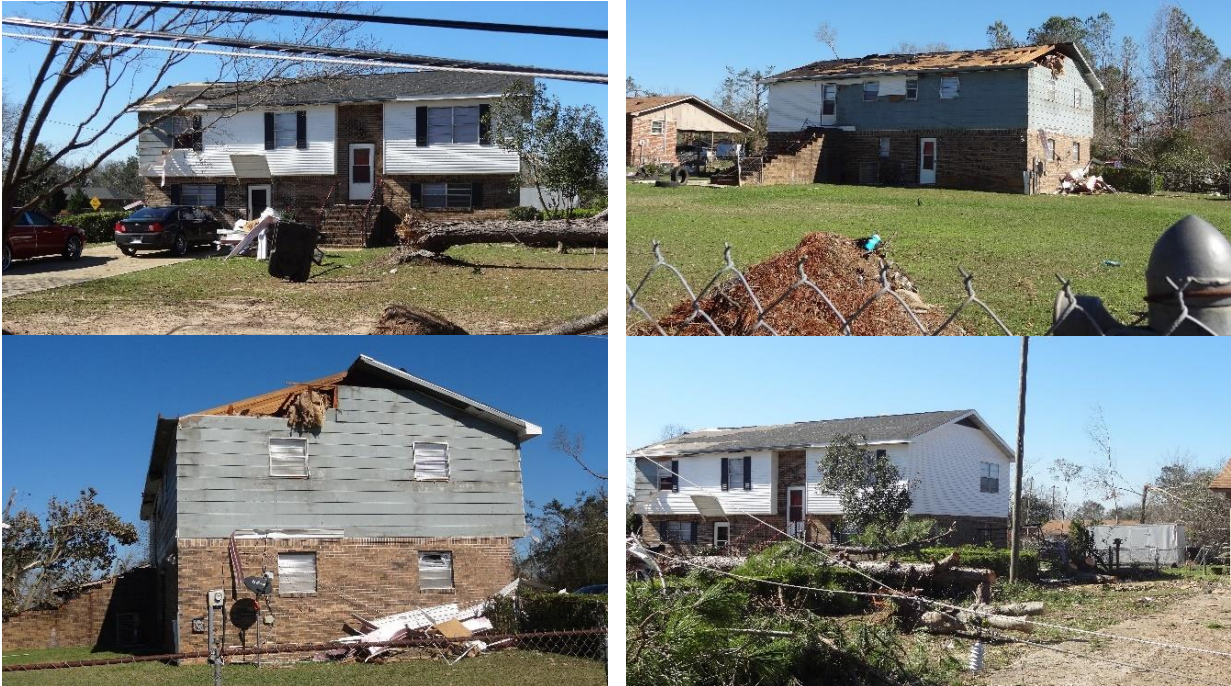
Figure 7: Damage to all four sides of a two story home located at 125 Ramsey Rd, Albany, GA.

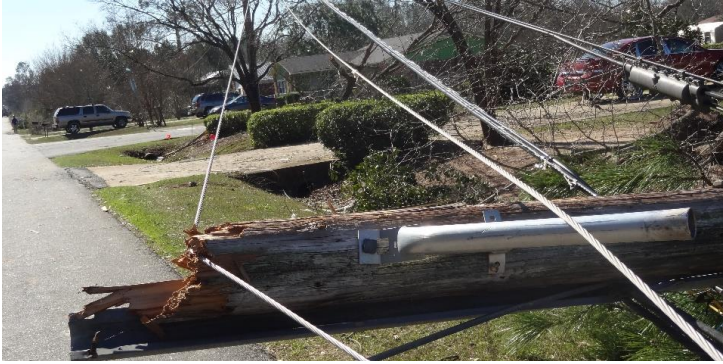
Figure 14: Downed electrical poles snapped throughout the tornado path, many observed with windborne debris. The EF Scale (DI24) gives an expected wind speed of 118 mph for this failure. (Source: UF WHDAG)

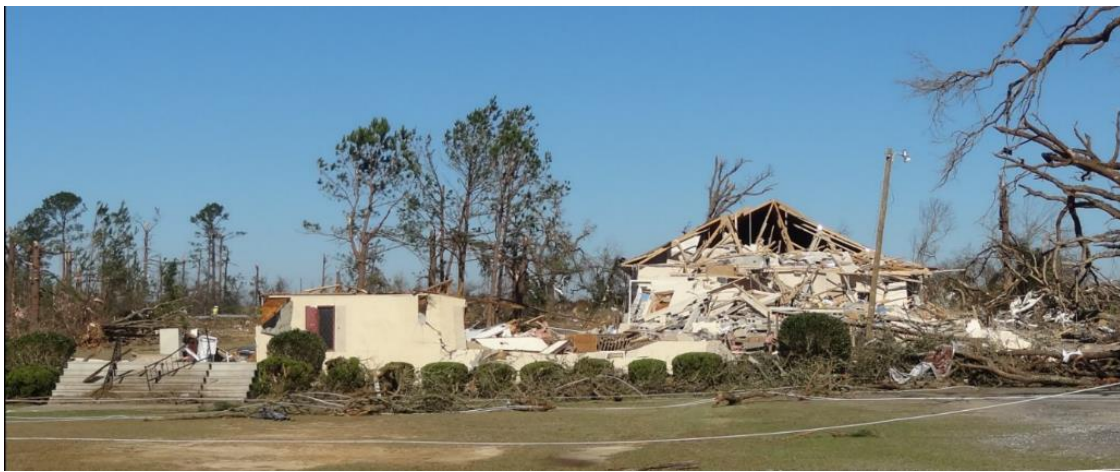
While the enhanced construction (at least relative to typical residential structures) might have enabled the church to perform better than it did, several factors may have contributed to its catastrophic failure, including the following:

- 1) The large open area in front of the church facing the road and the oncoming path of the tornado may have allowed the wind speeds interacting with the church to be higher than they would have been in a densely treed or otherwise sheltered area. Exposure effects on tornadoes are not yet well understood however, so this remains just a hypothesis.

- 2) The layout of the buildings on the property, with the older, wood-frame structure in front of the newer sanctuary, may have resulted in the older building failing first and the debris impacting the new building, breaching the envelope and increasing the loads.

- 3) The orientation of the new sanctuary was such that the gable end was in the oncoming path of the tornado. Winds coming from that direction impinging on the gable end of a structure typically produce the worst-case loading condition for the roof.

- 4) The relatively large overhang of 32 inches allows positive pressures on the underside of the overhang to add to the uplift pressures on the top of the roof surface, significantly increasing the uplift loads on the roof-to-wall connections.

Figure 21: Front view of Albany Baptist Church after the tornado. Nearly half of the new sanctuary was destroyed by the tornado. The older wood-frame sanctuary was completely destroyed except for one interior room.

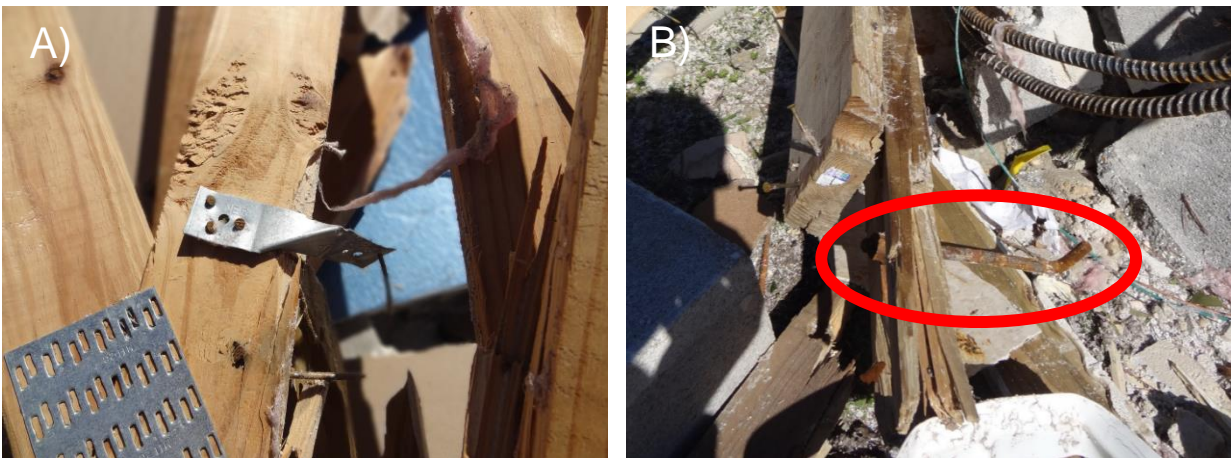
Figure 22: (C) USP RT12 hurricane tie used to attach each truss to the wall plate; (D) j-bolt with nut and washer used to fasten top plate to reinforced tie-beam along top of masonry wall.

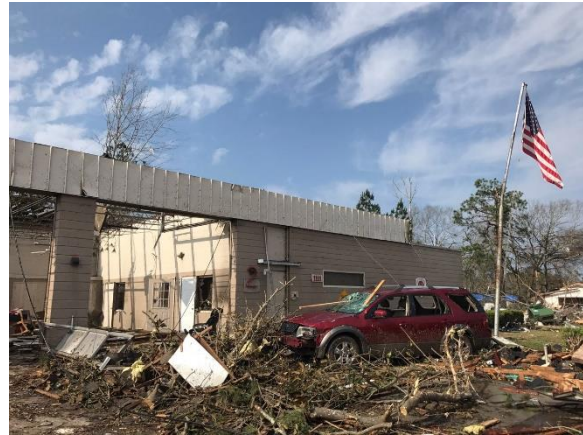
Figure 25: Damage in Hattiesburg to an apartment complex (left, by [Ryan Moore](#)) and to Fire Station 2 (right, by [Ryan Moore](#)). The large openings shown in the fire station allow wind to pressurize the interior space, enhancing wind loads on the roof system.
