Damage Survey Following the August 27th, 2012 Tornado in Vero Beach, FL

6 September 2012

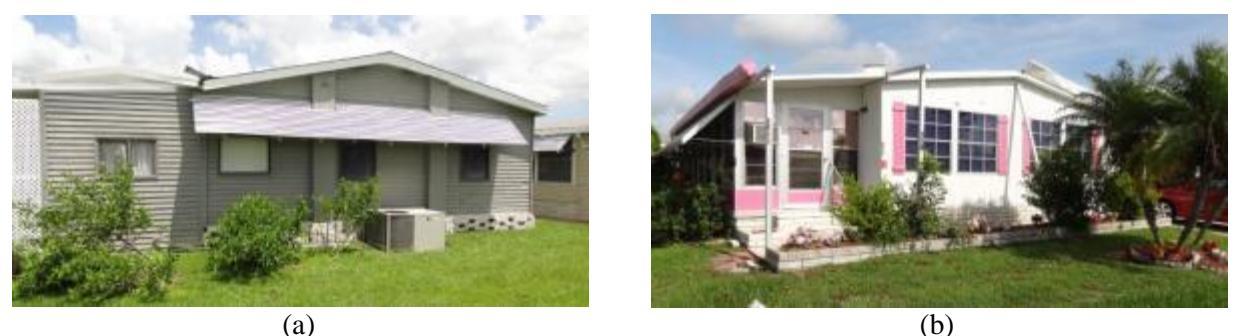
Figure 4: Threshold of Visible Damage (DOD 1)

For the first DOD, minor damage such as loss of a few metal panels and accessories usually occurs, but there is no evidence of any further damage. Figure 4a shows that very few parts, namely metal edge flashing or gutter, were damaged. From Figure 4b, it can be seen that a few protruded metal panels were torn down. However, neither of two examples had any evidence of any further damage. From Figure 3, it can be obtained that the probable wind speed leading to the first DOD is located in a range from 51 to 76 mph with an expected value of 61 mph.

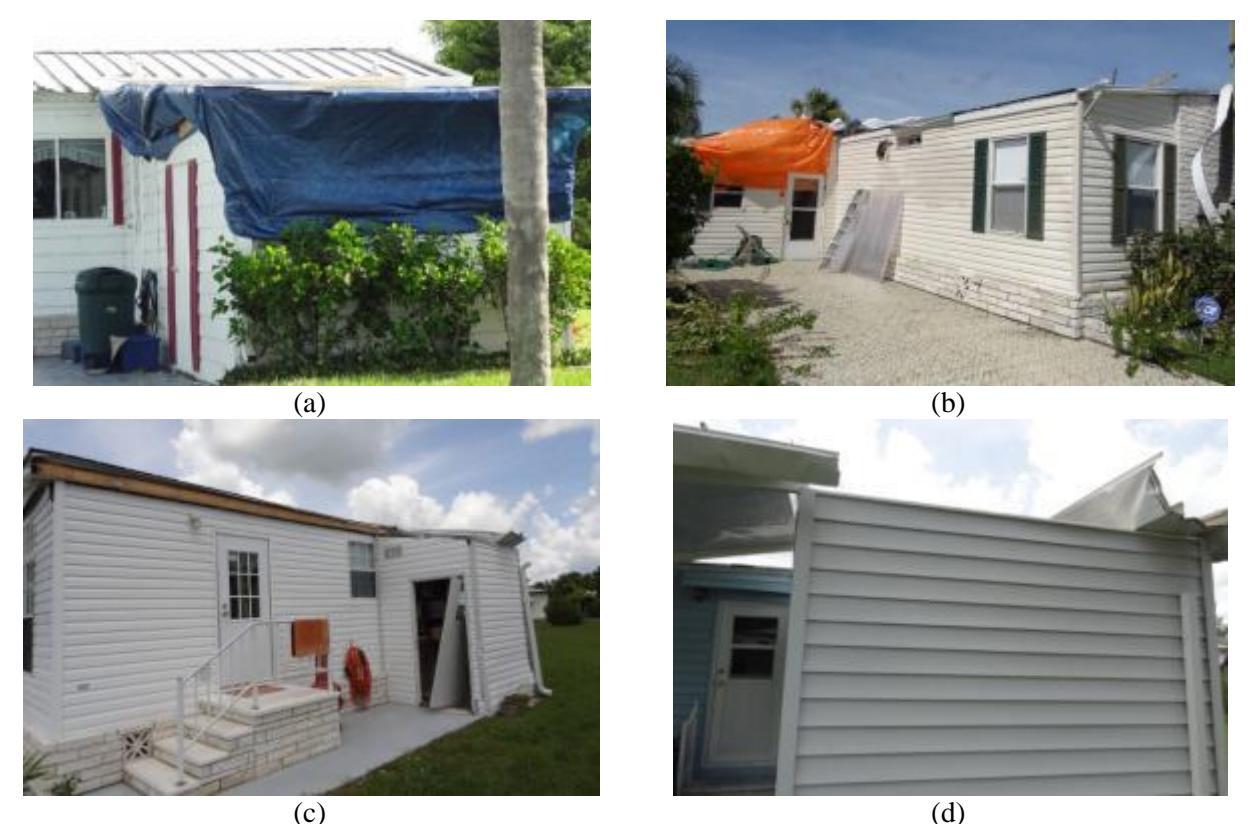
Figure 5: Loss of shingles or other roof covering material (<20%) (DOD2)

A few houses were observed in the survey that a significant loss of roof covering materials occurred but their total area of loss was no more than 20%. Most of the damages were caused by the failure of links between the metal panels over extra rooms and main structures (Figure 5). After the mobile homes were fabricated, people often built some subsidiary structures used for the storage. This roof covering material (e.g., shingle or metal deck) over the extra room was attached to the main structure by toe-nails, even without a beam supported. Due to the deficiency of lacking of effective support and connections with the main structure, the roof materials over the extra room were very vulnerable to wind. Thus, it is very easy to see that the roofs over them were damaged or even blown off when the tornado touched down. The described damage above can be defined as the second DOD, corresponding to a wind speed range of 62 ~88 mph in the recommendation of EF scale rating.

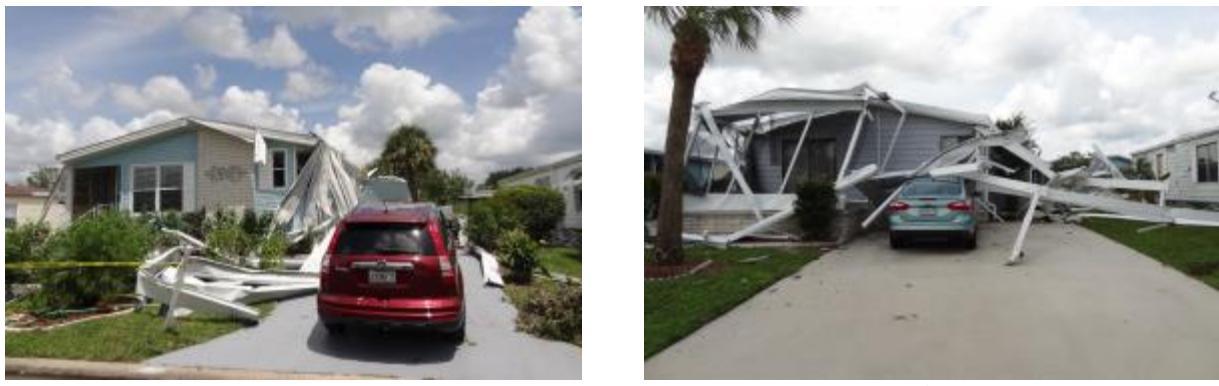
Figure 6: Damaged carports (DOD 3)

It was very common to see that the porches or carports were severely damaged in the surveyed regions. Figure 6 shows us some damaged carports and Figure 7 provides some pictures of collapse or damage of porches. Similar to the roof covering over the storage room, the roof metal decks of porches or carports were usually attached to the manufactured home. In addition, it was noted that the columns used were fixed to the ground with only very few nails or bolts and minimal lateral bracing or blockings. Even if the porches or carports were sufficiently connected, the sum of the positive pressure over the roof and negative pressure underneath might lift the covering up. Thus, the porches and carports are very vulnerable to the extreme wind event. The wind speed range to cause the described damage mentioned above is from 67 to 96 mph.

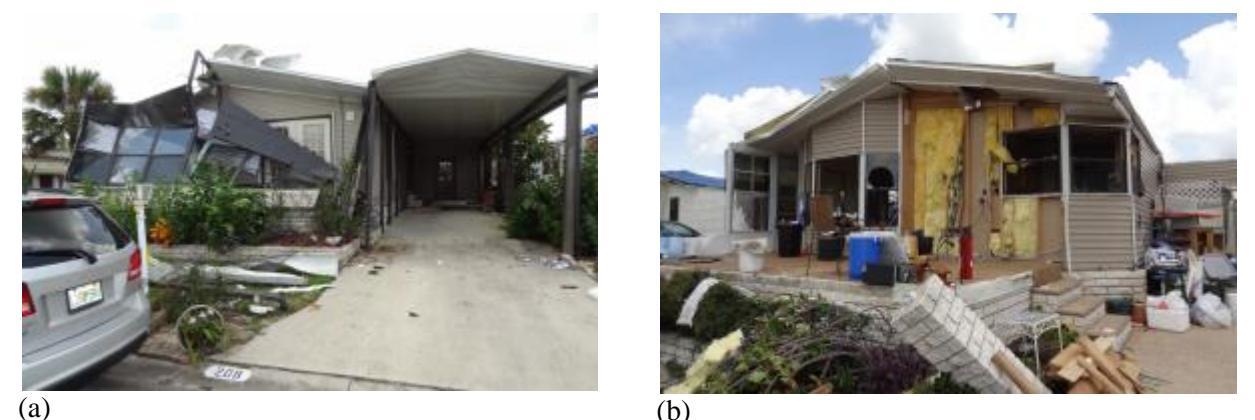
Figure 7: Damaged Porch (DOD3)

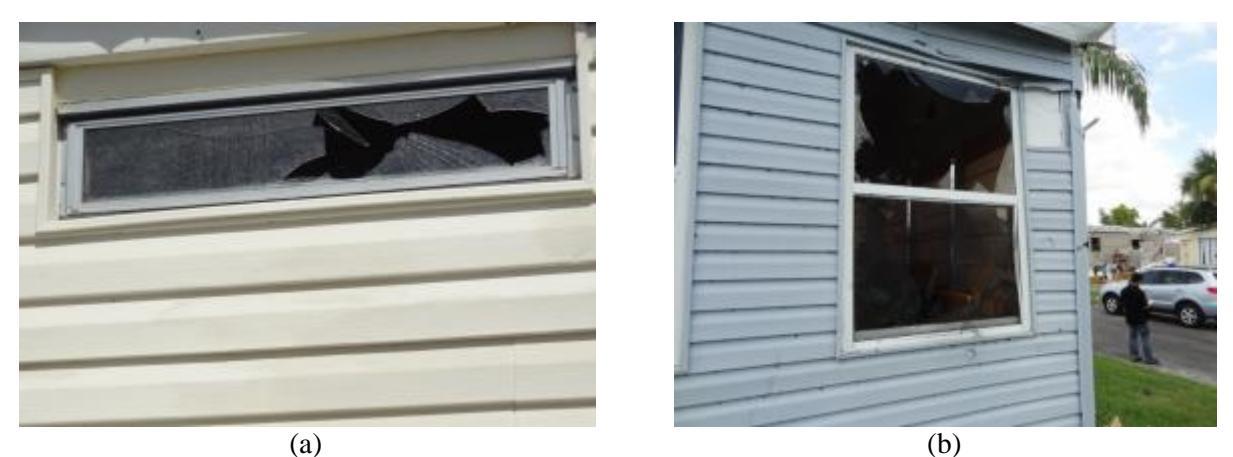
Figure 8: Broken windows (DOD 4)

Several homes were observed with broken windows (Figure 8). These instances occurred mostly in walls facing the direction of the tornado's translation, which matches the fourth DOD specified in the recommendation of EF rating with a wind speed range of 68~95 mph.

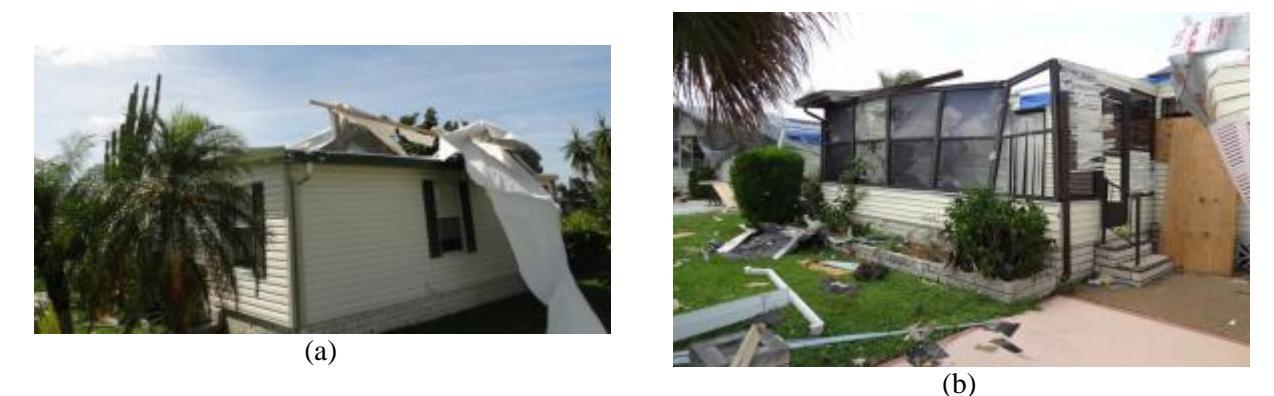
Figure 9: Uplift of roof deck and loss of significant roof covering material (>20%) (DOD5)

DOD 5 was observed in many homes where the significant loss of roof covering material occurred and the damaged area were more than 20%. From Figure 9a, it can be clearly seen that most of the roof metal deck were gone due to the strong suction on roof. Figure 9b shows another shot of damage of metal roof deck and pushover of porch. Although the main structure essentially remained intact or undamaged, the tornado resulted in the significant loss of roof covering materials (shingle or metal deck). The wind speed range for this DOD is from 75 to108 mph, having an average of 88mph.

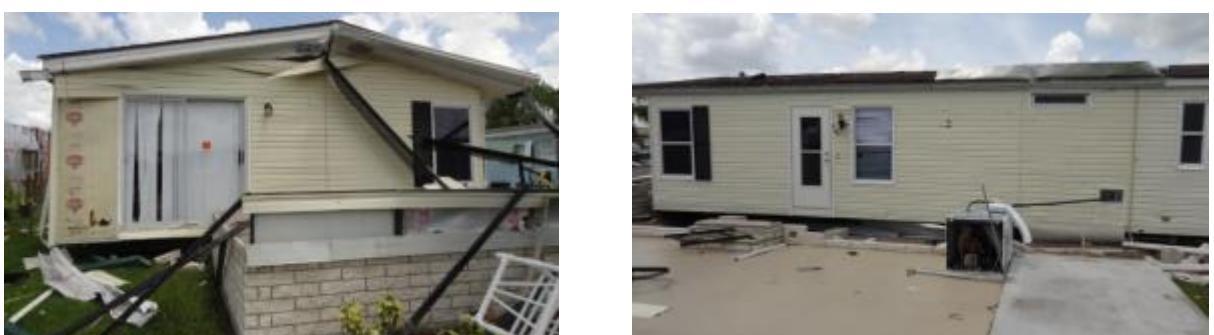
(a) Front elevation(b) Side elevationFigure 10: House shifted 7 ft off foundation slid off CMU block piers (DOD 7)

For the seventh DOD defined in the recommendation, only one house was observed where the unit slid off the CMU block piers. As shown as in Figure 10, the whole mobile home shifted 6 ft. from the original position. It is worth mentioning that three metal straps with a spacing of 12 ft. were deployed each side to prevent the house from sliding off, but were severely corroded (Figure 11). Despite the wall and most of metal deck for this home still kept well and the anchors was corroded, the wind speed producing this damage is within a range of 78 ~109 mph.

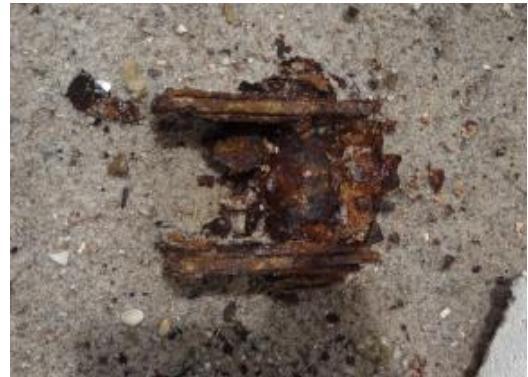
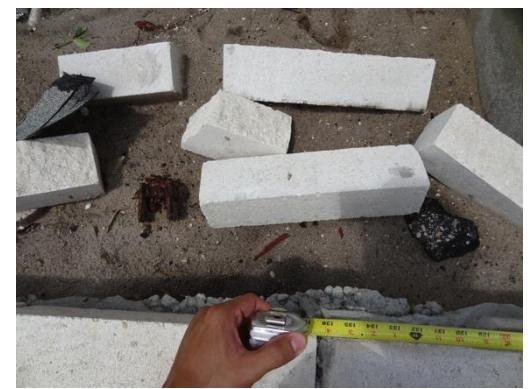
(b) Location of corroded strap near knee wall

Figure 11: Completely corroded strap anchor used to attach metal foundation strap to ground anchor of House in Figure 10

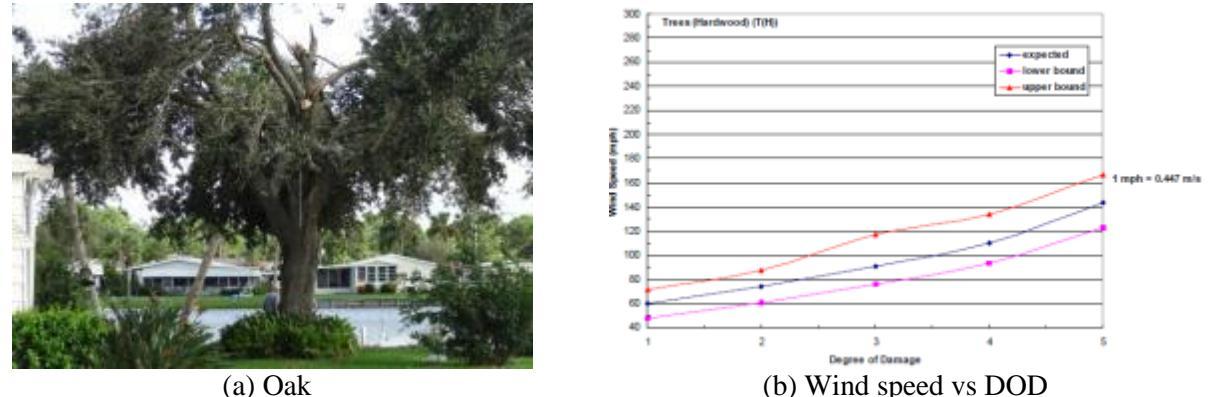
Figure 12: Hardwood tree damage

Besides the structural damage indicators mentioned above, the recommendation also provided the indicator on the tree damage. Figure 12a) shows the damaged Oak with the broken large branches. The corresponding wind speed for this DOD is a range of 61~88 mph with an average of 74 mph, which can be obtained from the Figure 10b. In contrast to the damage of hardwood tree, the expected wind speed resulting in the damage of softwood tree as shown as in Figure 13a slightly goes up to 75 mph.

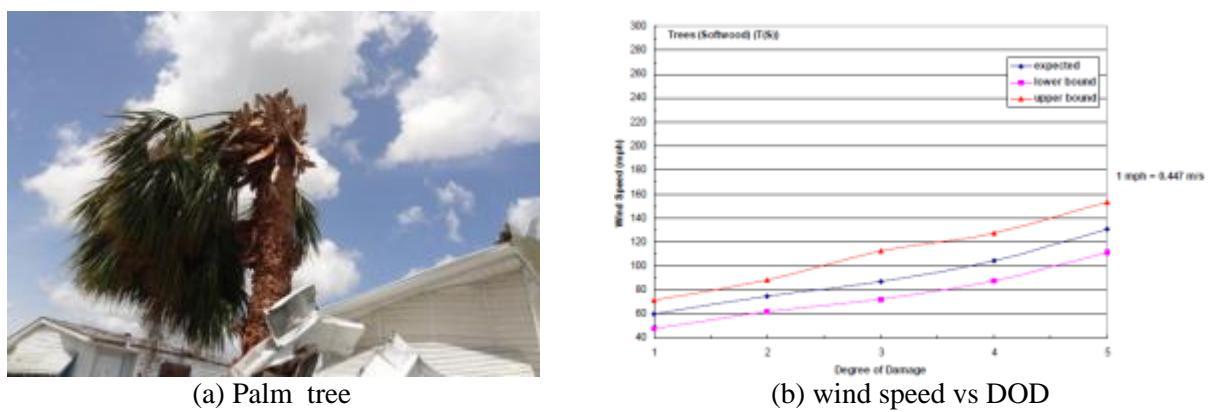
Figure 13: Softwood tree damage
