Online Summary

Damage from the 31 May 2013 Tornado in El Reno, OK

University of Florida Wind Hazard Damage Assessment Team

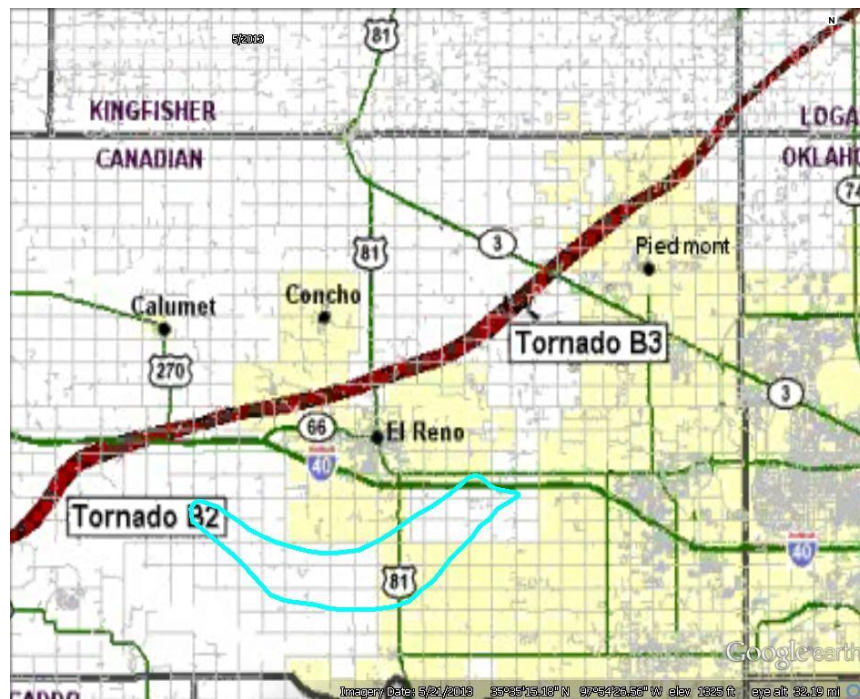
Figure 5: May24, 2011(Red) May 31, 2013 (Blue) El Reno Tornado Track

MAY 24 2011: At 3:50 PM CDT, the populated city of El Reno was struck by a devastating EF5 tornado that resulted in 9 deaths and 181 injuries. This 1760 yard wide tornado moved east-northeast through El Reno, creating a damage path more than 63 miles long, with peak winds greater than 210 mph. Similar to the May 31, 2013 tornado, wind speed measurements from a mobile Doppler radar were used to rate the tornado. The majority of the damaged buildings were one and two-story residential structures built on concrete slab foundations, several mobile homes were destroyed, and a few commercial buildings were badly battered. The May 24, 2011 and May 31, 2013 tornadoes are illustrate in Figure 5.

[The yellow, and grey areas illustrate the populated regions, gray being densely populated]

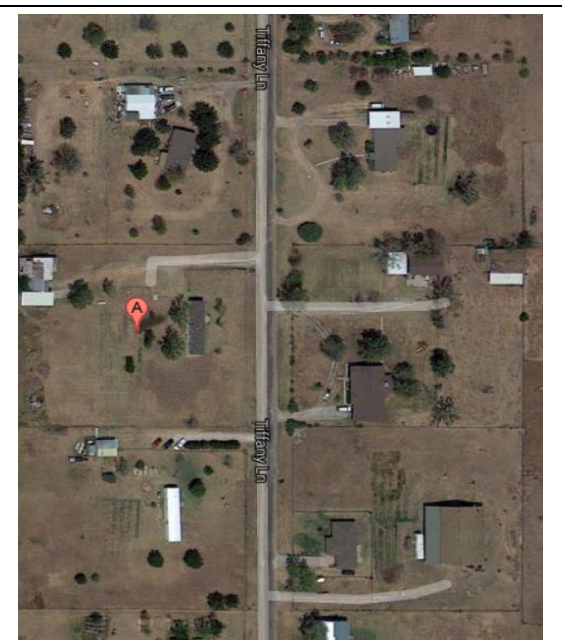
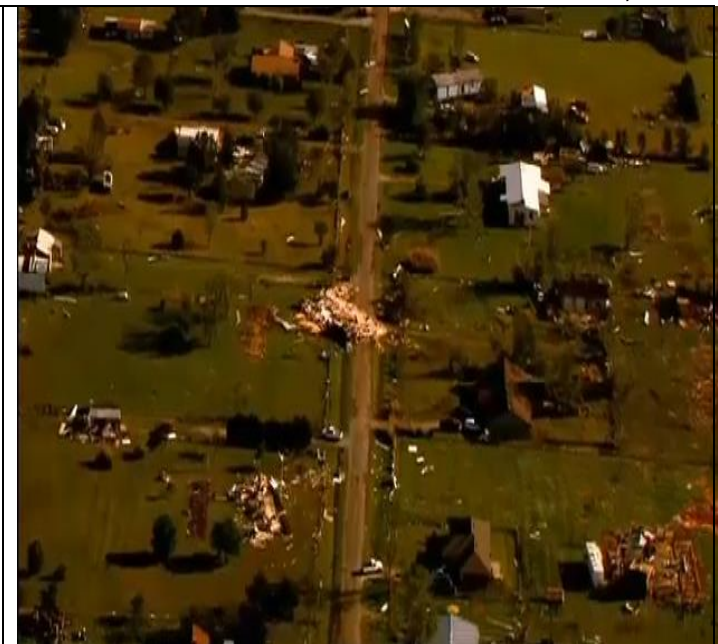
Damage to residential structures appears to be quite extensive, although no estimate as of yet has been given as to the number of homes damaged or destroyed. A neighborhood south of I-40 sustained heavy damage, as shown in Figure 9(b).

<p>This aerial photograph shows the same residential neighborhood after a disaster. There is significant debris scattered across the landscape, and some buildings appear damaged or destroyed.</p>
<p>(a) Residential Buildings (before)</p>	<p>(b) Residential Buildings (after)</p>

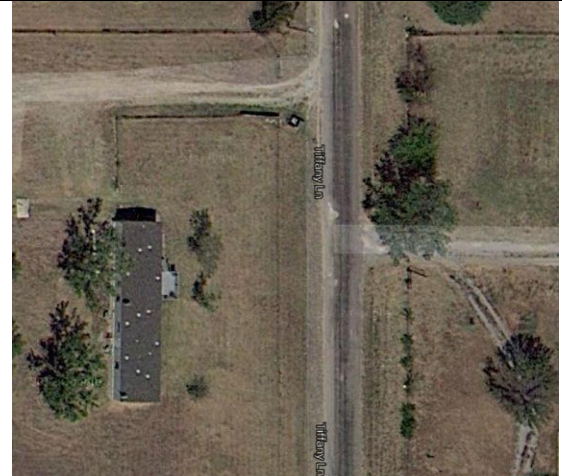
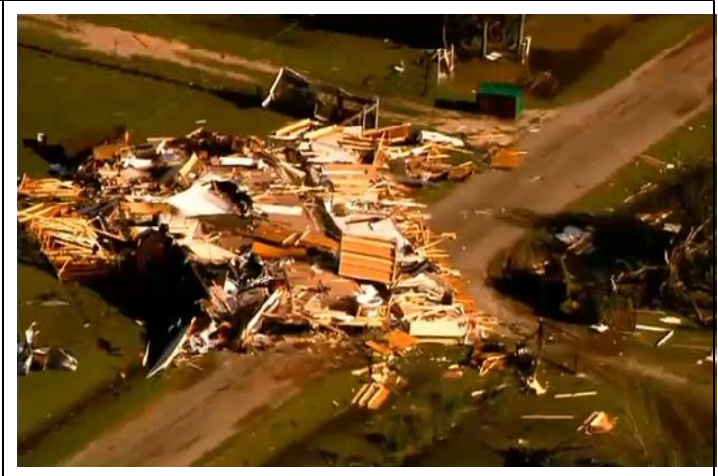
Using data available on Zillow.com, most of the homes within the damage path appear to have an average age of 30 years, years of construction ranging from 1935 to 2009. Figure 9(d) shows a mobile home, built in 1978, moved about 100 feet off its foundation and what's left of it scattered over Tiffany Lane. It was located near the centerline of the estimated tornado path. From the photo it can be seen that this was a wood-frame home, but no information can be seen to indicate the quality of the wall-to-foundation and roof-to-wall connections. Note that while this home was completely swept off its foundation, homes in the background have damage varying from minor sheathing loss to being completely leveled.

<p>This aerial photograph shows the same house after a disaster. The house is completely destroyed, with its remains scattered in a large pile of debris.</p>
<p>(c) Aerial View of house built in 1978 (before)</p>	<p>(d) Aerial View of house built in 1978 (after)</p>
<p>Figure 9: Before and after photos of damage to Residential Structures between S Manning Rd and S Evens Rd</p> <p>[(c) & (d) show extensive damage to a home at 4710 Tiffany Ln, El Reno, OK 73036]</p> <p>(Images Courtesy of Google maps & http://www.news9.com/story/22475572/news-9-pilot-jim-gardner-takes-aerial-look-of-tornado-damage-in-el-reno)</p>
