Damage Survey Following the August 27th, 2012 Tornado in Vero Beach, FL

6 September 2012

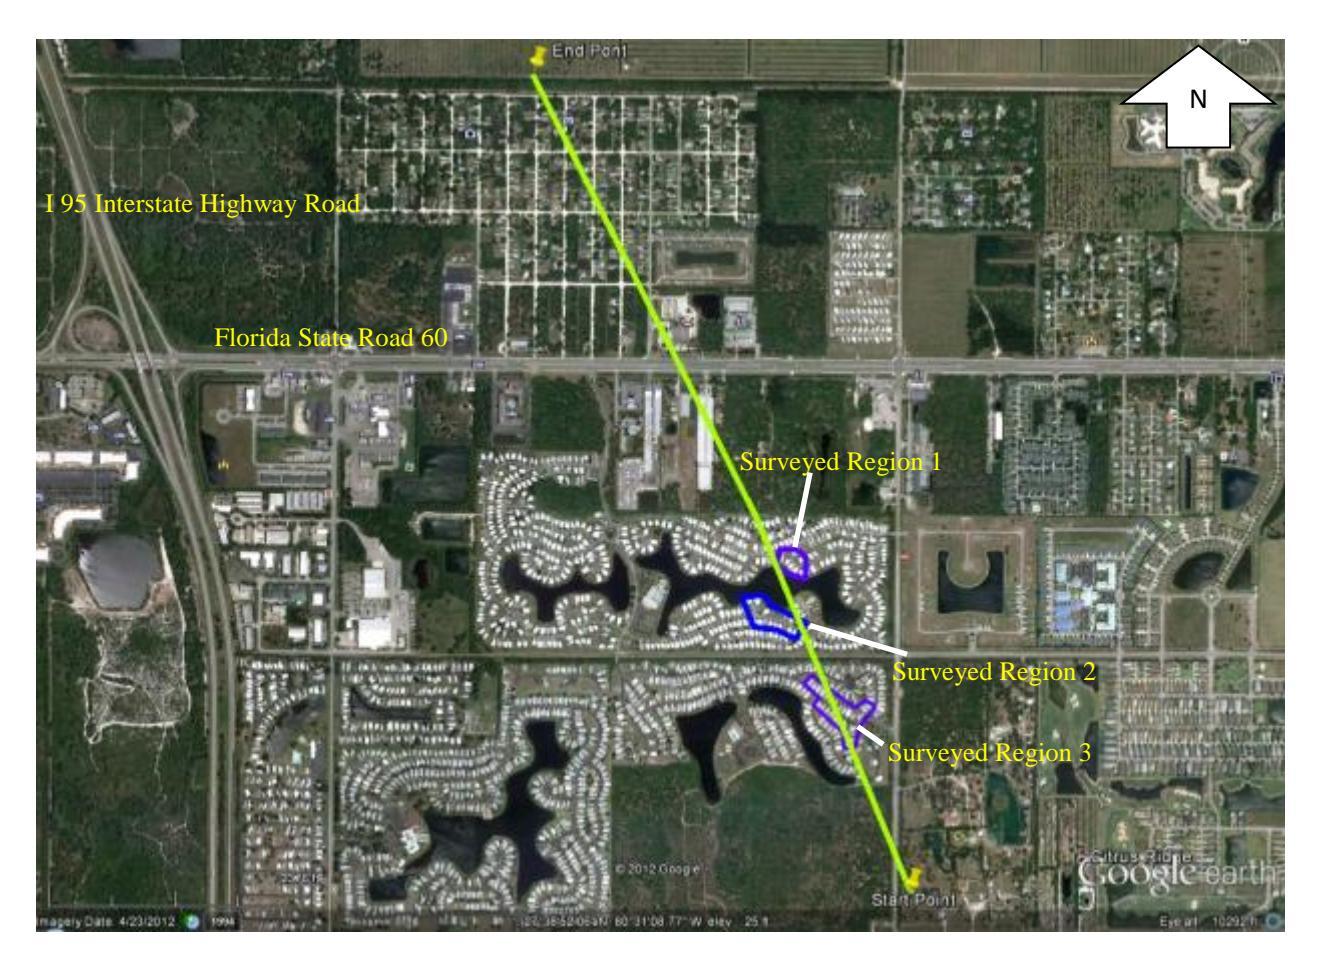
Figure 1: Estimated Path of Tornado based on observations

Tropical Storm Isaac brushed Florida's west coast and it spawned an **EF-1 tornado** on August 27, 2012 in Vero Beach, FL. This relatively weak it was strong enough to cause significant damage to approximately 104 homes within its path[1]. Local reports confirm that the rain band from Tropical Storm Isaac dumped 6.48 inches of rain in this area of Indian River County [2]. According to multiple reports, the Vero Beach tornado touched down at approximately 11:03AM ET and remained on the ground for nearly 1.6 miles before dissipating after about 2 minutes [3]Figure 1 shows the approximate tornado path based upon the damage observations.

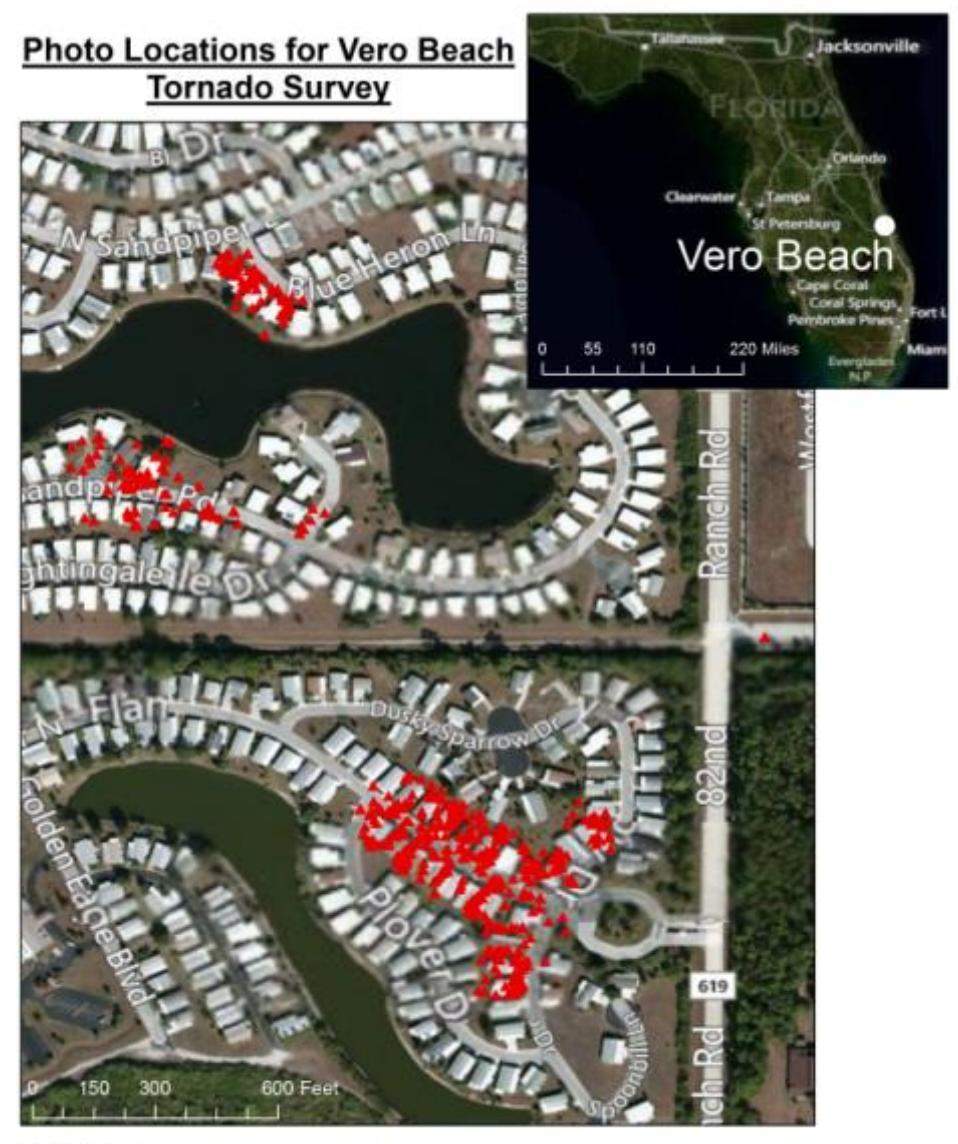
Figure 2: Photo Locations for Vero Beach Tornado Survey

The tornado in Vero Beach, FL mainly targeted two local mobile homes parks, where the typical buildings consist of double-wide manufactured homes built between 1989 and 1992 (Survey Region 3 in Figure 1) and Early 1980s (Survey Regions 1 and 2 in Figure 1). Both these communities had homes build after the enactment of the HUD (Housing and Urban Development) Code in 1974[4] but before the Manufactured Home Construction and Safety Standards on Wind Standards Rule became effective in July 1994 which was implemented to increase the safety of manufactured homes [5]A close up of these regions are shown in Figure 2.

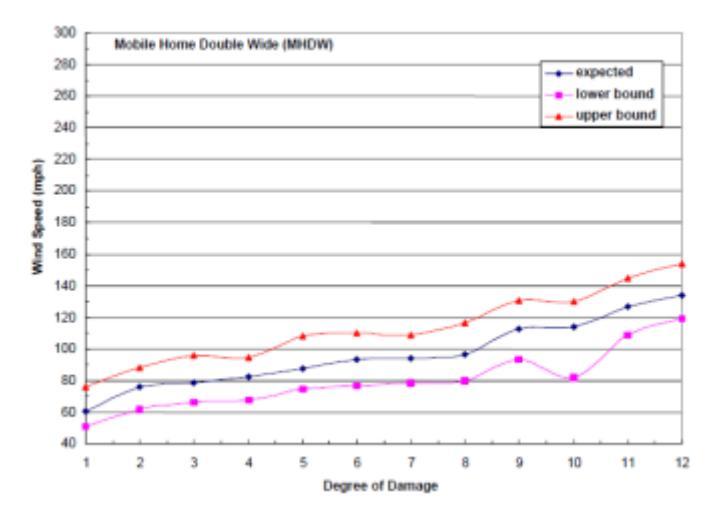
Figure 3: Wind Speed vs. Degree of Damage for double wide manufactured home

The recommendations of the EF Scale provided the 12 DODs and corresponding descriptions for this indicator. The wind speed is plotted along with each DOD in the recommendation as well (Figure 3). There were approximately six degrees of damage observed in the present survey, represented as follows:

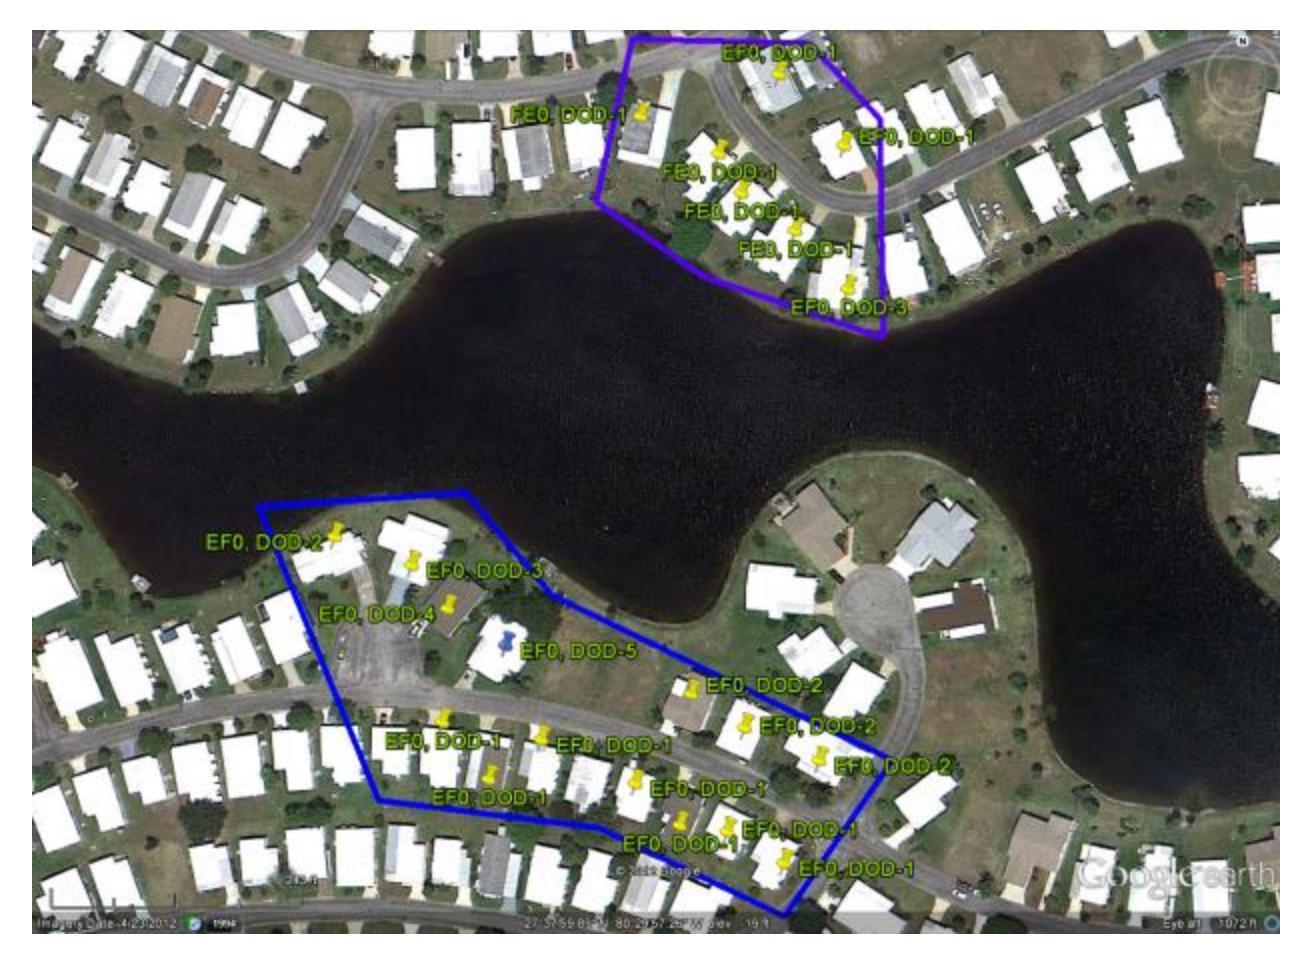
Figure 14: DOD assessment and EF Ratings for Surveyed Region 1 &2

Next, the EF rating is assigned based upon the estimated wind speed. Figure 14 and Figure 15 show the assessment of DOD and EF rating for the houses in the surveyed region 1, 2 and 3. From the analysis above, it can be obtained that the maximum wind speed range generating the DODs mentioned above is 78~109 mph, which mostly comes within the range of EF1 tornado, namely 86~109 mph. Thus, we could conclude that the tornado occurring in Vero Beach, FL, can be defined as the EF1 scale.
