## Summary of June 24, 2012 Lake Placid Tornado

David Roueche  
Ashlie Kerr  
Xinlai Peng

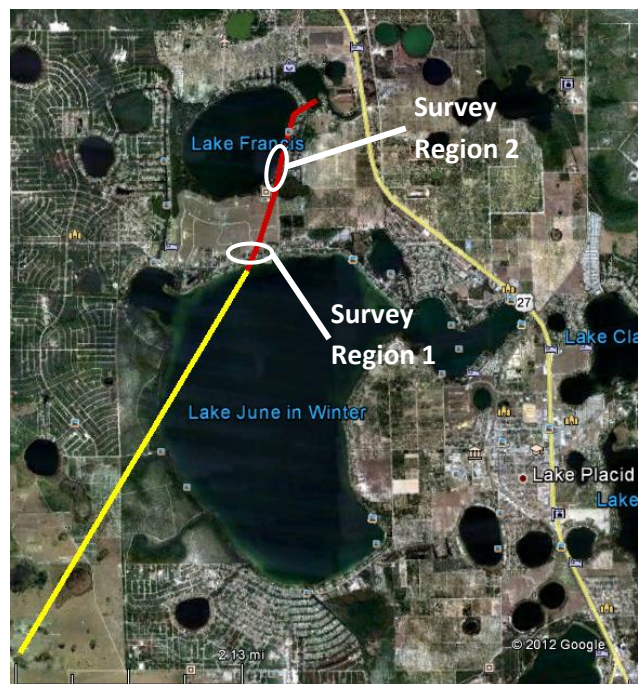
Figure 2: Close-up View of Estimated Tornado Track with Surveyed Portion in Red

The majority of the tornado track was over uninhabited regions and water but it did significantly impact approximately 10 homes between Lake June Rd and Cloverleaf Rd.

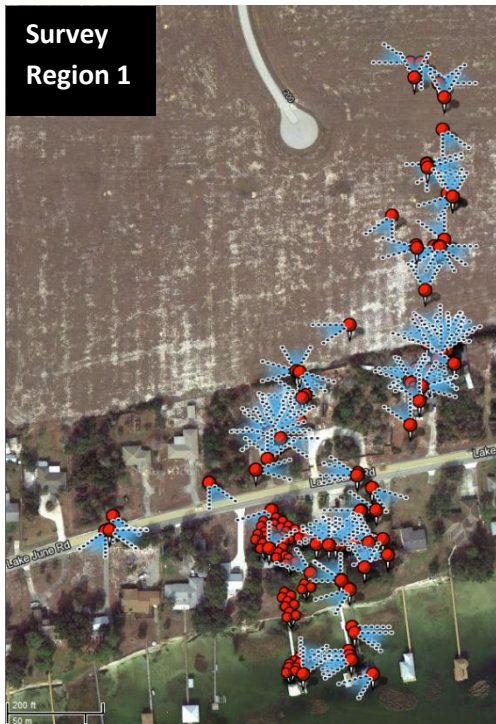
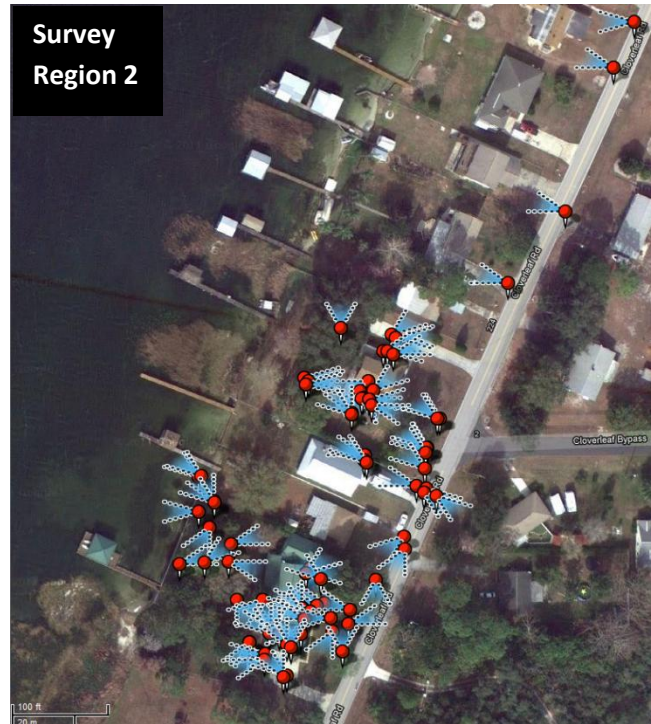
Figure 3: Locations and directions of photos taken during damage survey

The photo locations and directions are shown for Lake June Rd and Cloverleaf Rd in Figure 3.

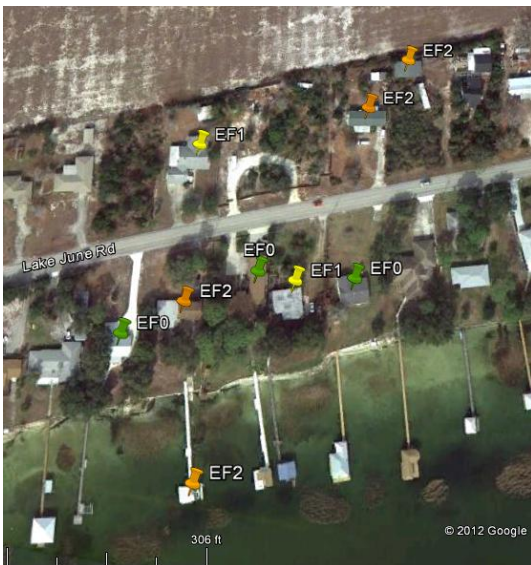
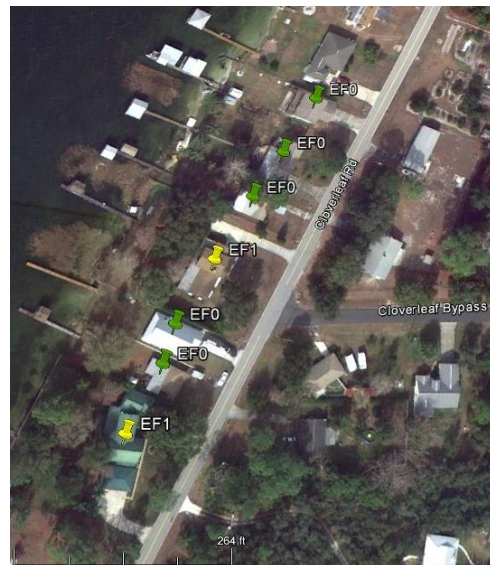
Survey Region 1 - Lake June Road  
Survey Region 2 – Cloverleaf Road  
Figure 3: EF Ratings for Surveyed Homes (no rating indicates no damage was observed)

Each of the surveyed homes were assigned a DOD rating using the recommendations of the EF Scale [2]. These DOD ratings were then used to estimate the wind speed necessary to cause the observed damage, taking into consideration the construction quality of the home and other factors such as tree damage. The EF rating is then assigned based upon the wind speed estimate. Figure 4 shows the location of each home surveyed and the assigned EF rating.

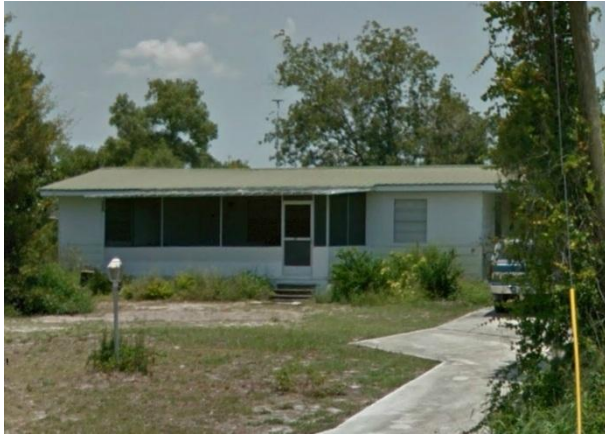
Original View from Google StreetView

Address: 819 Lake June Rd	DOD: 7
Year Built: 1972	Wind Speed Estimate: 130mph (low confidence)
Building Type: Single Family Residential	EF Rating: EF-2

Summary: This home was purchased by the homeowner in the early 1980's for \$57,000. It was a wood-frame house built onto a CMU block stem-wall with grouted cells 8' O.C. Workers were already cleaning up debris from the home by the time the assessment team arrived but from discussion with the homeowner and the workers there was very little remaining from the house after the tornado had passed through. Debris from the house, including a complete 20' truss, were scattered several hundred feet further in the path of the tornado. From analysis of the remaining debris the house appeared to be poorly built. The only foundation anchorage consisted of metal straps embedded in the concrete footing of the stem wall and screwed to one side of the sill plate with two small screws. There were no anchors in the grouted cells. Some metal straps were visible but they only appeared to be used at the corners and were anchored through the ground to the stem wall foundation. Trusses were toe-nailed with (3)8d nails. No indication as to how corners were connected.

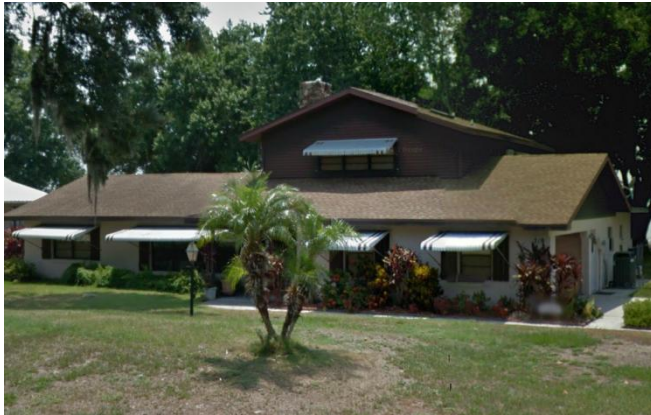
Original View from Google StreetView

Address: 218 Cloverleaf Rd	EF Rating: EF1
Year Built: 1981	DOD: 4
Building Type: Single-Family Residential	Wind Speed Estimate: 97 mph

This 2269 square foot gable home was built to South Florida Building Code standards. The homeowner was originally from Miami and when he moved from there to have this home built, he directed the builders to use the much more stringent Southeastern Building Code rather than the Central Florida Building code that was in existence. Because of this the construction quality of the house was above average. The walls were constructed of reinforced concrete. A wood top plate was bolted to the concrete wall with  $\frac{1}{2}$ " bolts and 1" washers every 4' O.C. Wood trusses were fastened to the top plate with metal hurricane straps, although it was noted that some hurricane straps only used three nails. A vent along the entire ridge of the house was provided by means of an approximately 3" gap in the sheathing at the ridge joint. Structural damage to the house was relatively minor at first glance. Approximately 30% of the roof sheathing had been lost and the garage door had buckled inward. However the failure of the sheathing led to the ingress of large quantities of water into the interior, which consisted of mainly wood paneling. As a result the economic impact of the structural failure was substantial.
