Online Damage Report

The 11th January 2014 Wind Damage and Collapse of the Brier Creek Condominiums in Brier Creek, NC

University of Florida Wind Hazard Damage Assessment Team

13 January 2014

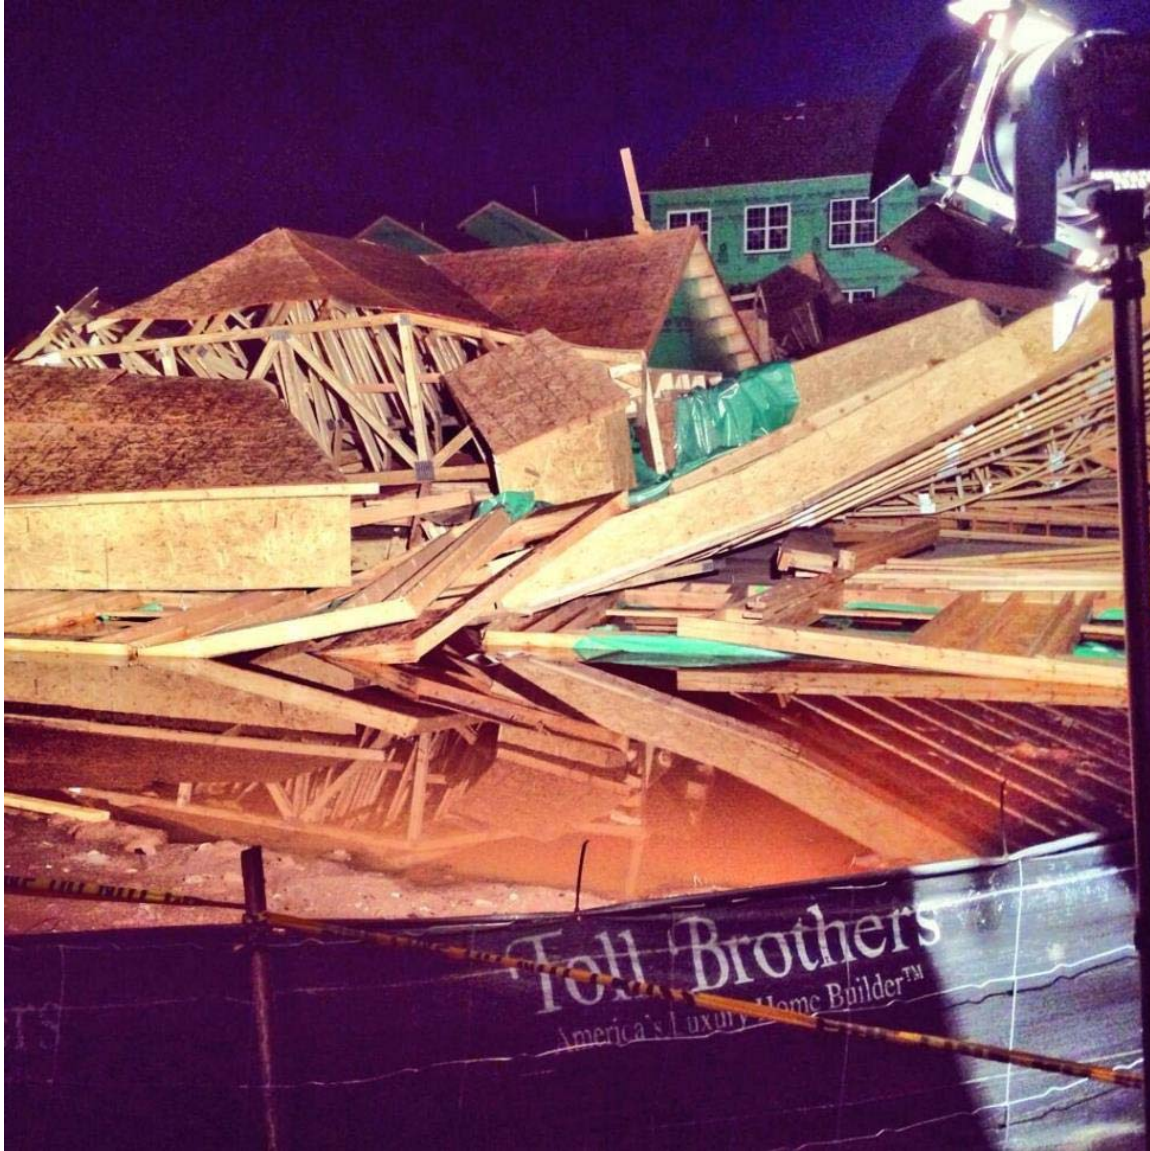
Figure 10: Courtesy of Carly Swanson (@CarlyTWCNews)

At this time few details are available about the collapse. Several pictures were posted to Twitter and these are reproduced here in Figures 6-10. There is a Toll Brothers sign in Figure 10.
