Online Damage Report

**The 17<sup>th</sup> November 2013 Illinois Tornado Outbreak**

**University of Florida's Wind Hazard Damage Assessment Team**

19 November 2013

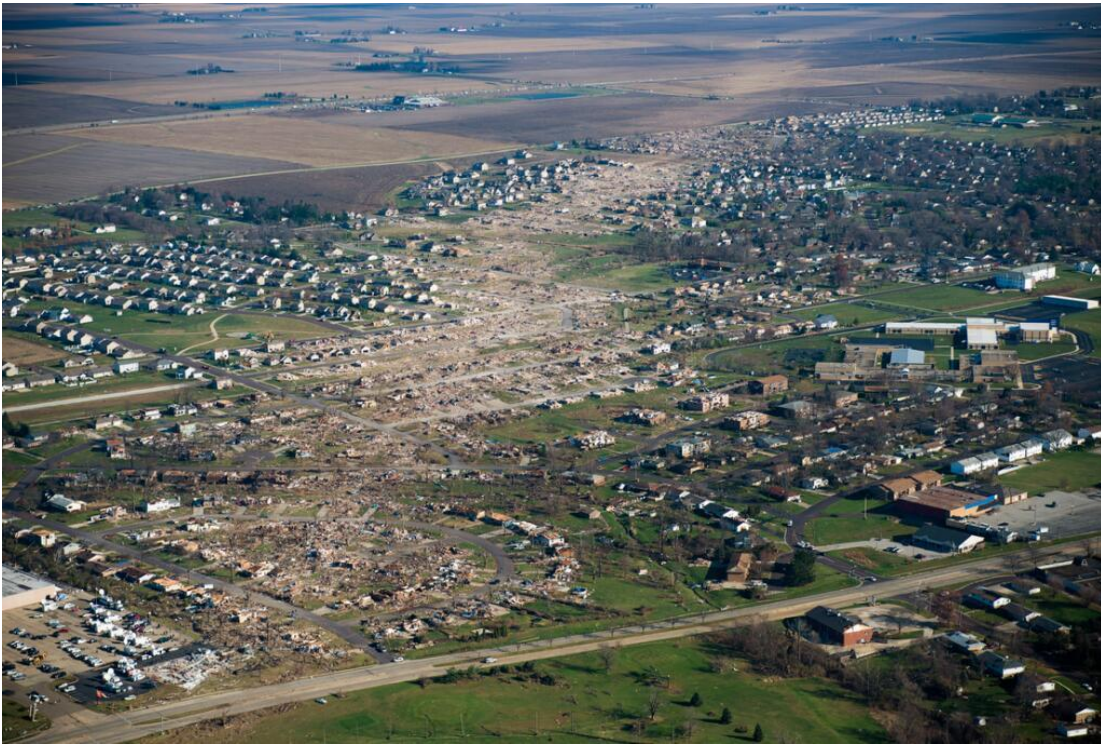
Washington, IL Nov 18, 2013  
(Image Courtesy: [Jessica Koscielniak via Twitter](#))

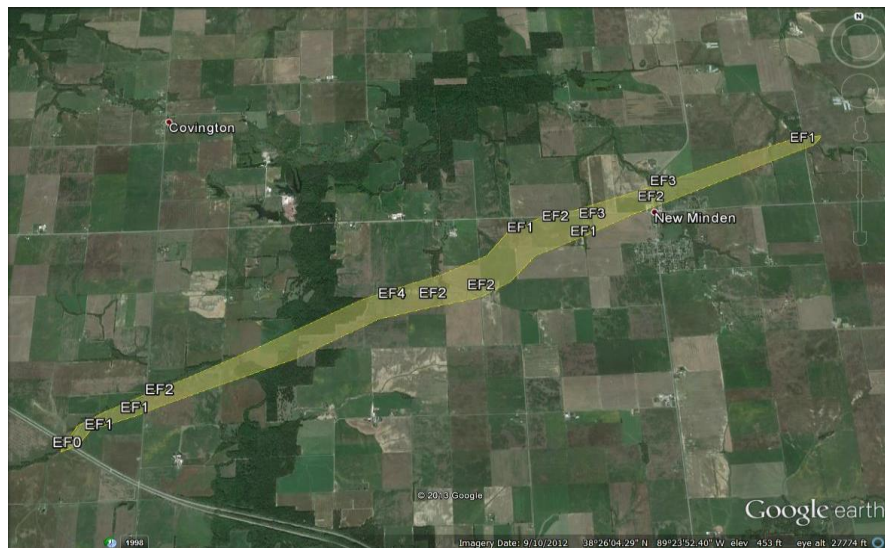
The Washington County tornado began at 12:04 pm CST as an EF-0 near I-64. It continued moving northwest, causing EF-4 damage and two fatalities at a farmhouse just outside the town of New Minden, IL. The complete tornado path is estimated as shown in Figure 10.

Figure 10: EF-4 Tornado Path through Washington County, Illinois  
(<http://www.crh.noaa.gov/lx/?n=survey1>)
