Online Summary

The 1 August 2013 Tornado in Jacksonville, FL

University of Florida Wind Hazard Damage Assessment Team

9 August 2013

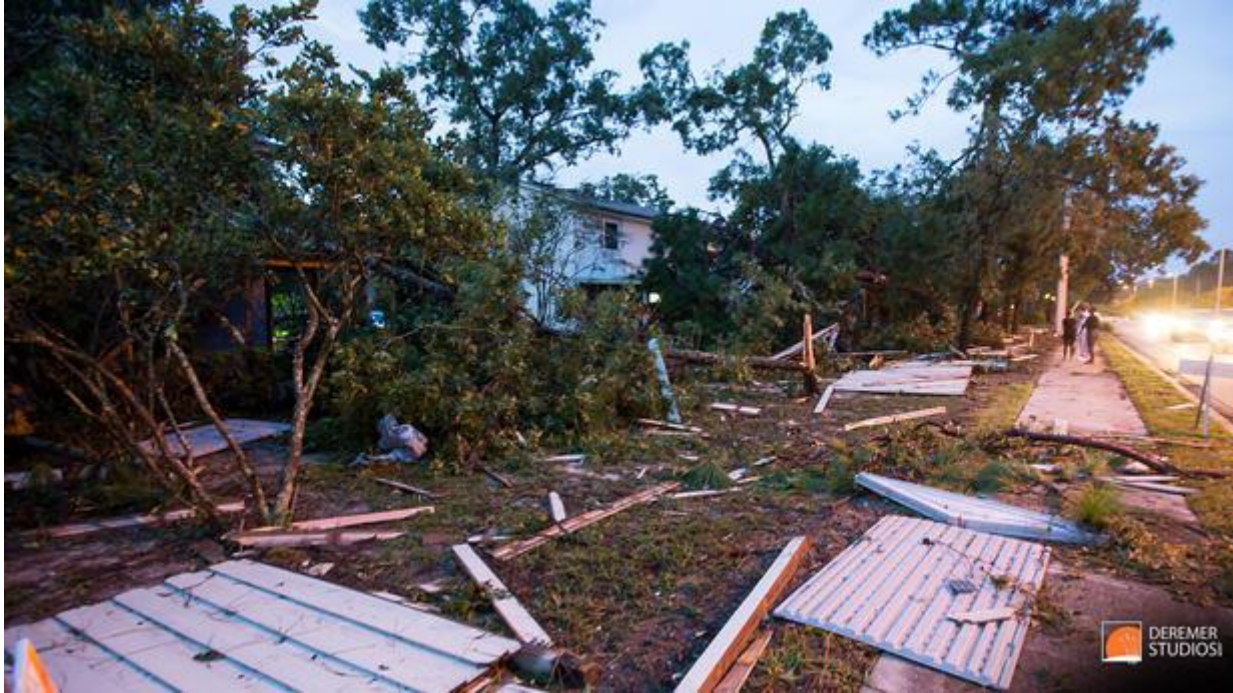
(Image Courtesy of <http://arlington.firstcoastnews.com/news/news/119963-ef2-tornado-has-people-thinking-about-renters-rights>)
