Online Damage Report

**The 27th April, 2014 Tornado Outbreak**

**University of Florida's Wind Hazard Damage Assessment Team**

29 April 2014

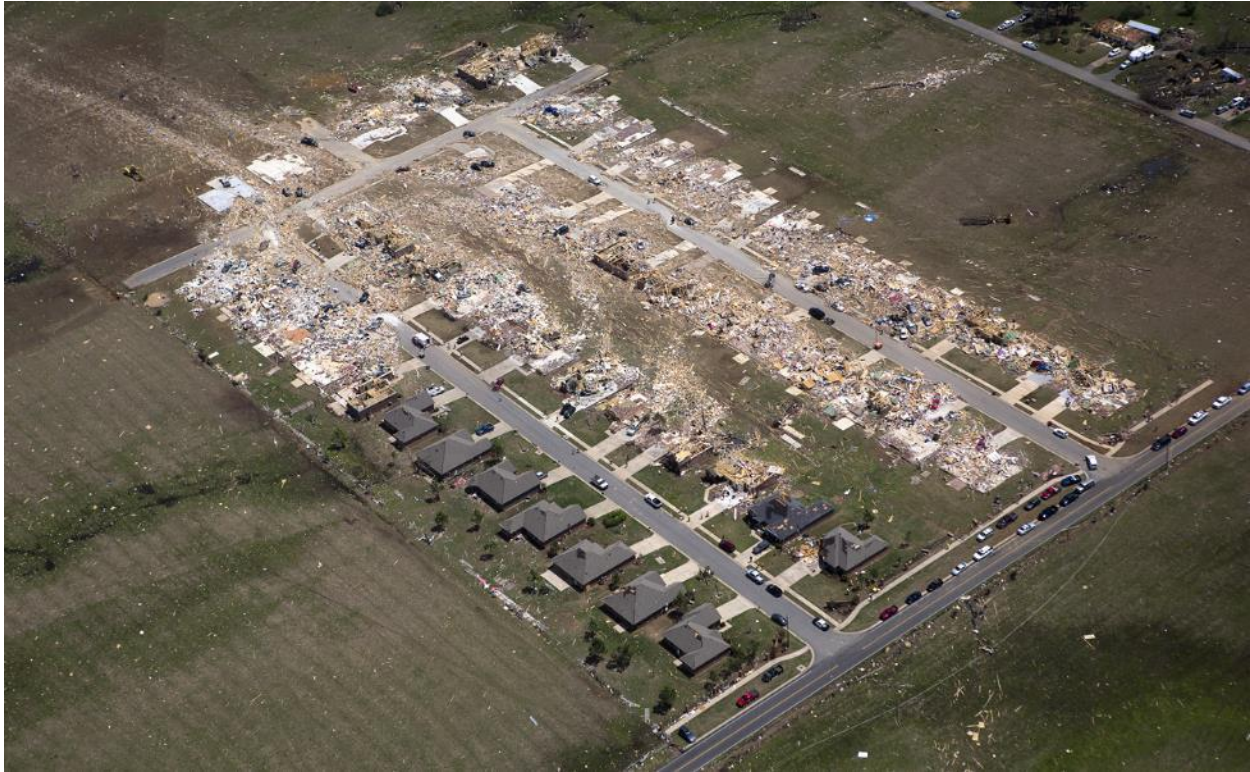
Parkwood Meadow Subdivision in Vilonia, AR, April 27, 2014  
(Image Courtesy: Reuters/Carlo Allegri)

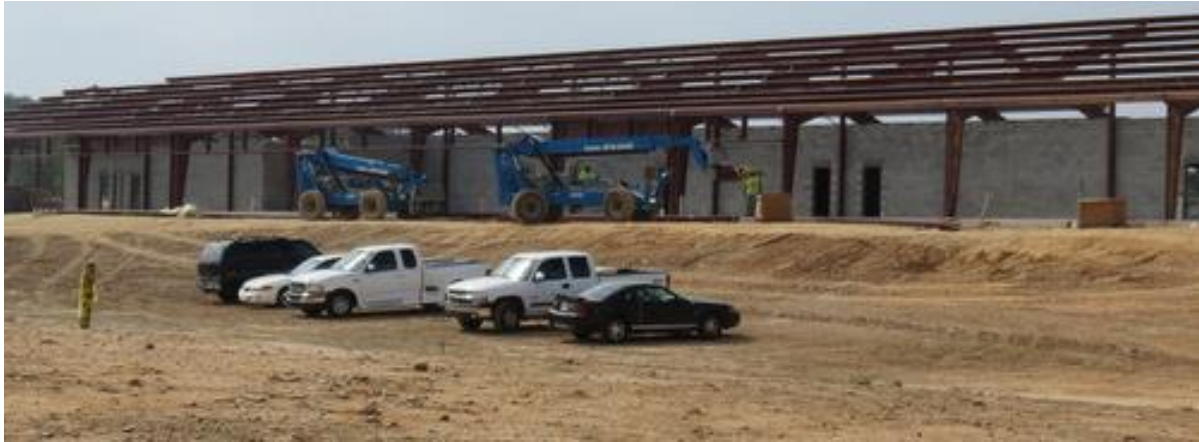
A new Intermediate School just SW of downtown Vilonia, AR suffered a direct hit from the tornado. The \$12 million school was under construction and [85% completed](#), set to open in Fall 2014. A construction photo from September 2013 shown in Figure 13 indicates the primary structure was a steel portal Frame with masonry walls between the steel columns and steel purlins supporting the roof.

Figure 13. New Intermediate School in Vilonia, AR while under construction. Photo was taken September 29, 2013 by Linda Hicks.
