Summary Report on the 14 December 2013 Palm Coast, FL Tornado

University of Florida Wind Hazard Damage Assessment Team

27 January 2014

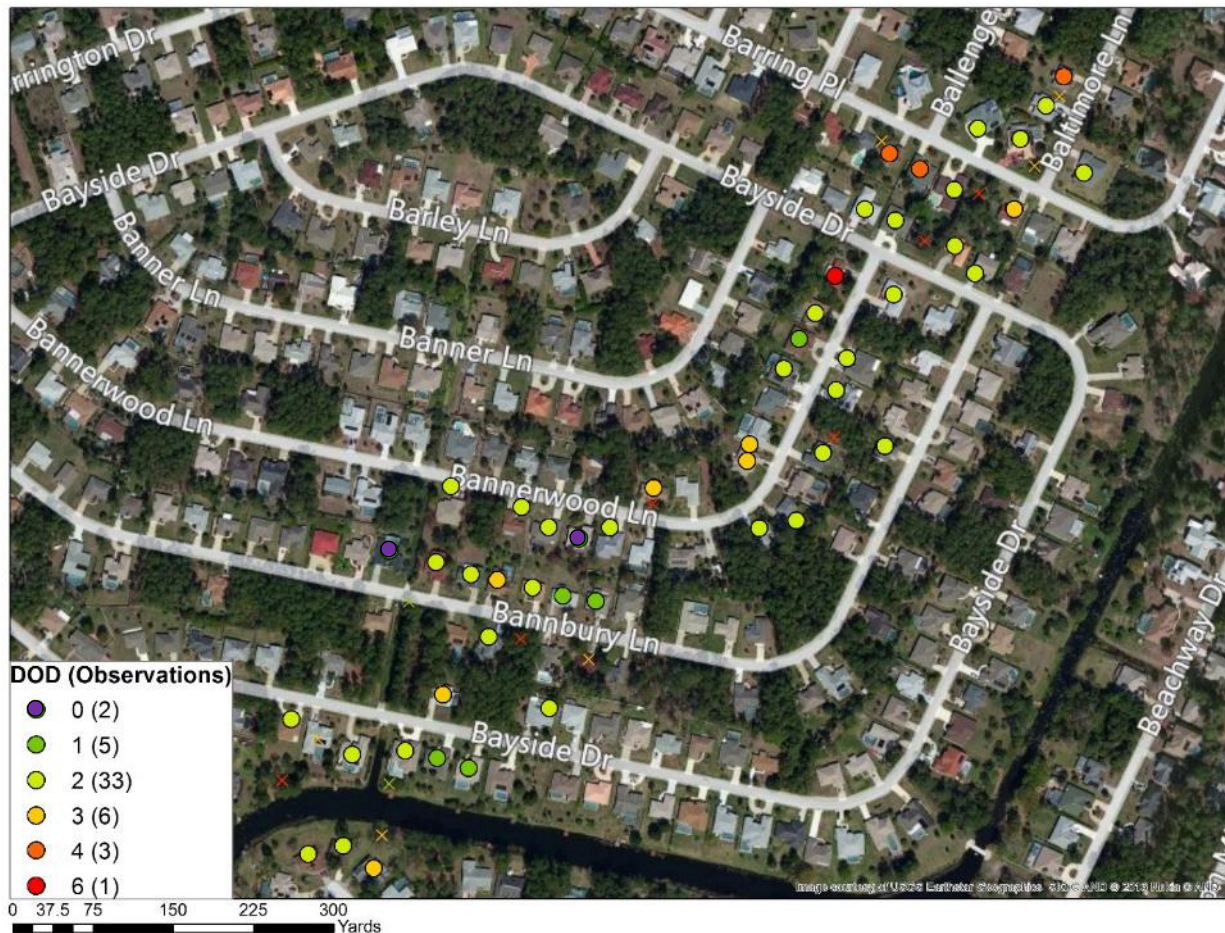
Figure 7: Assigned Degrees of Damage for the homes (solid circles) and tree damage (marked by X) surveyed by the UF WHDA team

The observed damage in the surveyed region ranged from a DOD of 1 to 6 for residential homes and 1 to 4 for trees. The location of each DOD rating is provided in Figure 7.

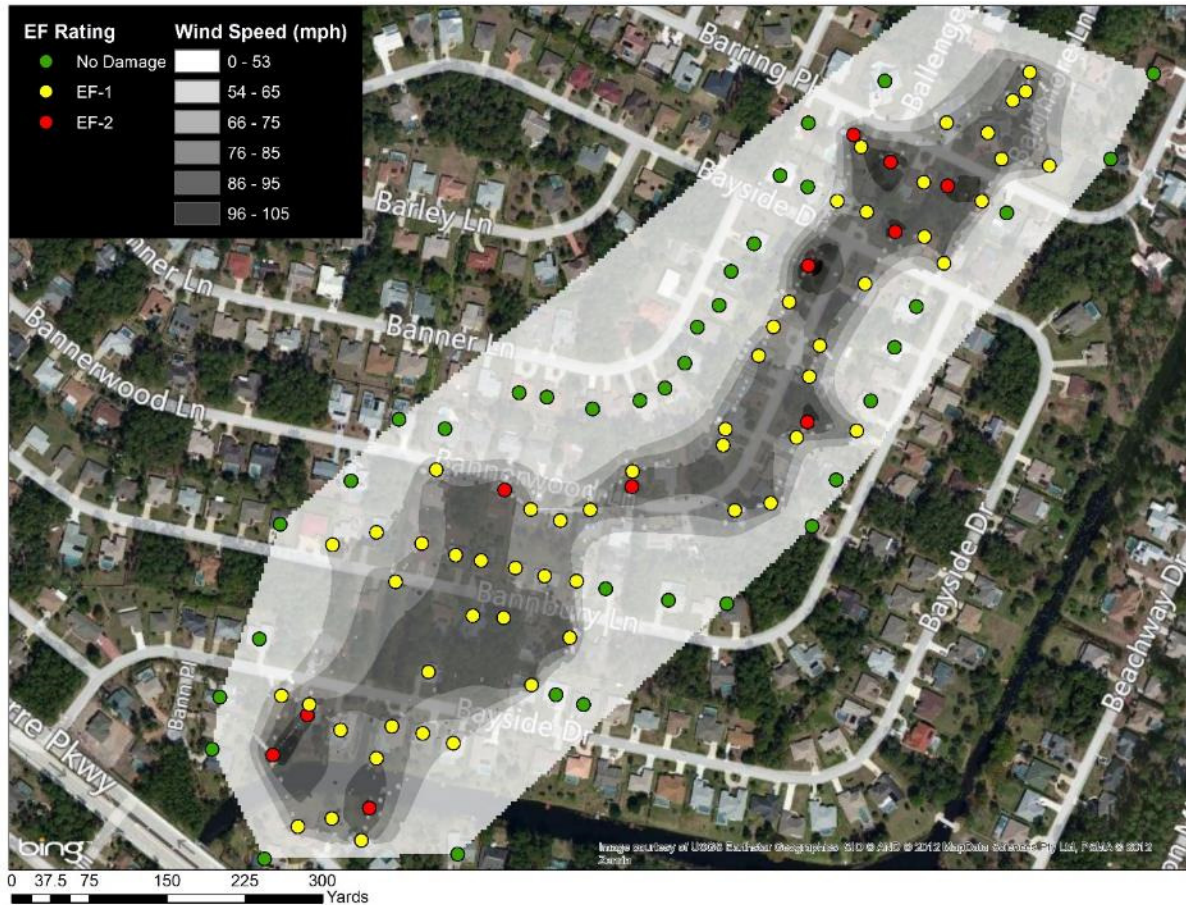
Figure 8: Estimated wind speeds (grey fill) interpolated from rated indicators (green, yellow and red circles)

The estimated wind speed map provides a reasonable portrayal of the tornado path based upon the collected data. Within the surveyed region, the tornado reached its widest point as it crossed Bannbury Ln, but narrowed and possibly increased in intensity as it reached and then followed along Bannerwood Ln, reaching Bayside Dr and Barring Pl. The accuracy of the wind field could be improved by a wider and more complete survey region, which will be considered for future events.

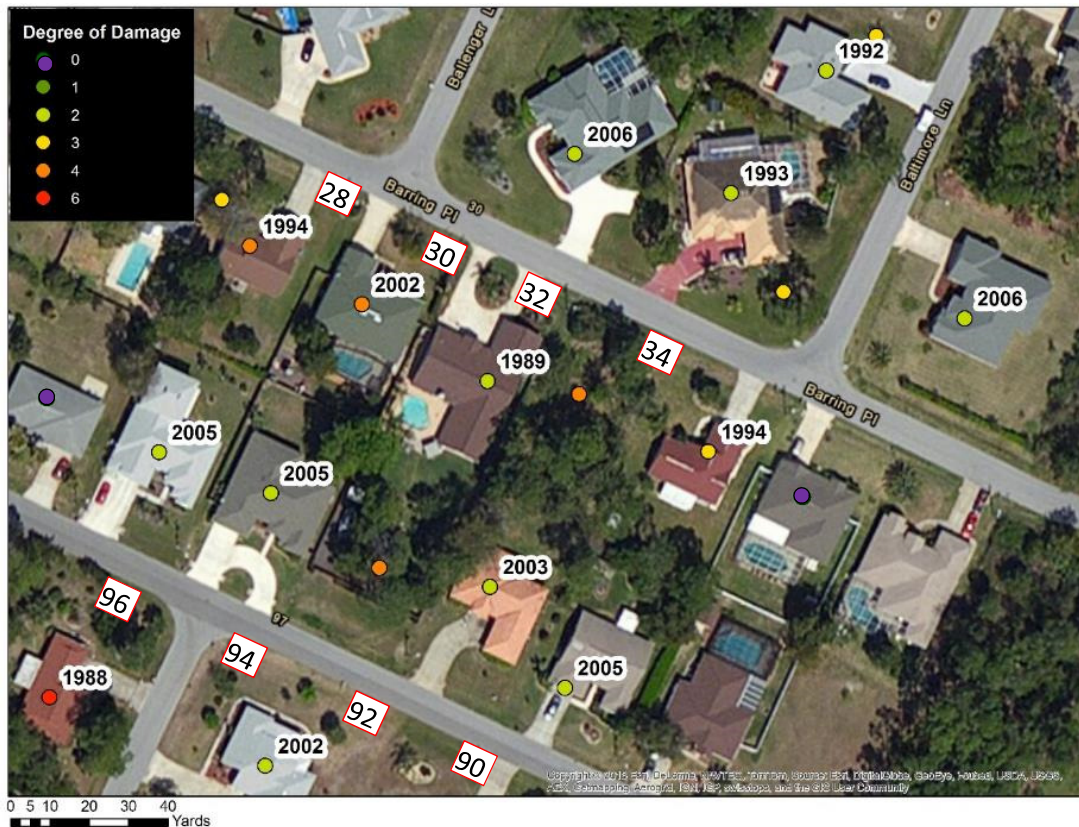
Figure 10: Enhanced view of homes along Barring PL and Bayside DR transecting the tornado path.

Observed DOD is shown using colored dots and labeled with the year built of each damaged home. Street numbers of select homes referred to in Table 3 are shown in the text boxes outlined in red.

More damage was observed to homes along Barring PL than to homes along Bayside Dr., despite the fact that the homes were less than 50 yards apart along the path of the tornado. Age of construction alone however does not appear to be the determining factor, because the heavily damaged home at 30 Barring PL was built in 2002, while an almost equally damaged home next to it at 28 Barring PL was built in 1994. Both of these homes were CMU block construction, and roof-to-wall straps were used in both as well.

Barring PLACE				
Street Number	28	30	32	34
Year Built	1994	2002	1989	Vacant
Roof Shape	Gable	Hip/Gable	Gable	N/A
DI/DOD	Res/4	Res/4	Res/2	Tree/4
Observed Damage	<ul style="list-style-type: none"> • Garage buckled inward • ~20% damaged shingles • Sheathing panel uplift 	<ul style="list-style-type: none"> • Garage buckled outward • ~25 damaged shingles • (2) Sheathing panels uplifted at gable over garage • Screened-in porch destroyed at back of house • (3) Broken windows 	<ul style="list-style-type: none"> • Shingle damage to back gable of house (fully tarped) • Back sliding glass door broken • Gutter knocked off house 	<ul style="list-style-type: none"> • (4) Pines snapped at trunks • Several trees uprooted • Multiple trees still standing as well
Bayside DRIVE				
Street Number	96	94	92	90
Year Built	2005	2005	Vacant	2003
Roof Shape	Hip	Hip	N/A	Hip
DI/DOD	Res/2	Res/2	Tree/4	Res/2
Observed Damage	<ul style="list-style-type: none"> • Small portion of roof tarped on front slope only • No other evidence of damage 	<ul style="list-style-type: none"> • Portions of front of roof tarped only • Garage door impacted but not buckled • Soffit missing along front edge 	<ul style="list-style-type: none"> • Palm tree and (3) pine trunks snapped • Wood privacy fence knocked down 	<ul style="list-style-type: none"> • Small portion of roof tarped on front slope • No other evidence of damage

Staples were used as the sheathing fastener in the 1994 home, an indication that the home was built to a weaker building code, however damage to these two homes was similar. All of the homes on Barring PL were gable roofs, whereas all the homes on Bayside DR were hip, which may have contributed to the heavier roof damage (specifically sheathing uplift) since hip roofs have a more aerodynamic shape that reduces the uplift loads. But this does not explain the greater damage that occurred to the walls and garage doors. Another possible explanation for the differences in damage between Bayside and Barring is that with the tornado being narrow, it may have moved sporadically such that when crossing Bayside DR it passed through the vacant lot at 92 Bayside DR, but when exiting onto Barring PL, it passed over or between 28 and 30 Barring PL. Such a path does not appear to be consistent with the overall path of the tornado beyond this point however.

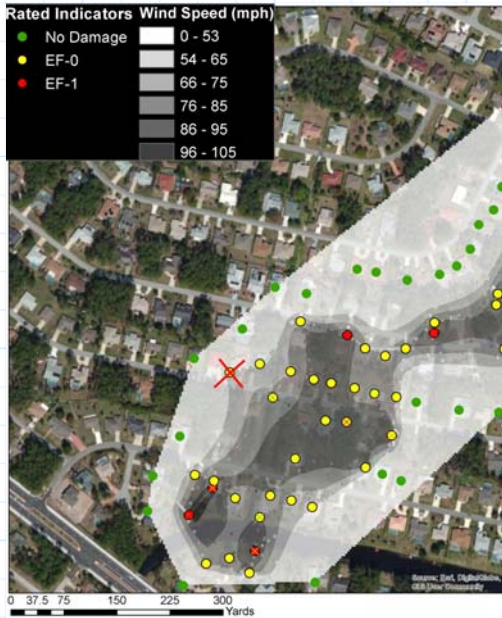
Figure A-1: Location of flagpole (red "X") in relation to tornado path

A flag pole was noted collapsed along the tornado path, located as shown in Figure 1. The buckled state of the flag pole is shown in Figure 2. The flag pole had buckled at the base and when found was pointing opposite the direction the tornado was traveling.

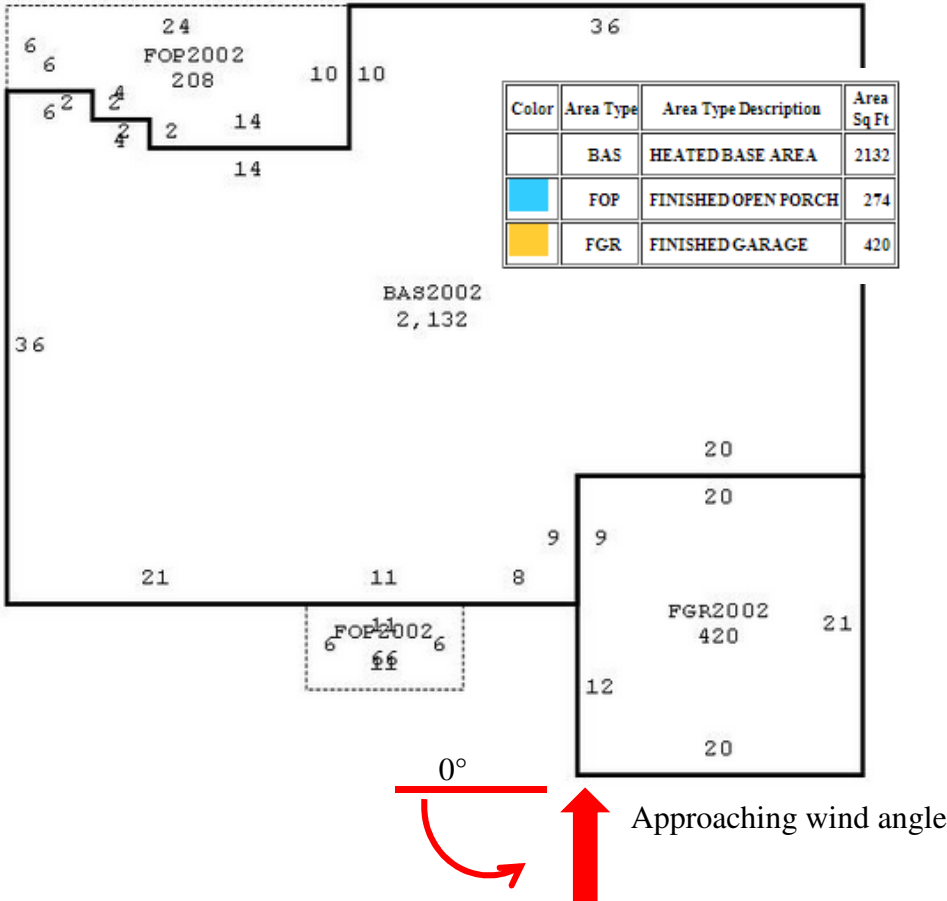
Figure B-3: Layout of building with possible wind approach angles

As is common during a tornado, the wind direction may have changed significantly as the tornado passed over and it is unclear at what specific point the garage collapsed. As can be seen from Figure B-4, the middle portion of the garage door is buckled outward, however branches and other debris were lodged in the right edge of the door in a manner that could have only been achieved if the wind direction was positive on the face of the door ($> 0^\circ$ using layout in Figure B-3). Since the main portion of the door appears to have buckled outward however, it will be assumed that a suction pressure was applied to the door that exceeded its capacity. To apply a suction pressure on the garage door, the wind direction will be assumed to be $\leq 0^\circ$. Under this assumption, the wind speed required to generate the necessary suction pressure is calculated below.
