Online Damage Report

The 27th April 2014 Tornado Outbreak

University of Florida's Wind Hazard Damage Assessment Team

30 April 2014

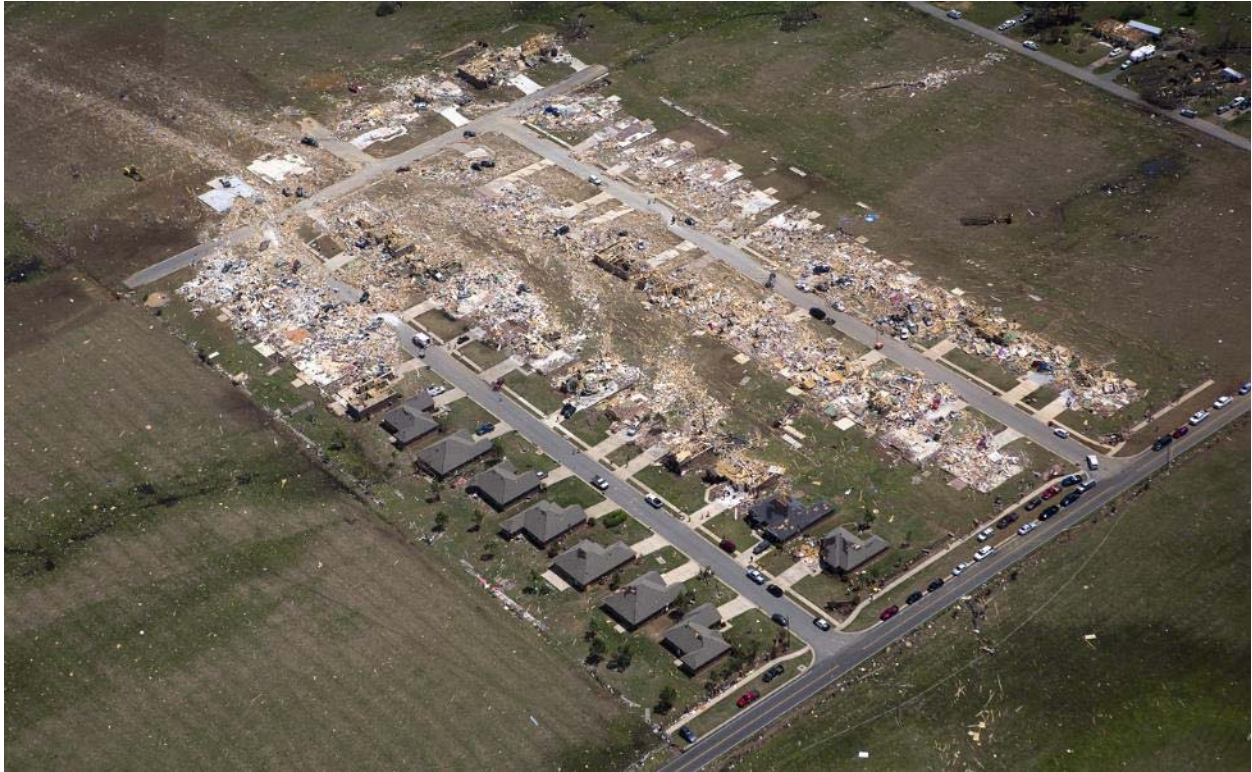
Parkwood Meadow Subdivision in Vilonia, AR, April 27, 2014
(Image Courtesy: Reuters/Carlo Allegri)

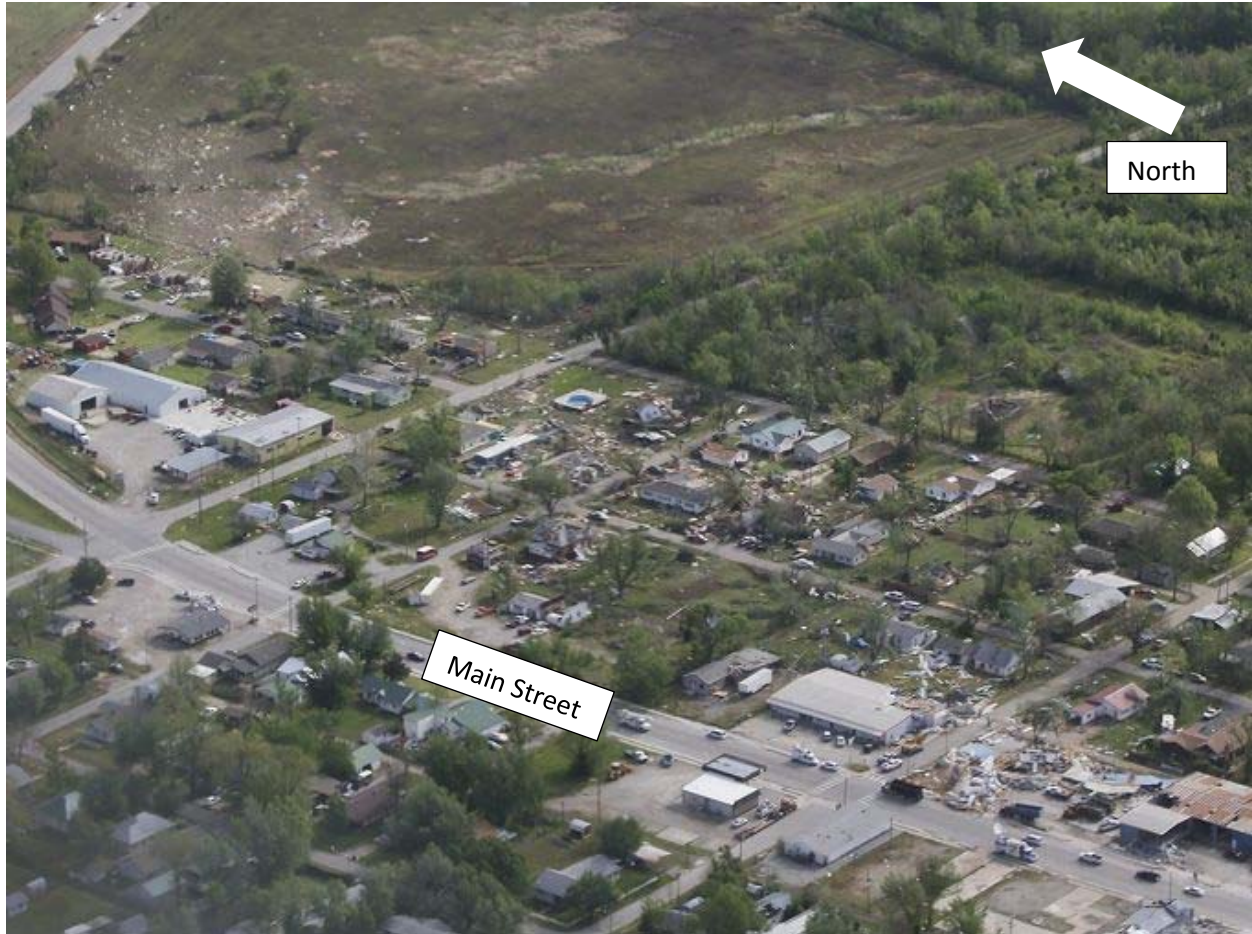
[structures](#) in the town, including five businesses and the volunteer fire department station. Approximately 45 other structures also sustained damage. One fatality was confirmed, due to a concrete wall falling onto a car, killing the driver. The National Weather Service has given a preliminary EF-2 rating to this tornado.

Figure 3. Aerial view of tornado path through Quapaw, OK.

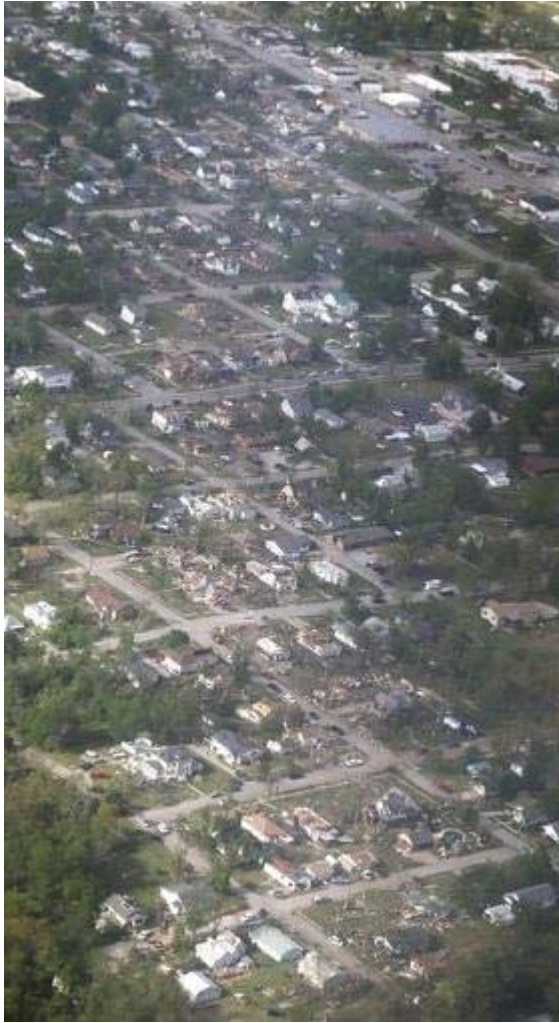
The April 27, 2014 tornado struck the town at about 5:45pm on Sunday afternoon, a time when most of the town's residents would be in their homes. The tornado damaged nearly 100 homes and businesses and caused 25 confirmed injuries, but fortunately no fatalities. The path of the tornado through the town is visible in Figure 5. Damage to homes is shown in Figure 6 and Figure 7.

Figure 5. Aerial view of damage through Baxter Springs, KS (AP Photo/Orlin Wagner)

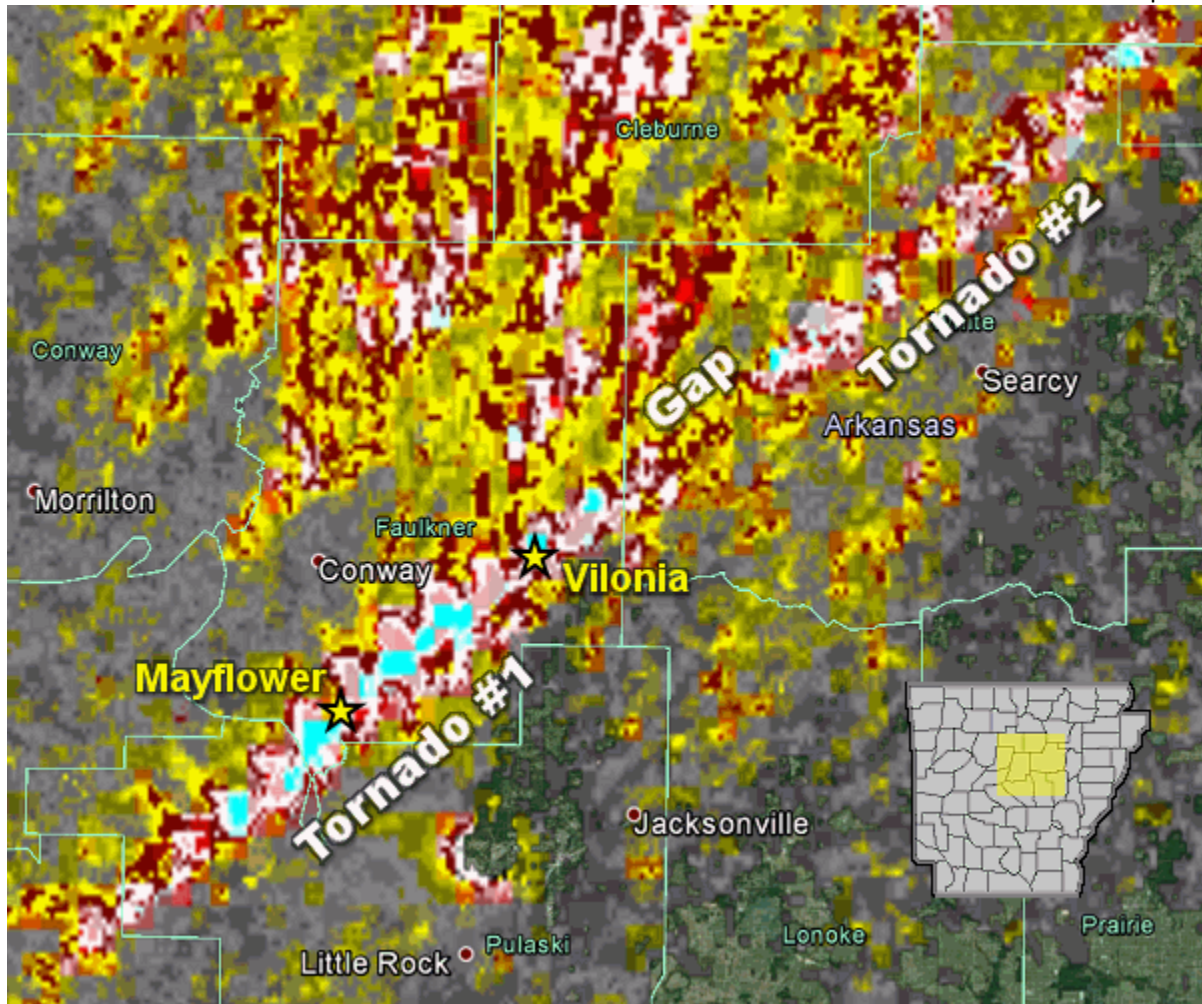
At approximately 8:25pm EST, a tornado touched down in Pulaski County, AR, nearly 16 miles NW of Little Rock, AR. The tornado and its parent supercell tracked almost continuously for over 80 miles, with only a small gap in the center separating two distinct tornado tracks. The heaviest damage occurred to the towns of Mayflower and Vilonia near the start of the tornado, as shown in Figure 8.

Figure 8. Long-track tornado in Central Arkansas on April 27, 2014 (Image Courtesy of NWS)

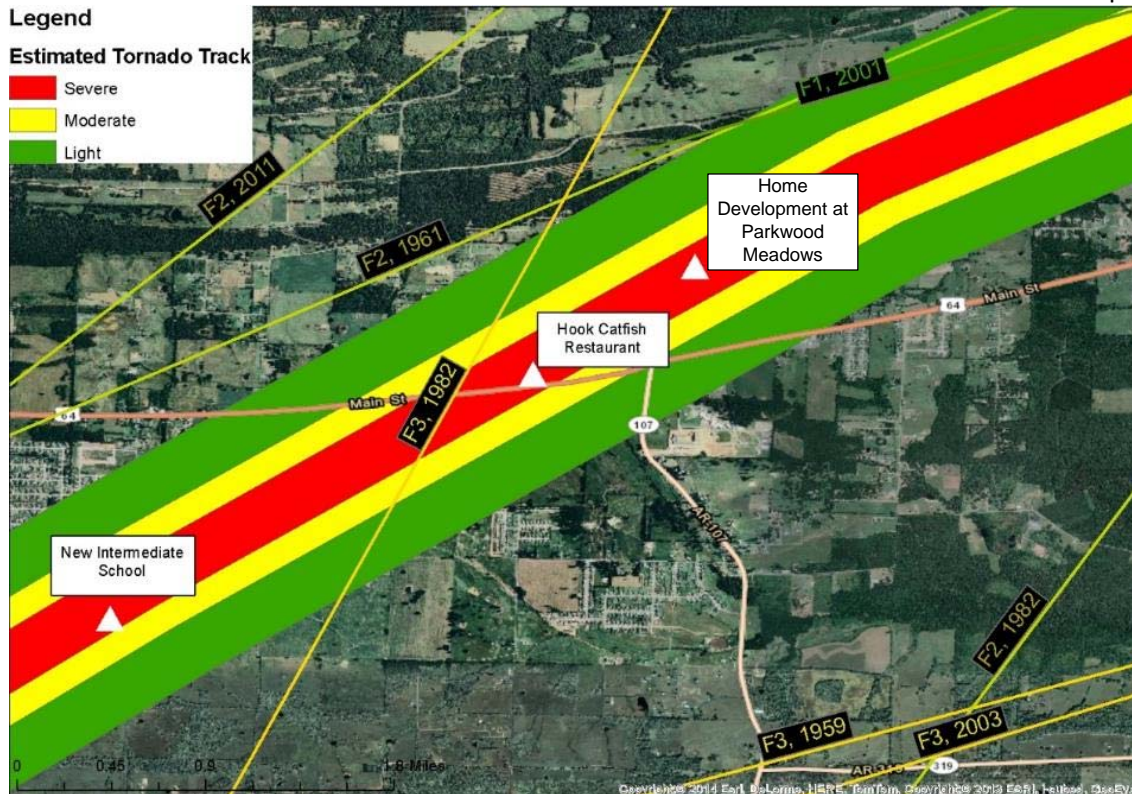
Vilonia, AR is a small town north of Little Rock, AR in Faulkner County with a population of 3,815. The town was formed in 1938 but has several new subdivisions around it. The town has had several tornadoes pass through or in close proximity in the past, including an EF2 tornado in 2011 that caused three fatalities when it struck a mobile home community southwest of the town. The 27 April, 2011 tornado struck a newly constructed Intermediate School SW of the town before traveling NE through the center of the town and through a new development NE of the town off Naylor Rd. The estimated tornado track is shown in Figure 12. Eight fatalities have been confirmed in the town so far, at least four in the new home development off of Naylor Rd.

Figure 12. Estimated tornado track through Vilonia, AR with historical tracks overlaid. Points of significant damage highlighted by white triangles. Estimated track from ESRI Disaster Response Maps.

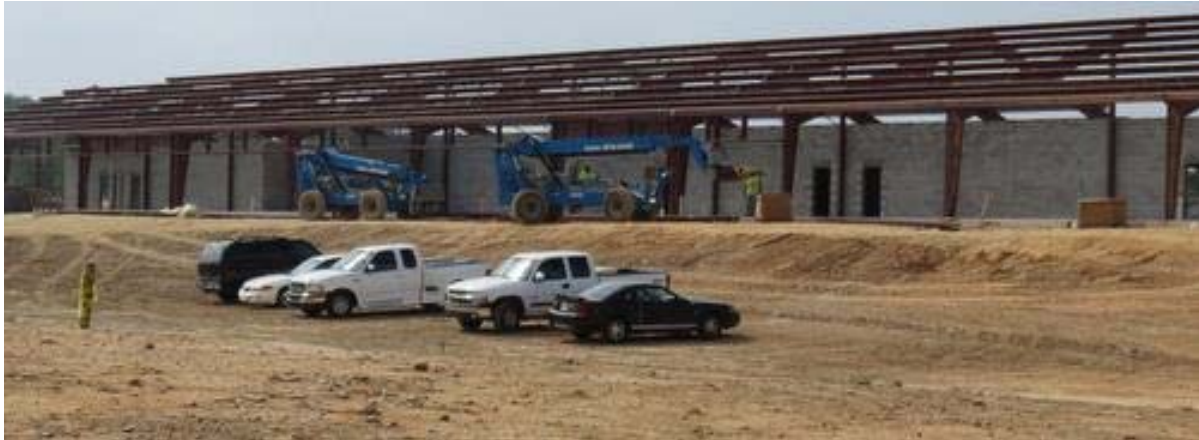
A new Intermediate School just SW of downtown Vilonia, AR suffered a direct hit from the tornado. The \$12 million school was under construction and [85% completed](#), set to open in Fall 2014. A construction photo from September 2013 shown in Figure 13 indicates the primary structure was a steel portal frame with masonry walls between the steel columns and steel purlins supporting the roof.

Figure 13. New Intermediate School in Vilonia, AR while under construction. Photo was taken September 29, 2013 by Linda Hicks.
