Online Damage Summary of  
June 16-18, 2014 Tornado Outbreak

University of Florida Wind Hazard Damage Assessment Team

June 20, 2014

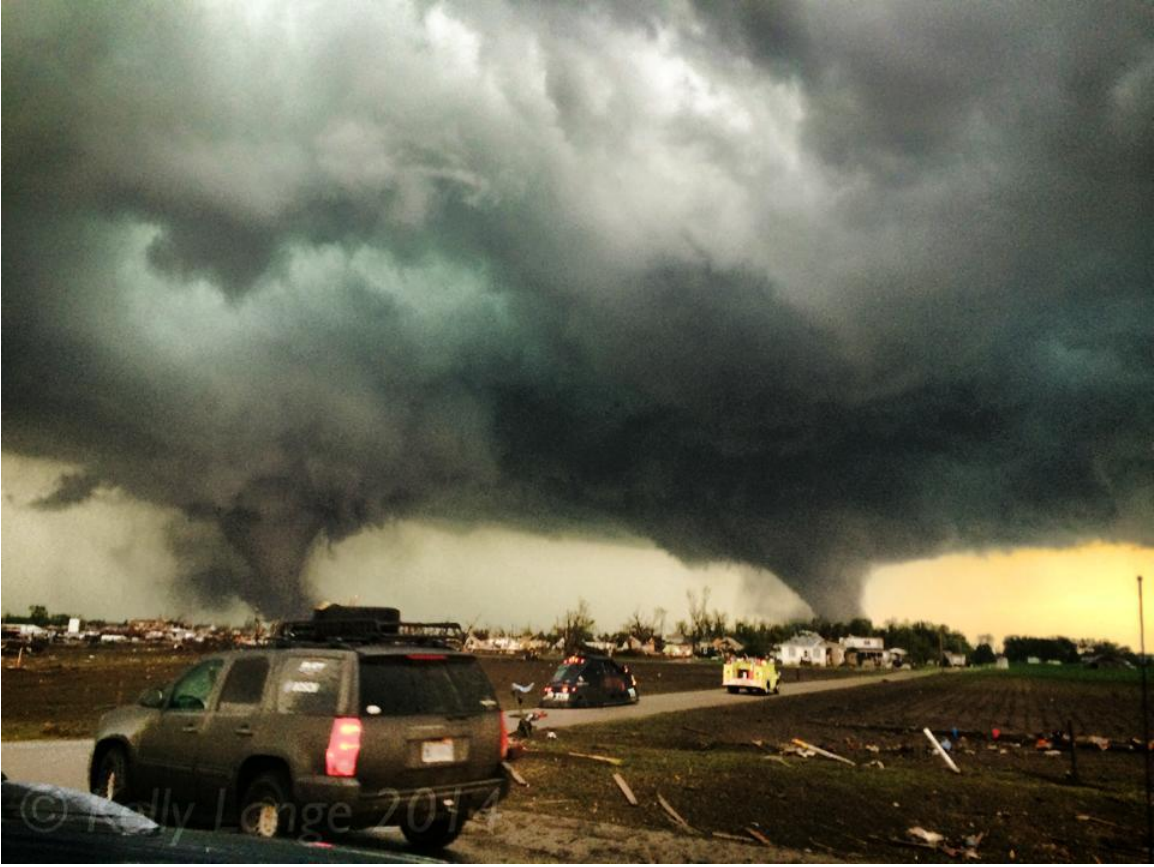
The most significant damage in this outbreak occurred in Pilger, NE, a small town of about 350 residents in NE Nebraska. Two different violent tornadoes passed by Pilger at nearly the same time, providing dramatic pictures such as that shown in Figure 10. The meteorological rarity of such an event - two strong tornadoes from the same parent supercell - is remarkable. Unfortunately, the tornadoes caused two fatalities and over 20 injuries. Reports indicate that the entire business district downtown was damaged, with some buildings completely destroyed ([Local10](#)). The preliminary NWS track of the Pilger tornado in relation to the other Nebraska tornadoes is provided in Figure 11. Individual assessments by the NWS survey team are provided in Figure 12, along with the location of key structures that were damaged in the town. An aerial view of the damage to the business sector in downtown Pilger is provided in Figure 13, while before and after views of key structures are shown in Figure 14.

Figure 10: Twin tornadoes near Pilger, NE. One passed directly through the town while the other passed just east of it. (Source: Kelly Rebecca via Facebook)

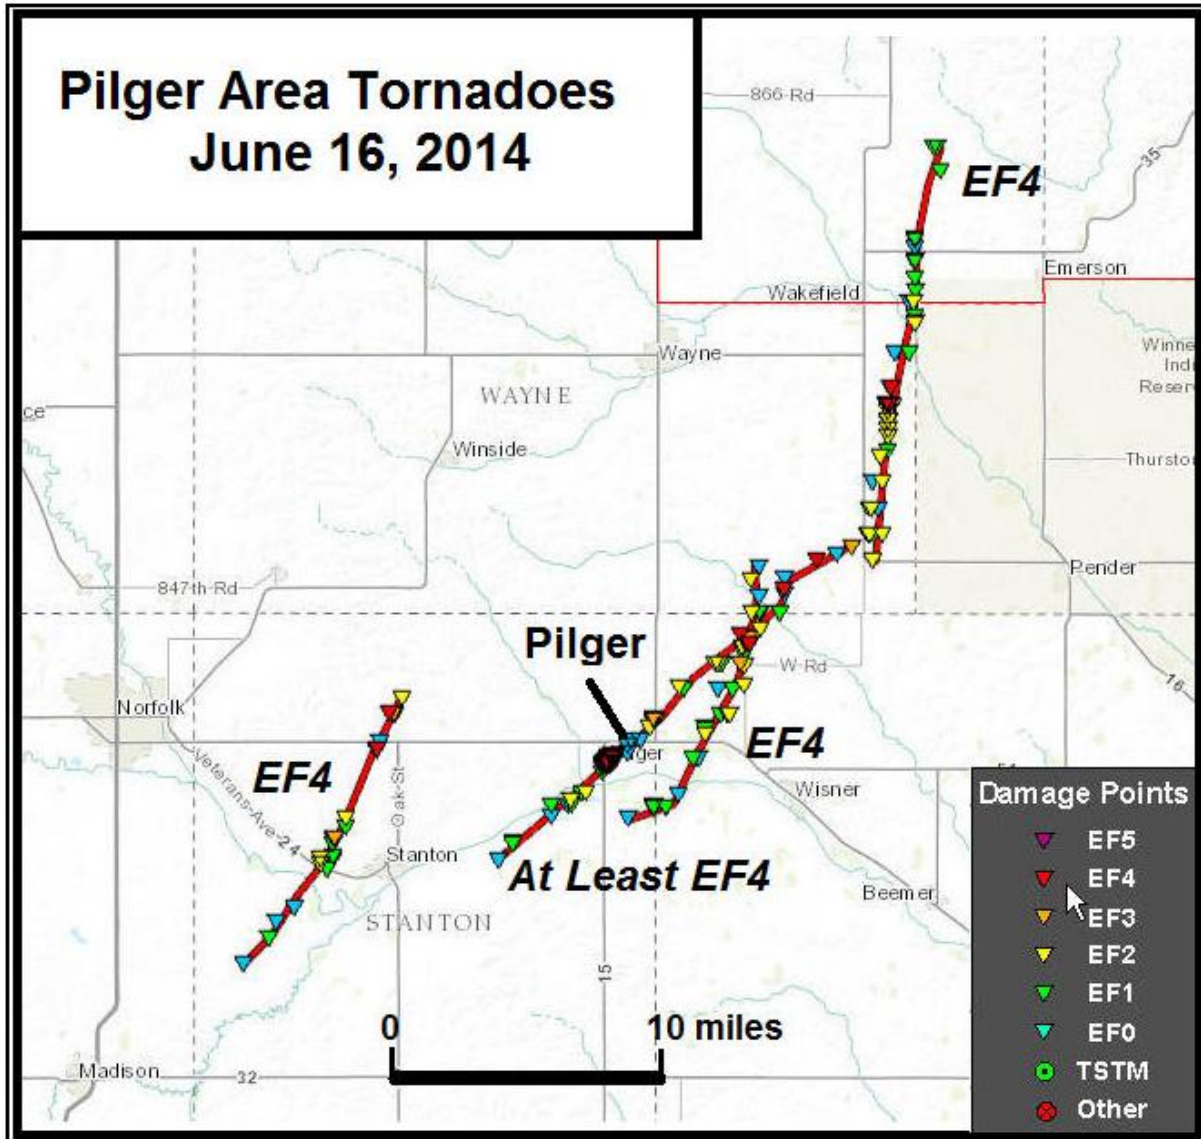
Figure 11: Results of NWS damage survey following tornadoes in NE Nebraska

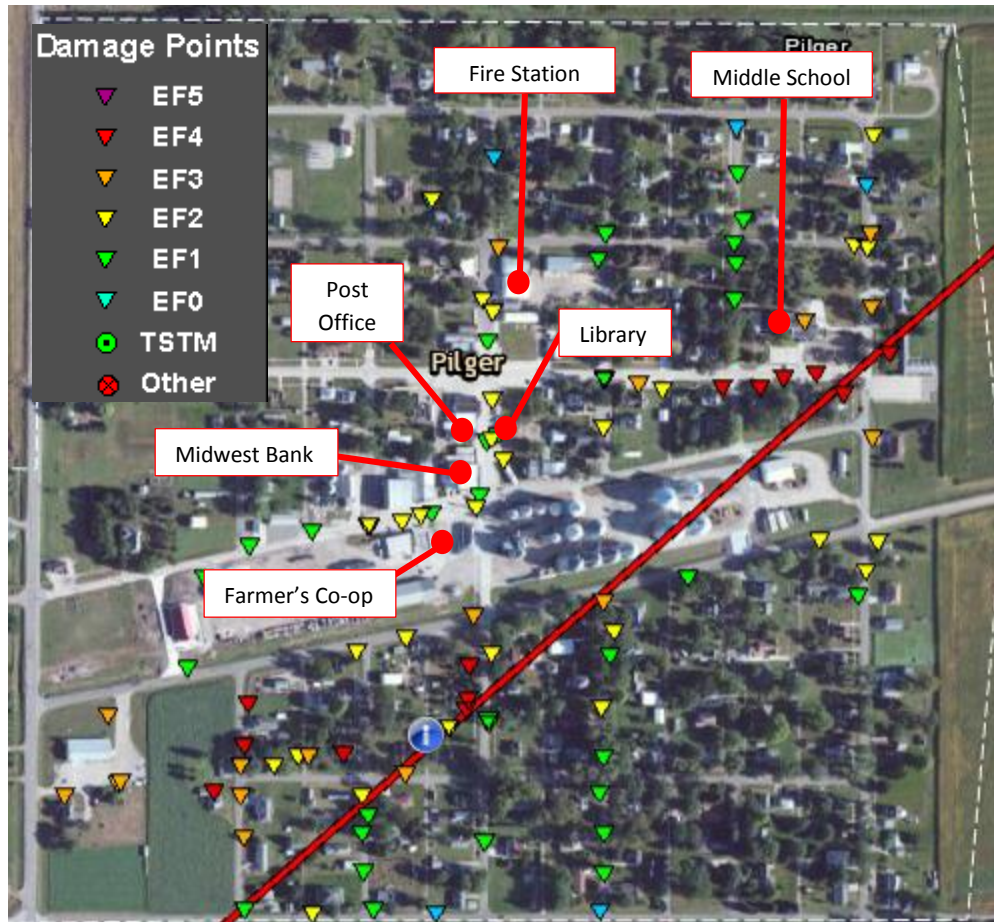
Figure 12: Preliminary results of NWS damage survey in Pilger, NE. The red line represents the estimated center of the EF-4 tornado as it passed through the town. Callouts provide the locations of key structures in the town damaged during the tornado.

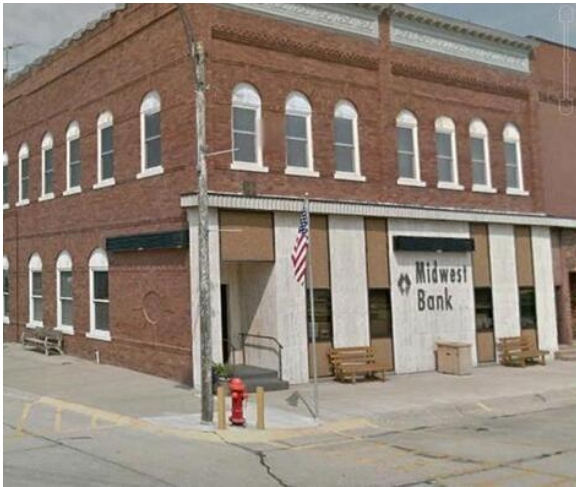
(a) Midwest Bank (before) looking NW

Figure 14: Before and after photos of damage to significant structures
