Online Damage Report

The 6 May 2015 Great Plains Tornado Outbreak and Flooding

University of Florida's Wind Hazard Damage Assessment Team

11 May 2015

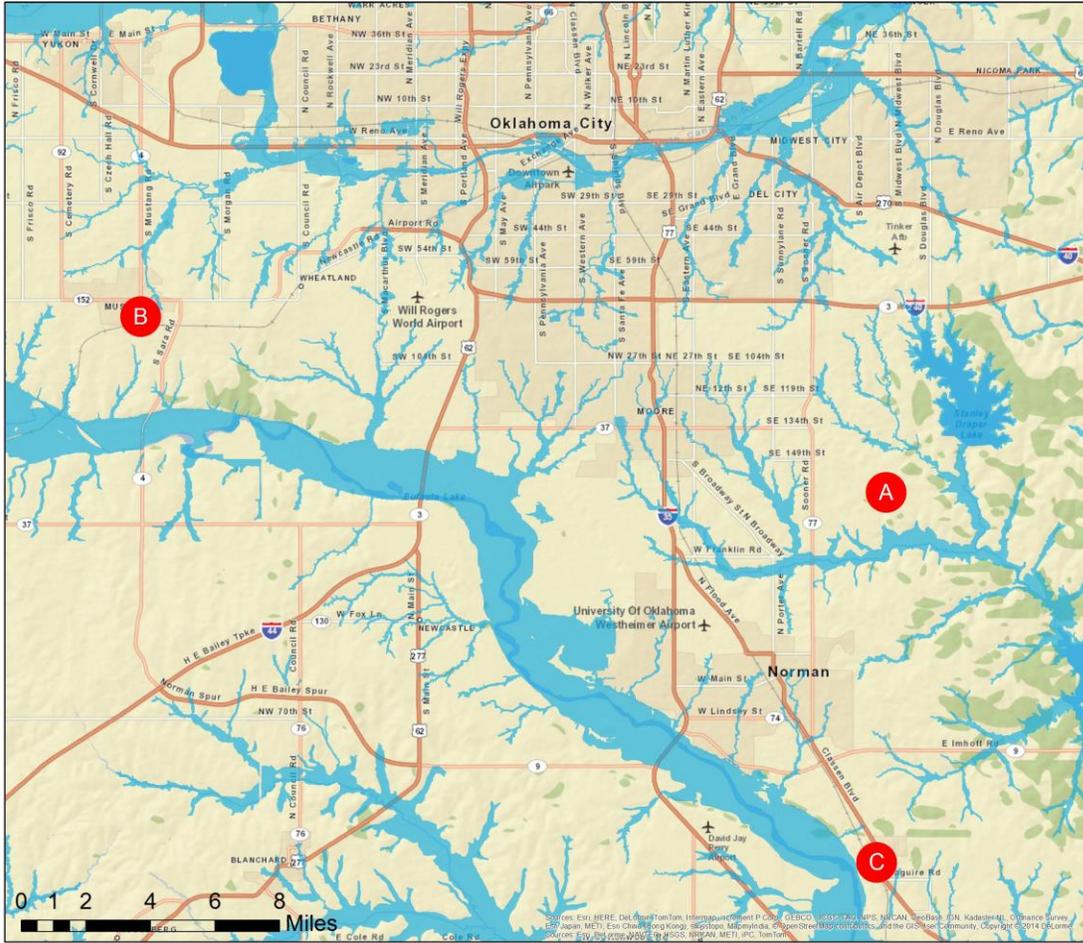
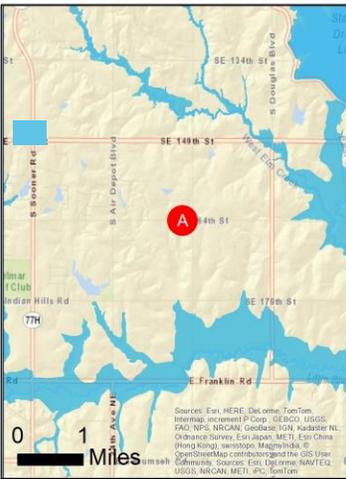
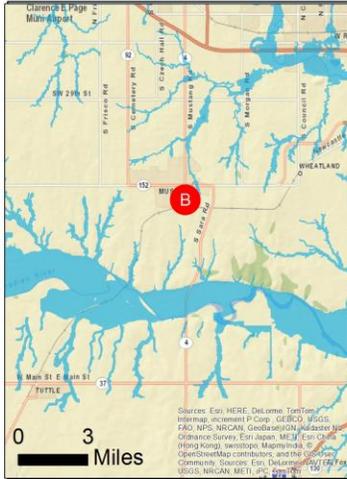
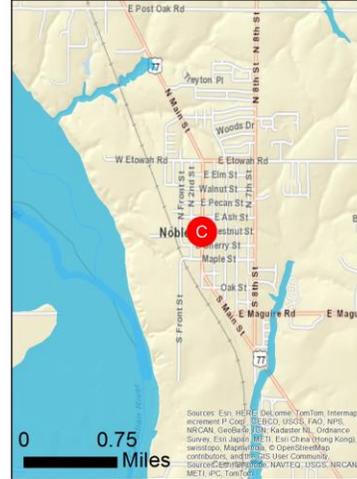
Only the exact location of the storm cellar fatality is known, and it is mapped in Figure 11 with the towns of Mustang, OK and Noble, OK along with the FEMA 100 year flood zones for this area. Without the exact locations of the storm shelters it cannot be determined whether they were located in a designated flood plain or not. The exact location of the fatality due to flooding of a storm cellar is known, and it was not located in a 100 year flood zone.

Figure 11: FEMA 100 year flood zones near Oklahoma City, OK (indicated by blue fill). (A) is the specific location of the fatality caused by flooding of underground storm cellar. (B) is the general location of Mustang, OK where a floating storm shelter was reported. And (C) is the general location of Noble, OK where another floating storm shelter was reported.

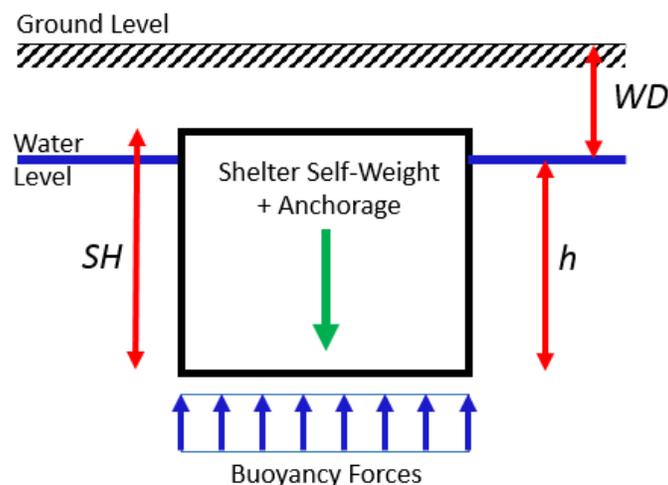
Figure 12: Simple force diagram for an underground storm shelter ignoring lateral and friction forces. (WD) is the depth from ground to the water level, defined here as the water table or surface of saturated soil enveloping the shelter; (SH) is the height of the storm shelter; (h) is the distance from the water level to the bottom level of the storm shelter.

The buoyancy forces estimated as weight of water displaced by the shelter volume that is below the water level, defined here as the water table or surface of saturated soil enveloping the shelter, as

where δ_w is the density of water (62.4 pcf) and h is the distance from the water table to the bottom level of the storm shelter.

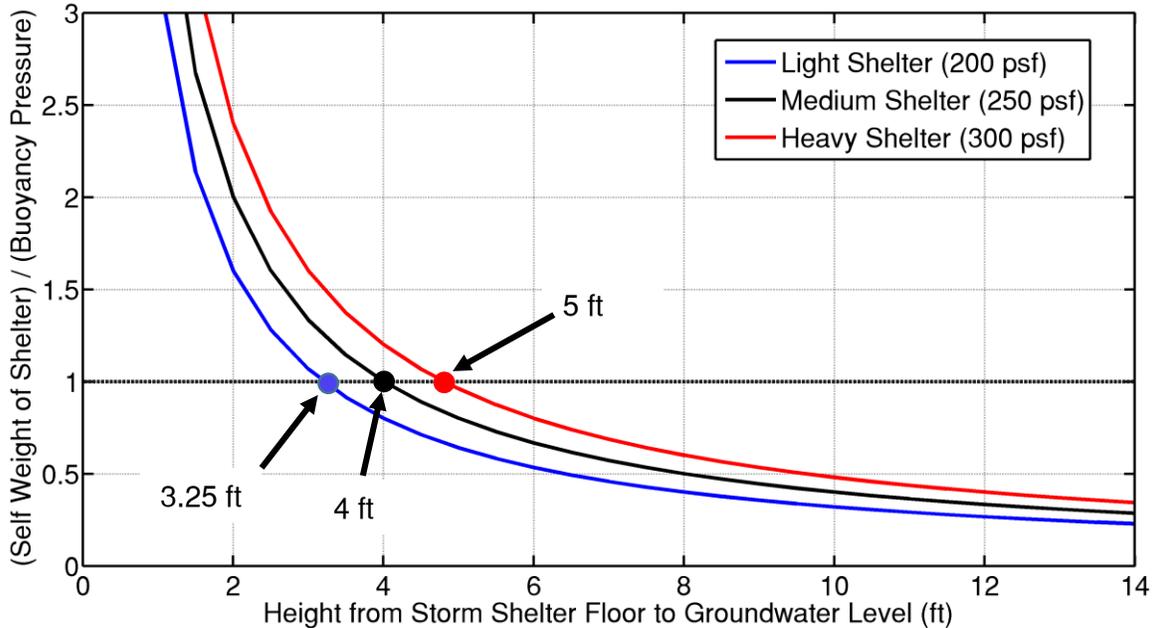
Figure 13: Critical distances from water table to storm shelter floor for light, medium and heavy storm shelters assuming a shelter height of 6 feet.

For storm shelters with self-weights between 200 and 300 psf, the water table need only be 3-5 feet above the floor of the shelter for the self-weight to be exceeded, triggering the need for additional anchorage and/or ballast to increase self-weight of the storm shelter. ICC 500 requires that underground storm shelter designs must assume that the water table is at the ground level, meaning that for a 6 foot high storm shelter, anchorage must resist the additional forces. This is exemplified for a series of cases below, assuming a 5ft

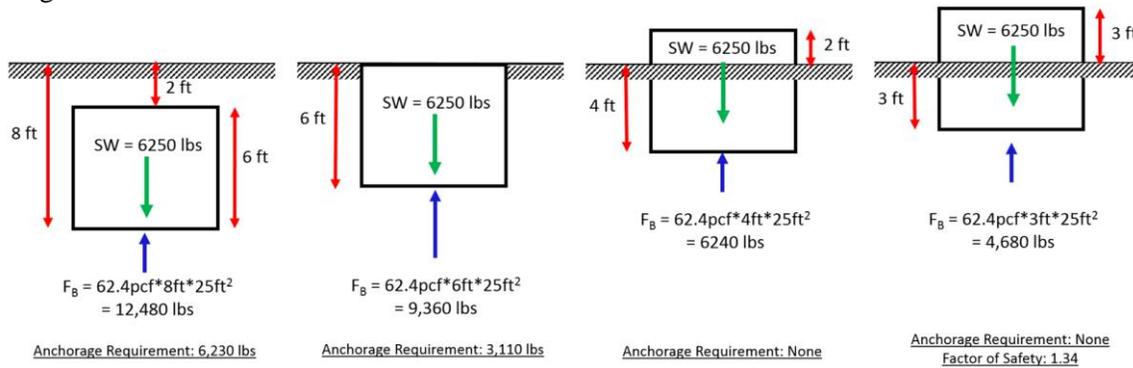
Figure 14: Anchorage requirements for underground storm shelters of various depths, assuming water table is at ground level (indicated by diagonal hatch) in accordance with ICC 500.

If ICC 500 Standards for the Design and Construction of Storm Shelters were used as a design basis, regardless of current water table existing at the time the shelter was designed, the underground storm shelters which lifted out of the ground appear to have been inadequately anchored. But a more in-depth analysis should be performed once more details are available to identify how similar failures can be prevented.
