Online Damage Report

The 25 September 2015 Johns Island Tornado

28 September 2015

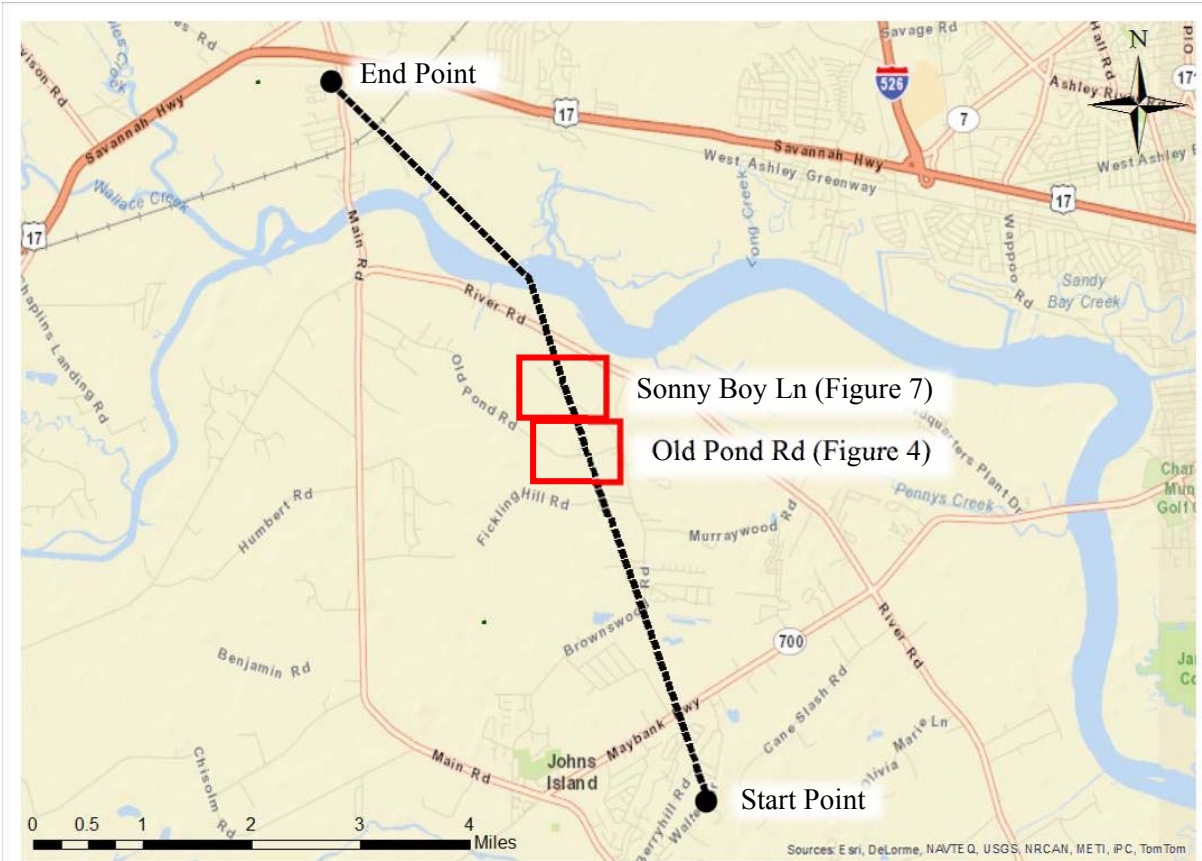
Figure 3: Overview of approximate damage path (dashed black line) through Johns Island, SC with areas of major damage shown in red outlines.

The damage reports available online focused on damage to homes along Sonny Boy Ln and Old Pond Rd. Tree damage and minor structure damage was also reported on several other roads, including Brownswood Rd, Fickling Hill Rd and River Rd, which were closed for portions of time while crews cleared the debris. Figure 4 through Figure 8 illustrates some of the damages observed along Old Pond Rd and Sonny Boy Ln.

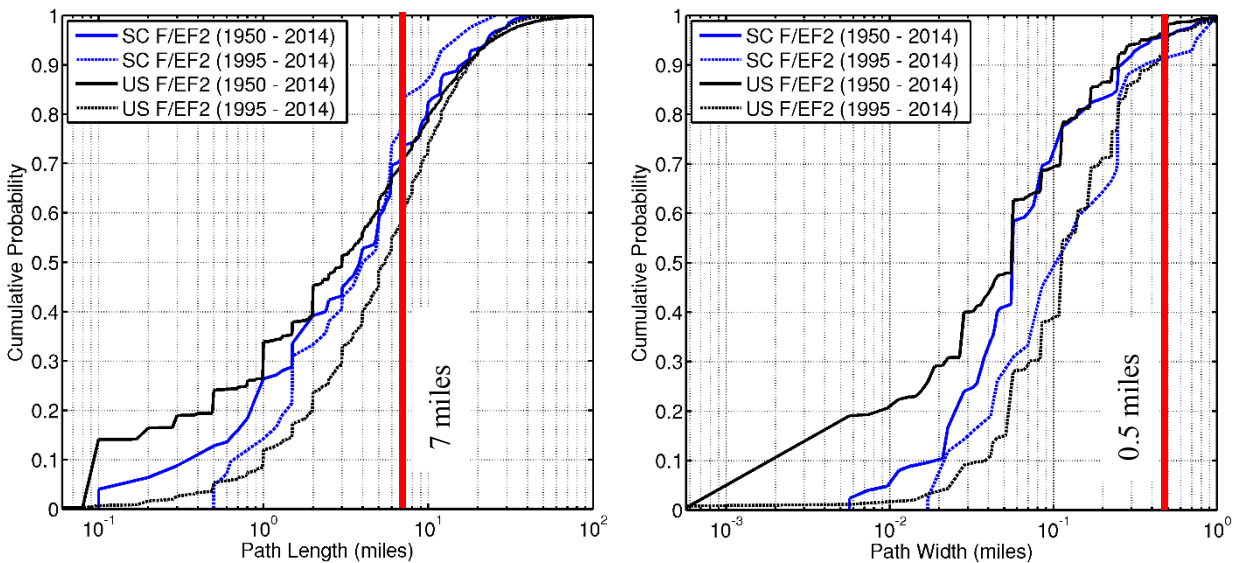
Figure 12: Empirical distributions of EF2 tornado path length and path width for South Carolina (blue lines) and the entire US (black lines). Distributions are shown for the entire SPC record (1950 – 2014) and for 1995 – 2014, since the definition of tornado path width was changed in 1994 to represent the maximum path width rather than the mean path width. The path length is in at least the 70th percentile, and the path width is in at least the 90th percentile, for EF2 tornadoes in South Carolina.
