## Southeastern US Tornado Outbreak 21-22 January 2017

**Destruction of Albany Baptist Church in Albany, GA**

**University of Florida's Wind Hazard Damage Assessment Group**

## EXECUTIVE SUMMARY

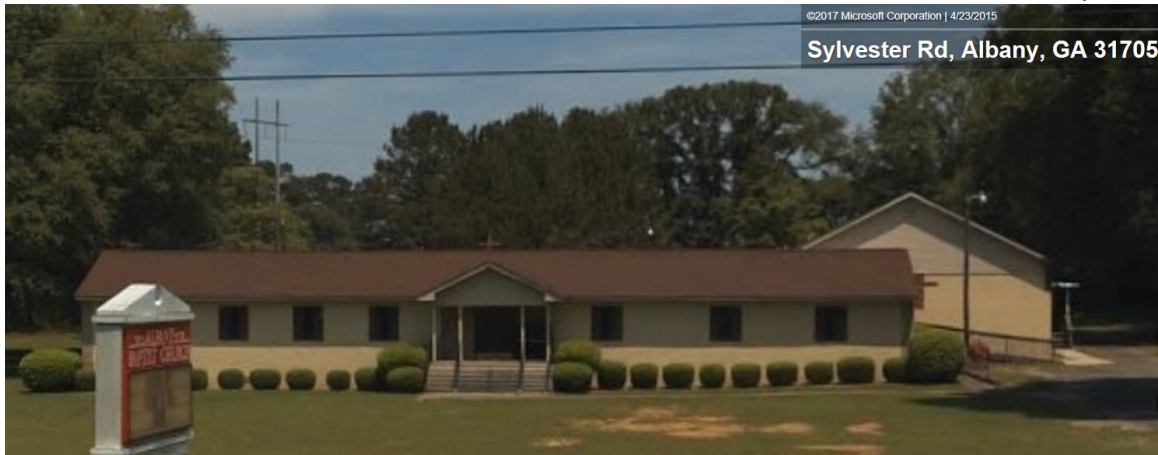
Albany Baptist Church is located at 3515 Sylvester Rd consisting of two main buildings, a fellowship hall which used to be the sanctuary, and a new sanctuary was built in 2002. Figure 20 and Figure 21 show before and after views of the church. The old sanctuary, is in the foreground and it is light-framed wood structure. The building in the background is the new sanctuary, and it is a reinforced concrete masonry units (CMU) block exterior walls with metal plate wood truss roof structure. The CMU wall had grouted cells, with rebar, at 8 ft on center. A wood top plate was fastened to the tie beam along the top of the wall with  $\frac{1}{2}$ -inch j-bolts at 4 ft on center. Trusses were spaced at 2 ft on center with a 32 inch overhang, and were fastened to the wood top plate using USP RT12 connectors with (3) 8d nails in each leg of the connector. USP gives an allowable wind uplift capacity of these connectors as 355 lbs. Further analysis is being conducted to estimate the wind speed necessary to cause the observed failures.

While the enhanced construction (at least relative to typical residential structures) might have enabled the church to perform better than it did, several factors may have contributed to its catastrophic failure, including the following:

- 2) The layout of the buildings on the property, with the older, wood-frame structure in front of the newer sanctuary, may have resulted in the older building failing first and the debris impacting the new building, breaching the envelope and increasing the loads.

- 3) The orientation of the new sanctuary was such that the gable end was in the oncoming path of the tornado. Winds coming from that direction impinging on the gable end of a structure typically produce the worst-case loading condition for the roof.

- 4) The relatively large overhang of 32 inches allows positive pressures on the underside of the overhang to add to the uplift pressures on the top of the roof surface, significantly increasing the uplift loads on the roof-to-wall connections.

Figure 20: Front view of Albany Baptist Church before the tornado using Bing Streetside.

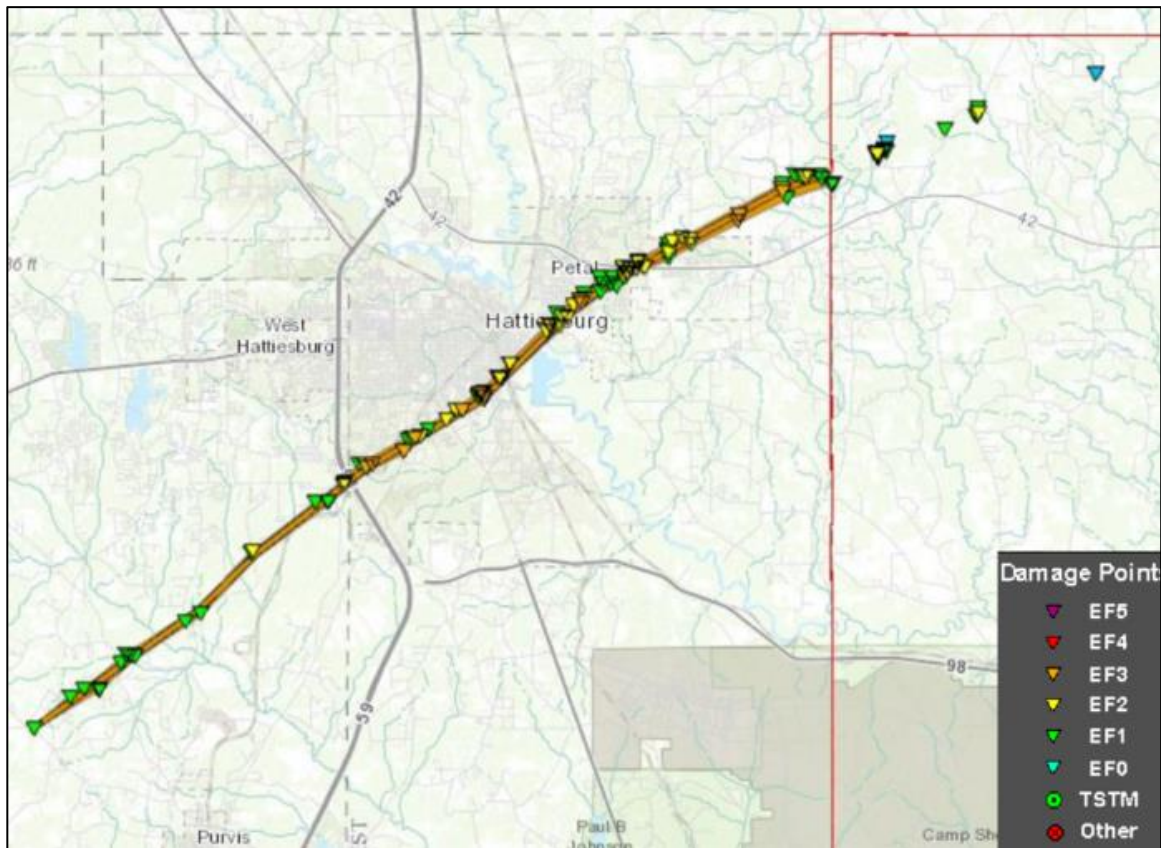
The tornado which struck Hattiesburg and Petal, MS has been given a preliminary EF3 rating, with maximum wind speeds estimated at 145 mph. The tornado was on the ground for approximately 31.3 miles and the widest swath of damage was 0.5 miles, according to the NWS Jackson, MS office (<http://www.weather.gov/jan/20170121tor>). As of 1 PM on 23 January, the [Mississippi Emergency Management Agency](#) reported 1,220 homes were damaged in eight counties from the severe weather, with 1,131 of these in Forrest County, where Hattiesburg and Petal are located. Of these 1,131, 499 were deemed destroyed. Four fatalities and 56 injuries were reported in Forrest County. Significant damage was sustained by a variety of structures, including older homes closer to downtown Hattiesburg, institutional buildings at William Carey University, fire stations and churches.

Figure 23: Damage path through Hattiesburg, MS from the NWS Jackson, MS office.

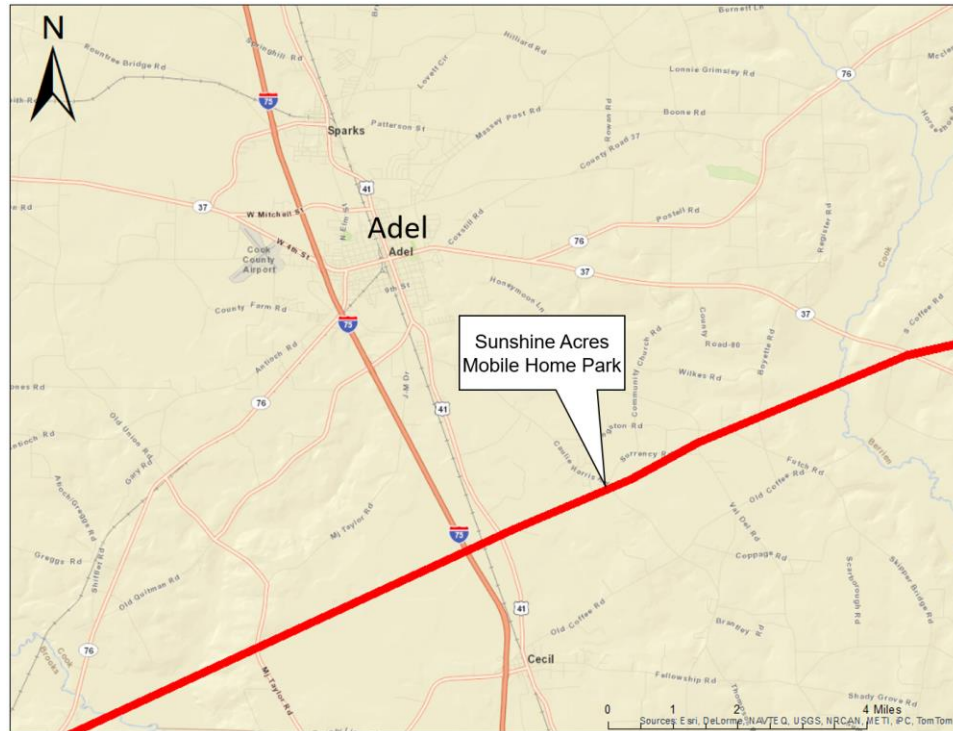
Adel is a small community of approximately 5,344 people in Cook County, GA. A tornado struck the southern outskirts of the town early in the morning of 22 January. A mobile home park about 3 miles southeast of Adel suffered the most damage, with seven confirmed fatalities and at least 15 homes leveled according to local reports. Much of the area directly in the tornado path was rural, with the exception of Sunshine Acres and a few site-built homes that sustained heavy damage. The damage and fatalities could have been even more extensive if the tornado had traveled a few miles north of its path, as shown in Figure 26.

Figure 26: Location of Sunshine Acres, where seven fatalities occurred, relative to Adel, GA.
